Service Bulletin

17-021

Safety Recall: 2017 RDX Certification Label

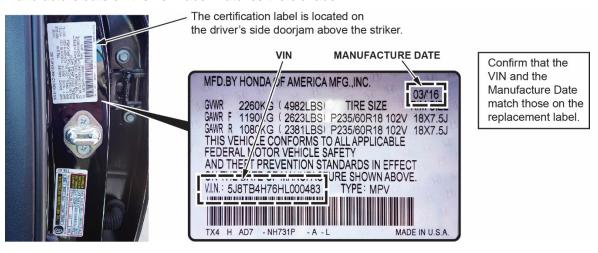
2. Confirm the VIN on the dashboard matches the VIN on the new certification label. Also, make sure the VIN and manufacture date on the new label matches the old label.

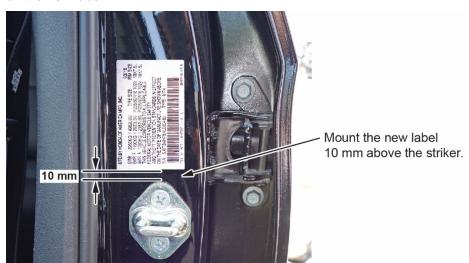
5. Apply the new certification label 10mm above the striker. Make sure the label is applied in the same orientation as the removed label.

NOTE: Make sure the label is properly applied to the body, and make sure there are no wrinkles, tears, or bubbles on the new label.
