## INSTRUCTIONS TO PERFORM RECALL CAMPAIGN 145

- Certain 2014 - 2017 model year Winnebago View<sup>®</sup>, Era<sup>®</sup>, and Via<sup>®</sup> and Itasca Navion<sup>®</sup> and Reyo<sup>®</sup> motorhomes.
- These motorhomes were manufactured from May 28, 2014 through August 8, 2016.

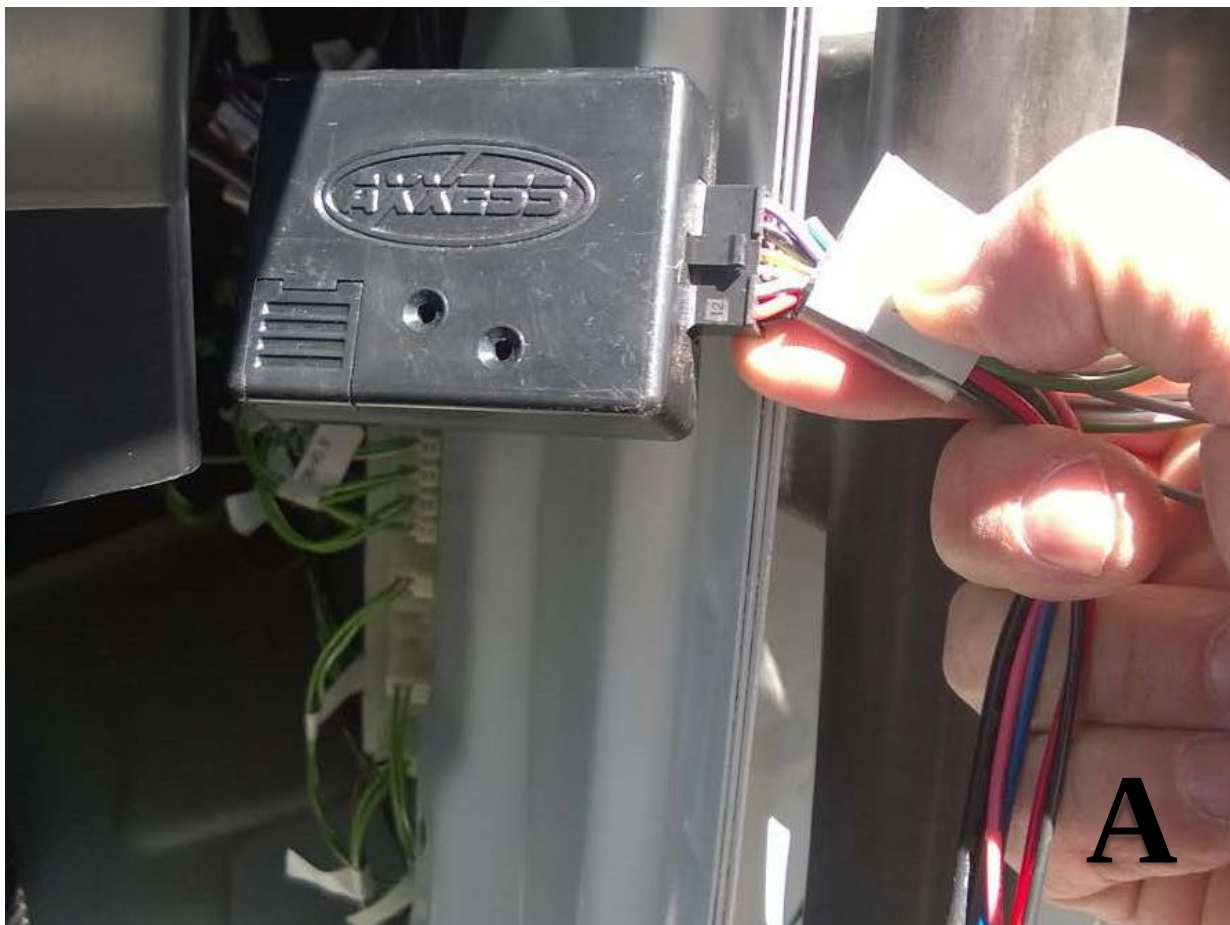
- Locate the Axxess radio volume control module by removing the passenger side kick panel.
- Identify the module as shown in Photo A.
- Unplug the white six- (6-) position wire connector and remove both the module and the harness from the vehicle.
- Dispose of the module and harness.
- Reinstall the kick panel.
