**Gillig Campaign ID Number: 17V-263**

### **RECALL REMEDY INSTRUCTIONS**

| <b>Topic:</b> | Inspection and Rework Procedure for Valve Snap Rings in Norgren Suspension Kneeling Modules<br> |

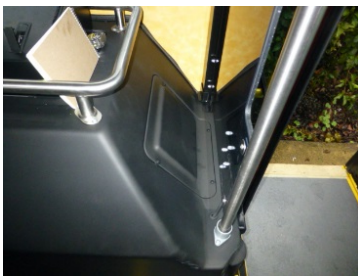
Detail 1  
35'/40' Bus with Taper  
Top Wheelwell,

2. Locate and remove the kneeling valve access cover.

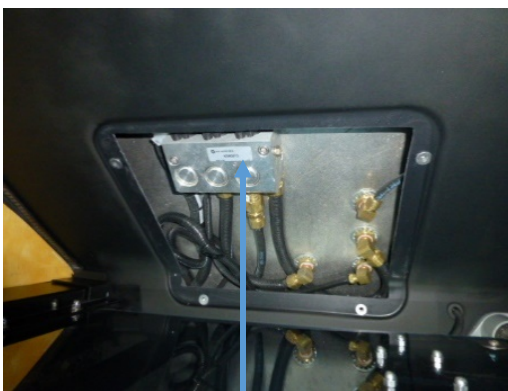
**Date Codes that require rework: M15, A16, B16, C16, D16, E16, F16, G16**

Date code on decal on face of  
kneeling module.

3. If possible, locate the part number decal and confirm the date code. If the date code is not one of the following, no further inspection and rework is required. Reinstall cover and inspection/rework of the front module is complete.

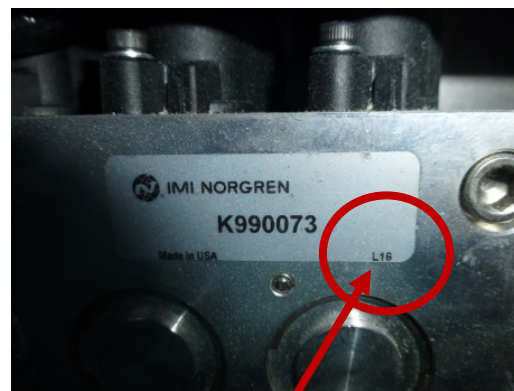
Date Code is in lower right hand corner.  
The date code on this module is "L16."  
Therefore, it does not require rework.

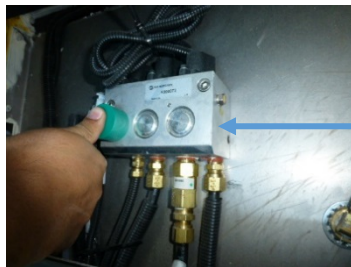
Place snap ring tool into snap ring cavity and press down by hand. Apply moderate force about 3-8 lbs. to seat snap ring. Repeat in all snap ring cavities.

*(The 3-valve module is shown in the picture. Your front module may have 3 or 5 valves to reset.)*

Place the snap ring tool over the snap ring/valve cavity and press down by hand with only moderate pressure (about 3-8 lbs.) to press the snap ring to the correct position. If you push the tool all the way into the cavity and nothing happens (i.e., no snapping noise), the ring is already properly seated. No further actions are required for that cavity. Repeat procedure on all the snap ring/valve cavities. Kneeling modules have 3 or 5 snap ring cavities depending upon application.

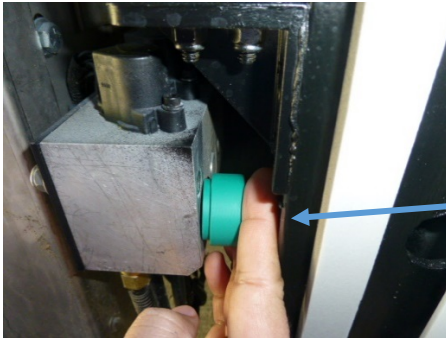
Insert snap ring tool into snap ring cavity. Press down by hand with moderate force about 3-8 lbs. to seat snap ring. Repeat for all 3 cavities in the rear module.

6. ⚠ Place the snap ring tool over the snap ring/valve cavity and press down by hand with only moderate pressure (about 3-8 lbs.) to press the snap ring to the correct position. If you push the tool all the way into the cavity and nothing happens (i.e., no snapping noise), the ring is already properly seated. No further actions are required for that cavity. Repeat on all 3 snap ring cavities.
