RECALL CAMPAIGN BULLETIN

NTB17-088a

VOLUNTARY RECALL CAMPAIGN 2016-2017 TITAN; REAR SEAT BELTS

CAMPAIGN ID #: R1719
NHTSA #: 17V-268
APPLIED VEHICLES: 2016-2017 Titan (A61) with Crew Cab
2016-2017 Titan XD (X61) with Crew Cab

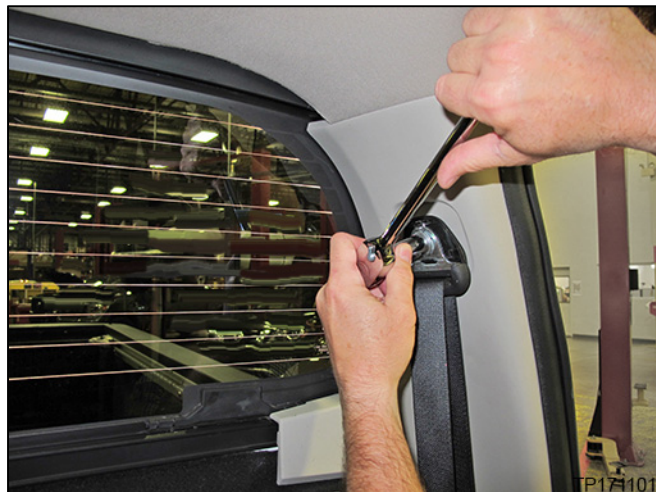
Figure 6

4. Remove D-ring anchor bolt.

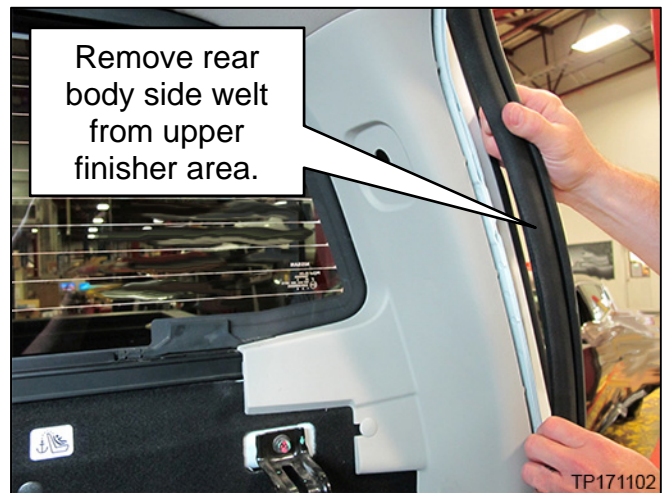
Figure 7

5. Partially remove the rear body side welt from the rear pillar upper finisher area.

- Do not completely remove the body side welt. Remove only in the area shown.

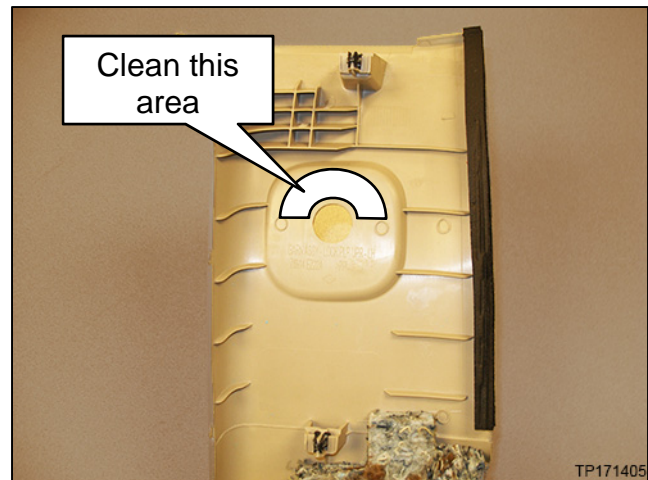
Figure 10

8. On the rear side of the rear pillar upper finisher, use isopropyl alcohol to clean the area indicated in Figure 10.

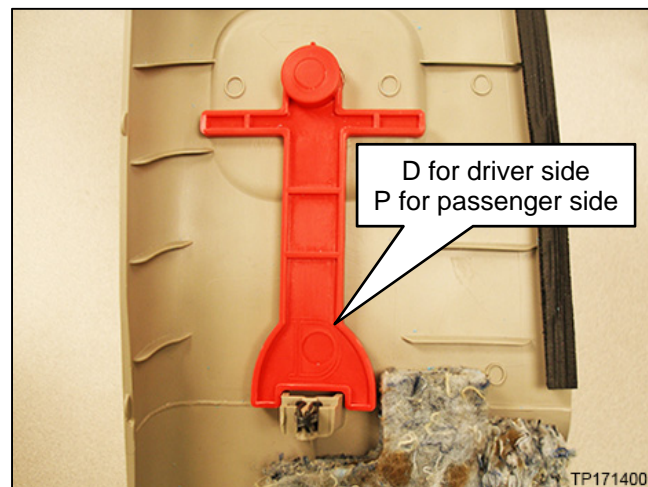
Figure 11

9. Position J-52504 on the rear pillar upper finisher. This will be used as a guide to install the foam spacer.
- Insert the upper part of J-52504 into the shoulder anchor bolt access hole.
 - Position the lower part of J-52504 onto the retaining clip holder.

Position J-52504 so that the letter "D" faces up when working on the driver side.

Position J-52504 so that the letter "P" faces up when working on the passenger side.

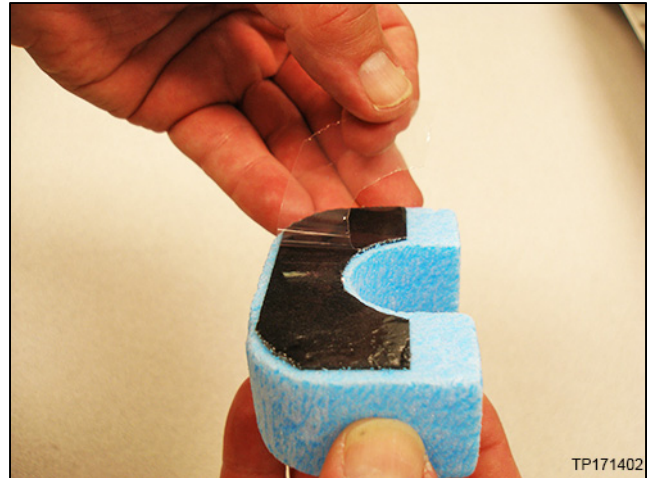
Figure 12

NOTE: Do not remove the protective cover until ready to affix to the rear pillar upper finisher.

10. Peel the protective cover away from the adhesive on the foam spacer.

IMPORTANT: The adhesive is very aggressive. Once the foam spacer is attached to the rear pillar upper finisher, it cannot be moved.

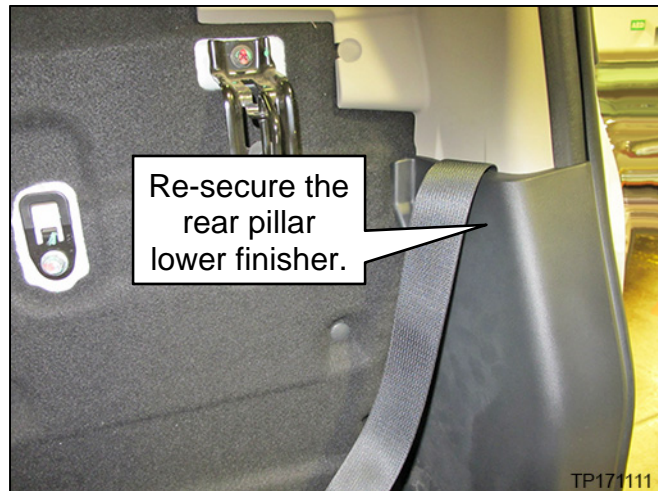
Figure 16

17. Re-secure the top of the rear pillar lower finisher.

- Make sure all clips are fully seated into the clip holes.
- Make sure the body side welt is not pinched under the lower finisher.

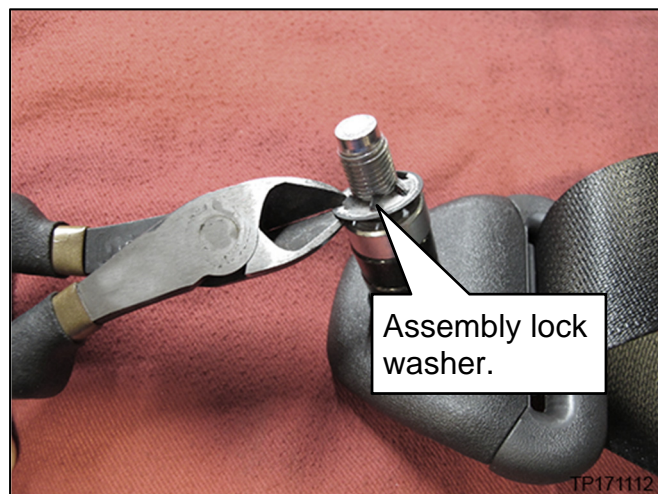
Figure 17

18. Remove the assembly lock washer holding the 4 spacers on the D-ring anchor bolt.

- Use a suitable tool to cut or bend as needed to remove lock washer.

NOTE: The lock washer will not be reused. A new one will **NOT** be installed.

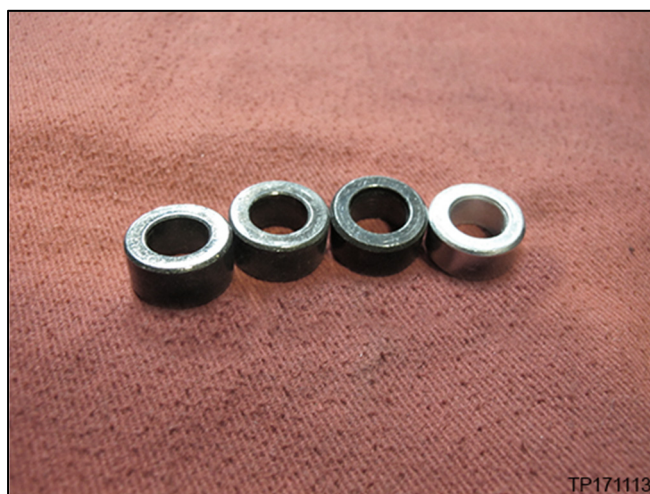
Figure 18

19. Remove the 4 spacers from the anchor bolt and retain for reinstallation.

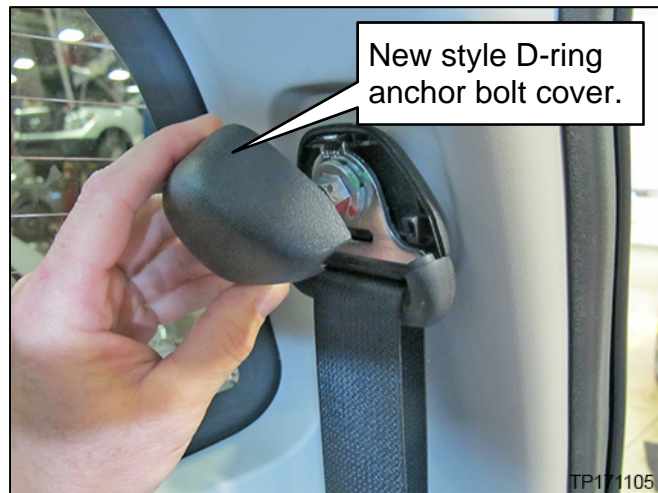
Figure 22

25. Install **new** style D-ring anchor bolt cover.

- New cover is listed in the **PARTS INFORMATION** section of this bulletin.
