## RECALL CAMPAIGN BULLETIN

NTB17-088

### VOLUNTARY RECALL CAMPAIGN 2016-2017 TITAN; REAR SEAT BELTS

**CAMPAIGN ID #:** R1719  
**NHTSA #:** 17V-268  
**APPLIED VEHICLES:** 2016-2017 Titan (A61) with Crew Cab  
2016-2017 Titan XD (X61) with Crew Cab

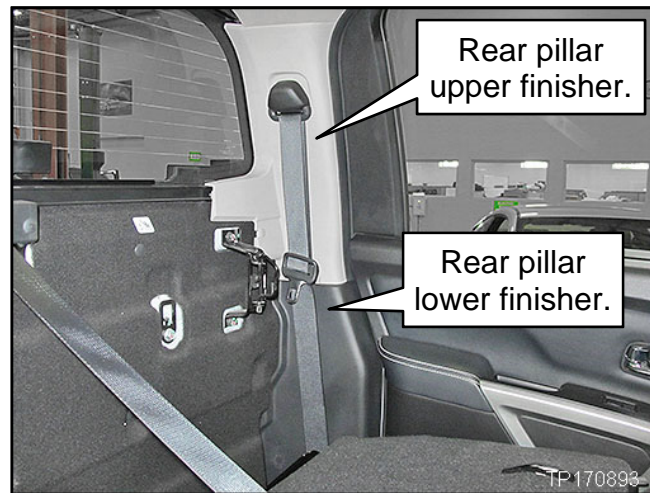
Figure 1

1. Fold the rear seat backs into the down position to gain access to the rear pillar upper and lower finishers.

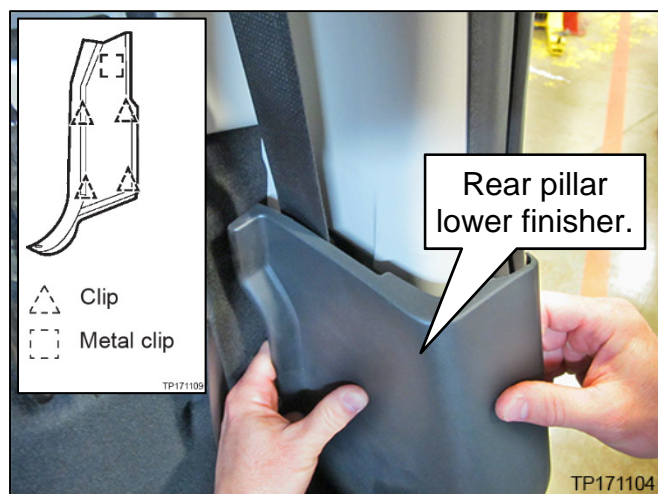
Figure 2

2. Gently unclip the top of the rear pillar lower finisher to allow access to remove the upper finisher.
  - The lower finisher **does not** need to be completely removed.
  - Use a plastic trim tool as needed.
  - Unclipping the top will allow access to remove the upper finisher.

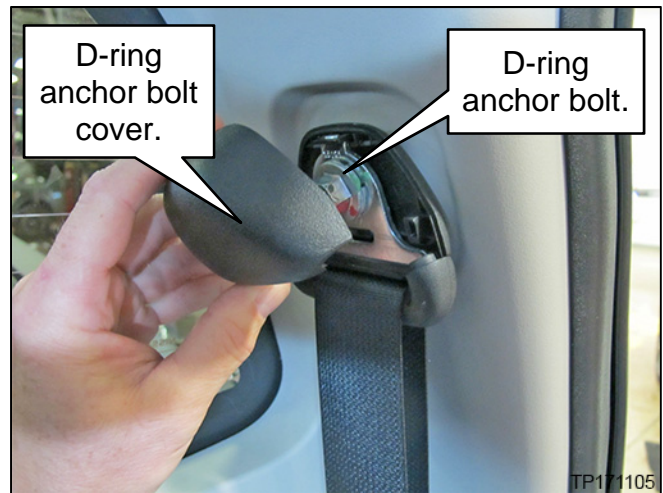
Figure 3

3. Remove (unclip) the D-ring anchor bolt cover from the rear pillar upper finisher.

- Use a plastic trim tool as needed.

**NOTE:** This cover will not be reused. A new one will be installed.

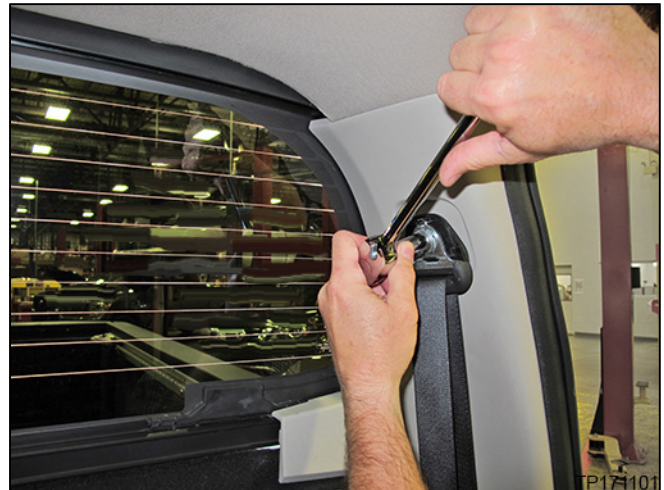
Figure 4

4. Remove D-ring anchor bolt.

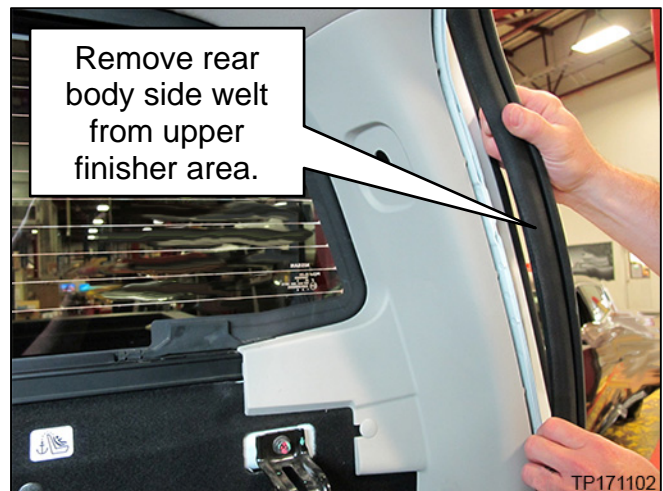
Figure 5

5. Partially remove the rear body side welt from the rear pillar upper finisher area.

- Do not completely remove the body side welt. Remove only in the area shown.

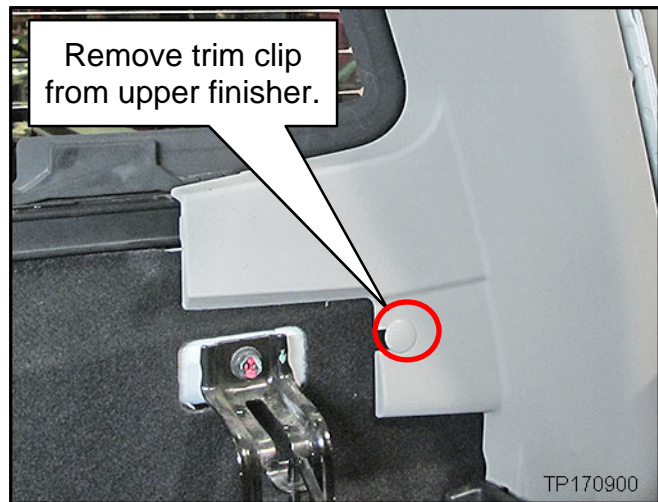
Figure 6

6. Gently remove the trim clip shown in Figure 6.

- Use a plastic trim tool as needed.
- Do not damage the clip – it will be reused.

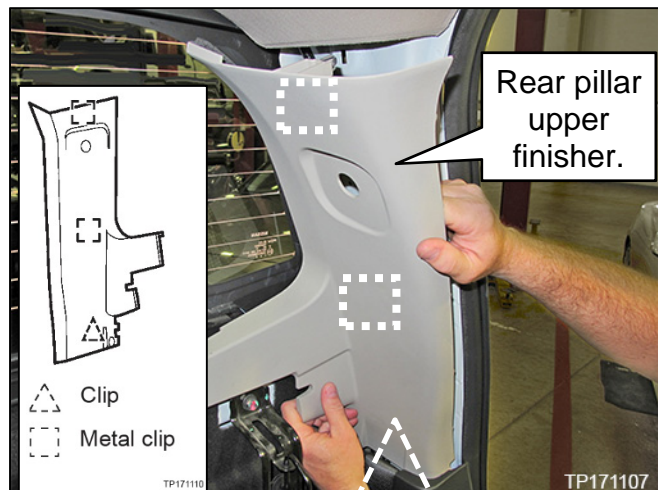
Figure 7

7. Remove the rear pillar upper finisher by releasing the clips shown in Figure 7.

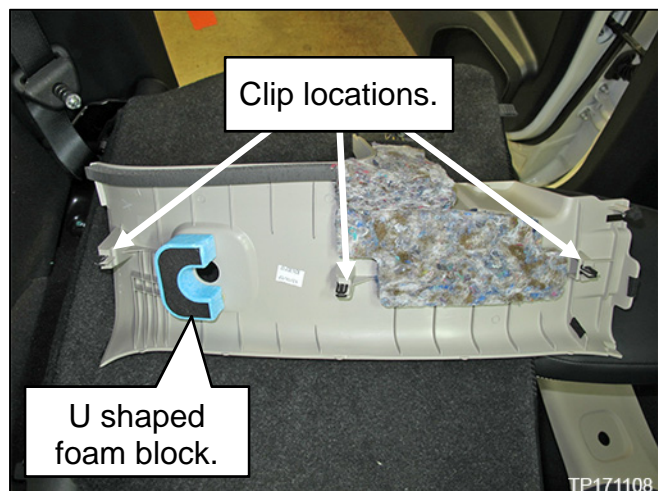
Figure 8

8. Obtain the new rear pillar upper finisher.

- New upper finisher is listed in the Parts Information.

**NOTE:** Verify that the **NEW** rear pillar upper finisher is equipped with a U shaped foam block near the D-ring anchor bolt hole.

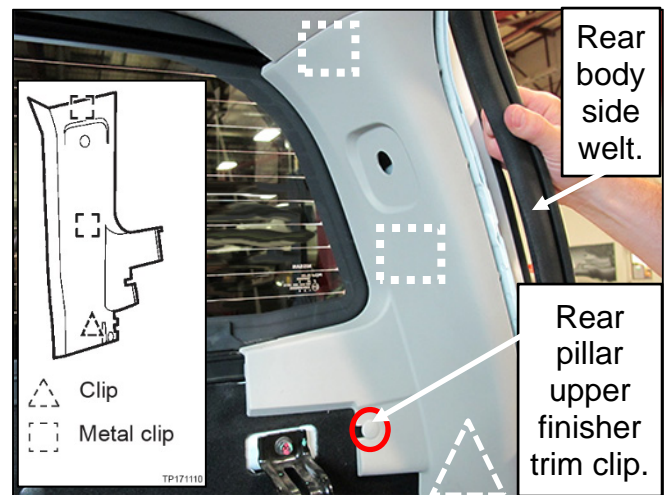
Figure 9

9. Install the new rear pillar upper finisher.
10. Reinstall the trim clip.
11. Reinstall the body side welt on rear pillar.

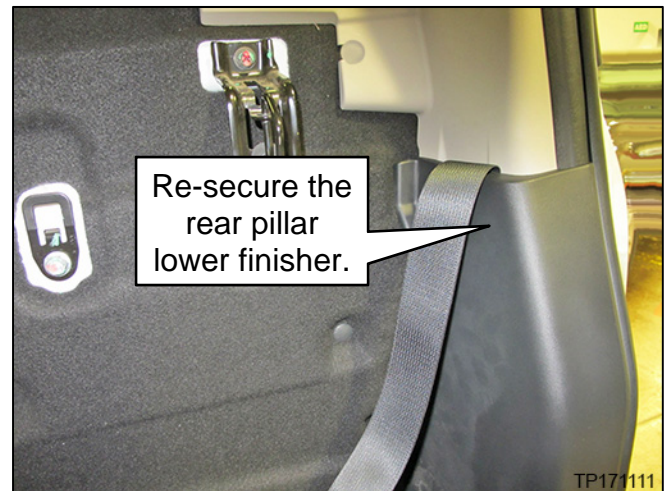
Figure 10

12. Re-secure the top of the rear pillar lower finisher.
  - Make sure all clips are fully seated into the clip holes.
  - Make sure the body side welt is not pinched under the lower finisher.

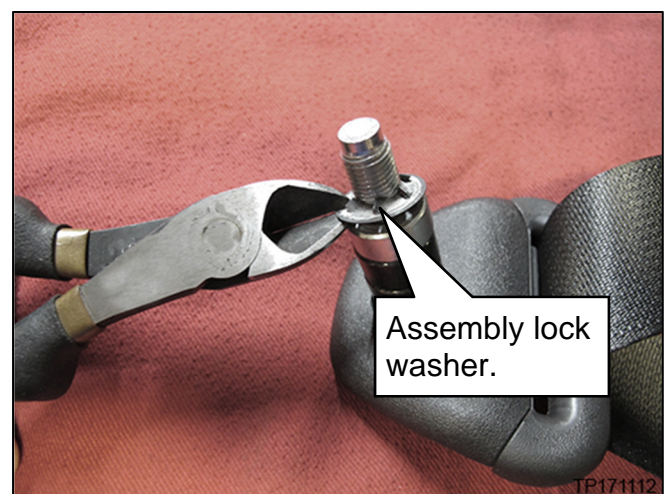
Figure 11

13. Remove the assembly lock washer holding the 4 spacers on the bolt.
  - Use a suitable tool to cut or bend as needed to remove lock washer.

**NOTE:** The lock washer will not be reused. A new one will **NOT** be installed.

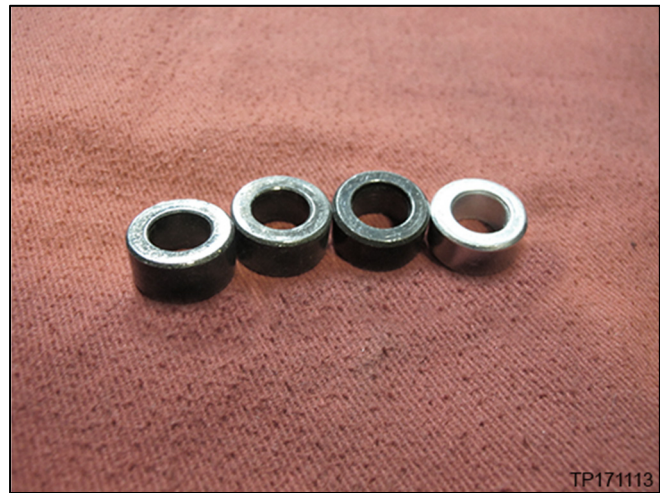
Figure 12

14. Remove the 4 spacers from the anchor bolt and retain for reinstallation.

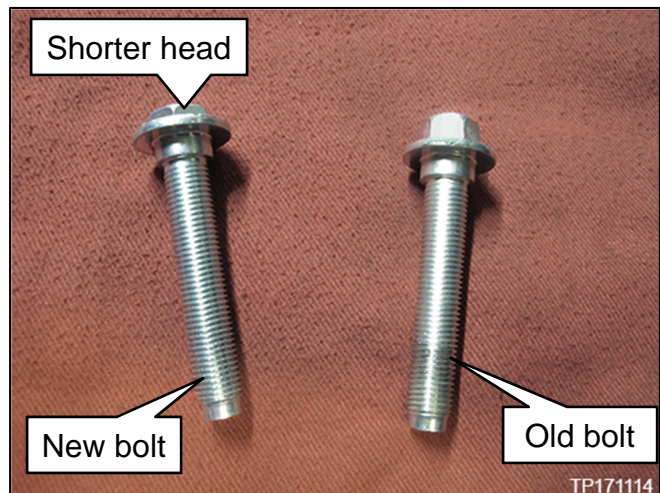
Figure 13

15. Remove the old anchor bolt from the D-ring anchor and install the new one.

- The new bolt is equipped with a shorter head than the old bolt.
- New style anchor bolt is listed in the Parts Information.

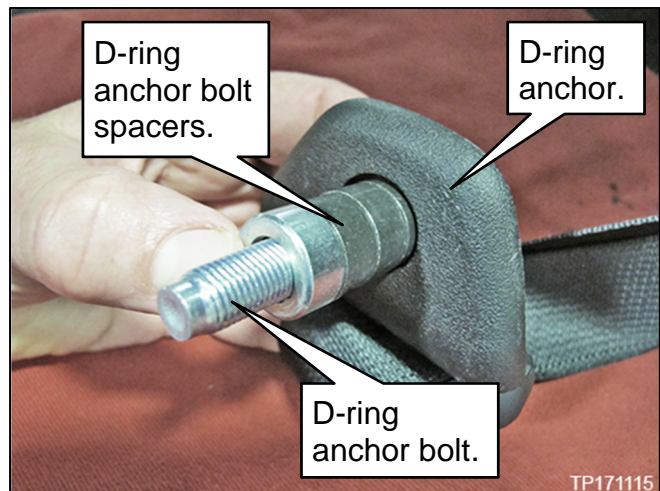
Figure 14

16. Install new D-ring anchor bolt into D-ring anchor.

17. Install D-ring anchor bolt spacers.

- These spacers were removed in step 14.
- Make sure all 4 spacers are installed.
- Spacers can be installed in any order.

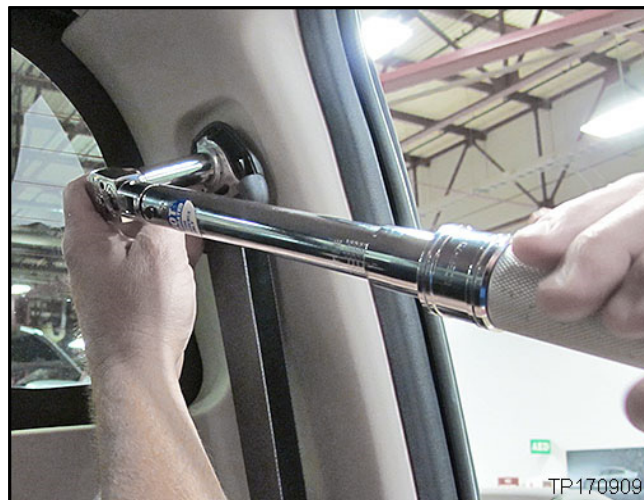
Figure 15

18. Install D-ring anchor bolt through new rear pillar upper finisher.

- Use caution to ensure the spacers do not slide off of the new D-ring anchor bolt.
- Verify the seat belt strap is properly routed and not twisted.

19. Torque the new D-ring anchor bolt to:  
49 N·m, (5 kg-m, **36 ft-lbs**)

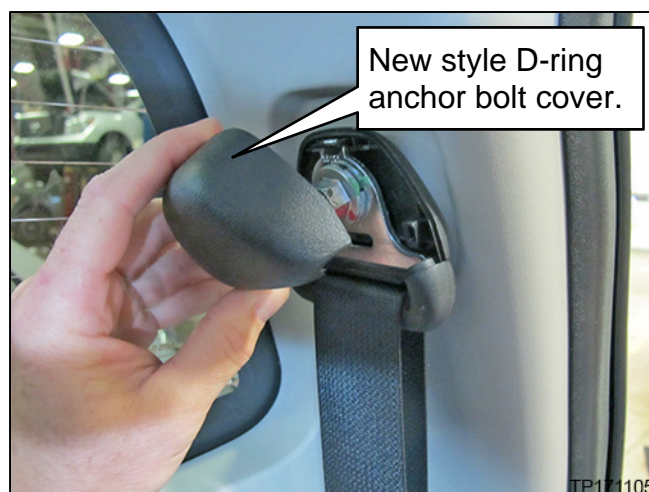
Figure 16

20. Install **new** style D-ring anchor bolt cover.

- New cover is listed in the Parts Information.

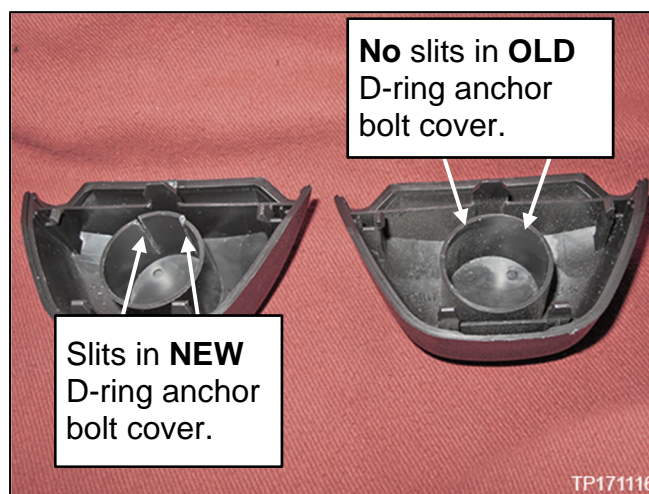
**NOTE:** Refer to Figure 17 to verify NEW style D-ring anchor bolt cover is being used.
