Dealer Service Instructions for:

Safety Recall T24 / NHTSA 17V-273

Sun Visor Labels

2014-2017 (VF) RAM ProMaster

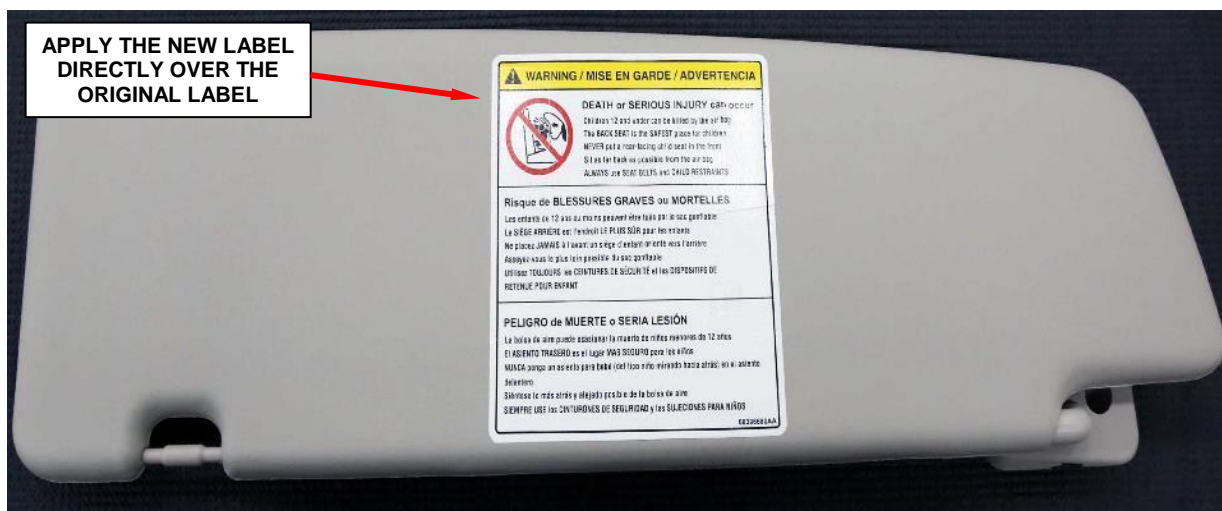
Figure 1 – Sun Visor Safety Label (Left-Side Shown)

1. Locate the original right and left side sun visor safety labels.
2. Clean the original labels with glass cleaner or equivalent using a soft cloth.
3. Starting with the left-side sun visor, remove one of the **supplied** sun visor safety labels from its paper backing and apply the **new** label directly over the original label (Figure 1).
4. Repeat Step 3 for the right-side sun visor safety label.
5. Firmly press and smooth the labels to ensure good adhesion.

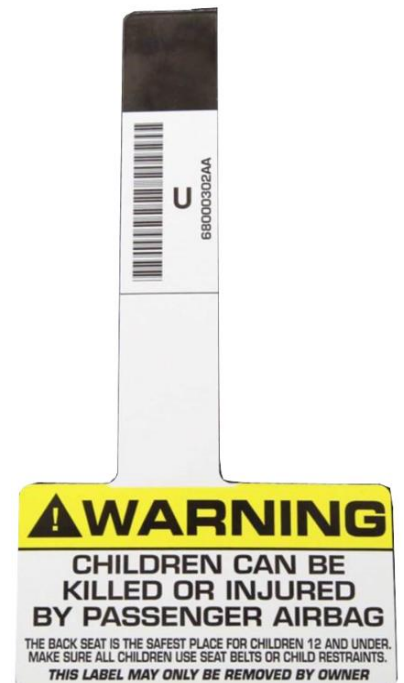
Figure 2 – Dashboard Hangtag Label

6. Locate the original dashboard hangtag label and discard.
7. Replace the original dashboard hangtag label with the new label (Figure 2).
8. Locate the original vehicle’s User’s Guide.
9. Remove the two paper backings from the **supplied** User's Guide Addendum (Figure 3).
10. Carefully position the User's Guide Addendum to the back cover of the original User’s Guide and press firmly to ensure good adhesion (Figure 3).
11. Return the User’s Guide to the vehicle.
