**POLARIS**

# TECHNICAL SERVICE BULLETIN

Bulletin Number: L-17-01-A/B  
Model Years: 2016-2017

#### 2016-2017 GEM STEEL WHEEL LUG NUT TORQUE

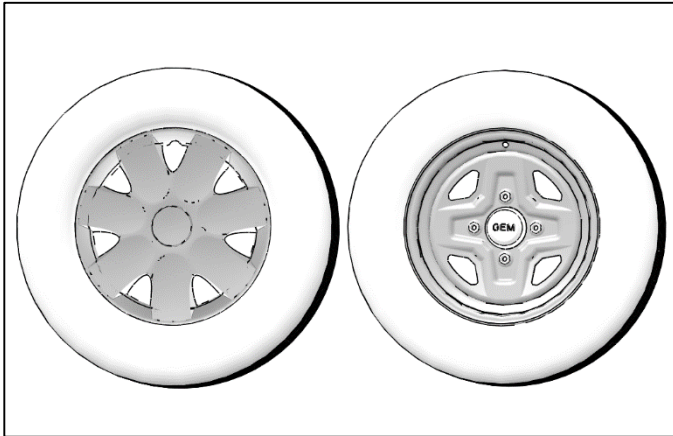
**AFFECTED**

On some models equipped with steel wheels, the wheel lugs may become loose over time, which may allow the wheel to separate from the vehicle and pose a safety hazard. Vehicles with aluminum wheels are not affected by this concern.

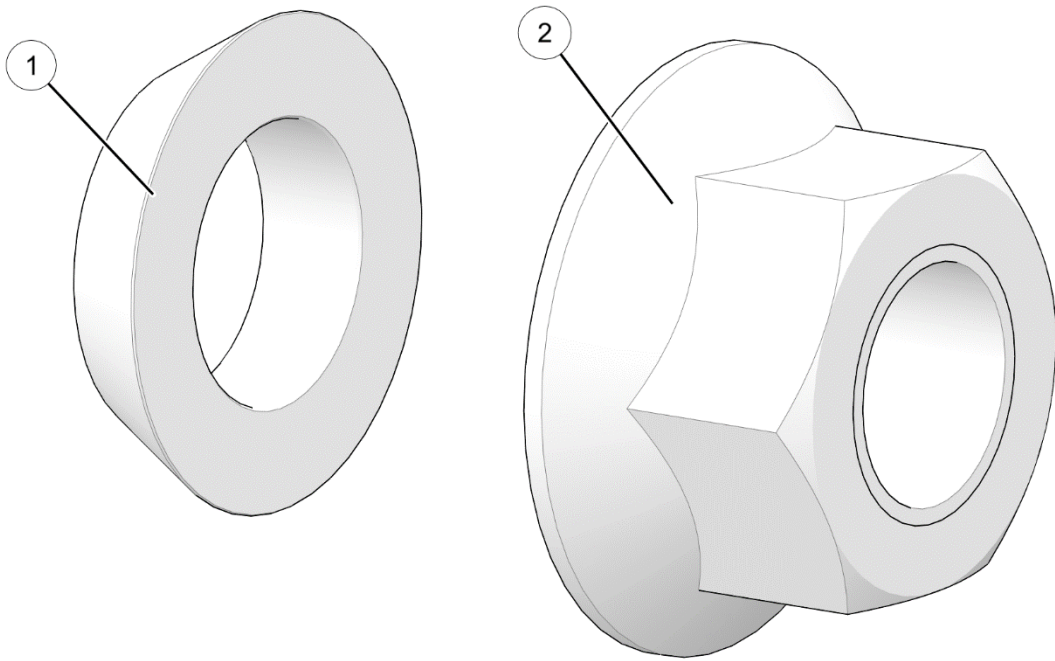
## KIT CONTENTS (P/N 2207415)

| REF | PART DESCRIPTION | PART NUMBER | QTY |
|---|---|---|---|
| ① | WASHER | 7557119 | 16 |
| ② | NUT | 7547908 | 16 |

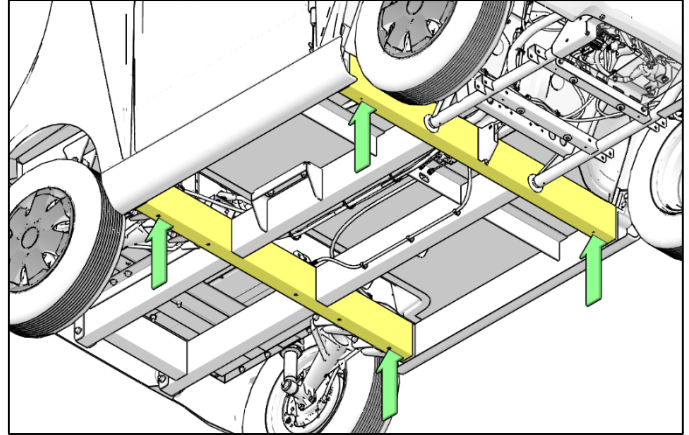
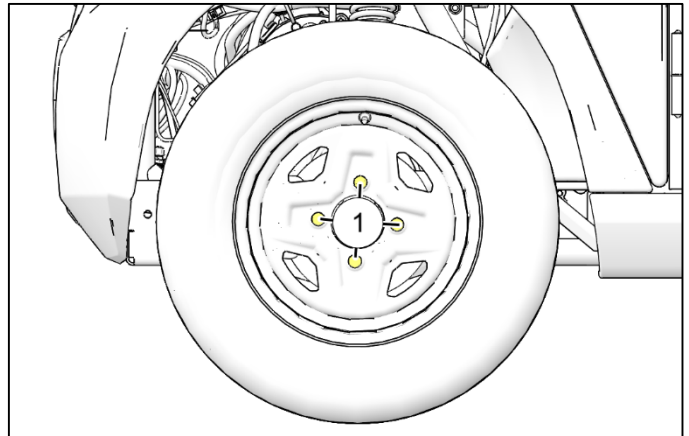
8. Remove and discard lug nuts ① from front wheels and remove front wheels.

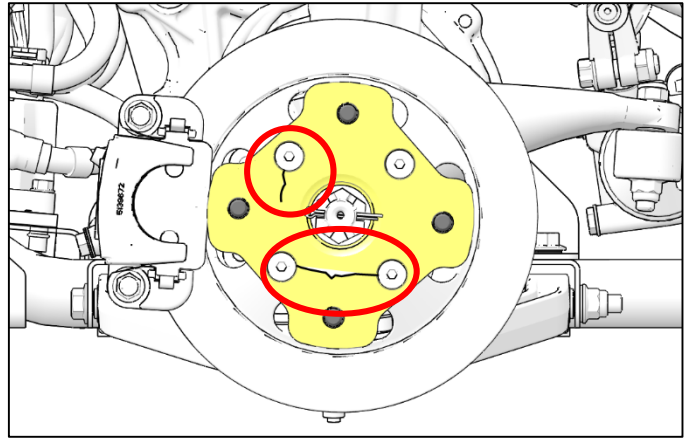
9. Inspect the wheel hub, studs, and wheel for any signs of cracks or damage. If damages are found, contact Polaris Technical service, or submit an Ask Polaris case.

A secondary dealer representative must verify the wheel hub, studs, and wheel do not show any signs of damage.

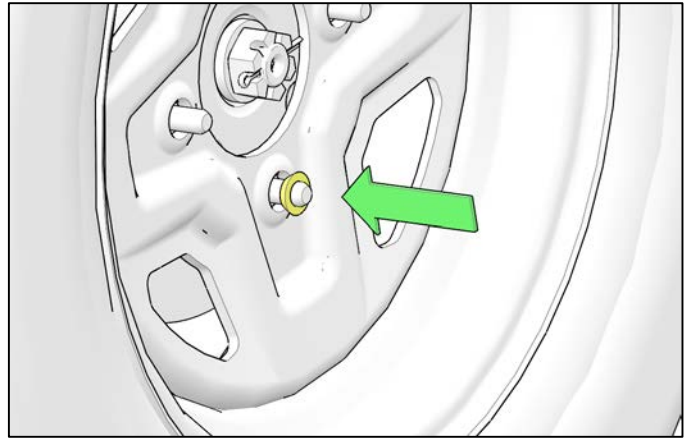
11. Install new cone washers, taper facing inward as shown.

Ensure that the rim, cone, and wheel studs are clean and free of any foreign substance or lubricants.

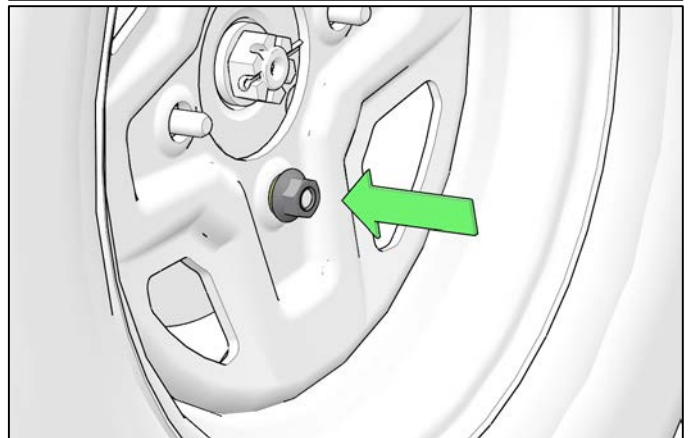
12. Install new lug nuts. With hand tools, lightly tighten the nuts.

To ensure cone washers fully seat in the wheel taper, use other hand to position and center wheel, if necessary.

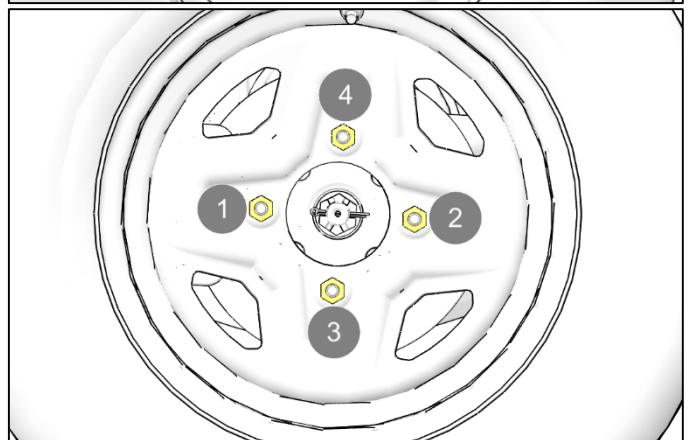
15. Torque lug nuts to specification in the sequence shown.

Wheel Lug Nuts  
**50 ft-lbs (68 Nm)**

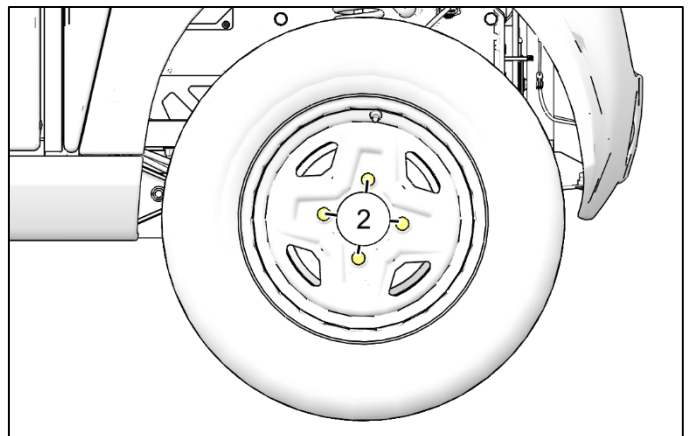
22. Remove and discard lug nuts ② from rear wheels, do not remove rear wheels.

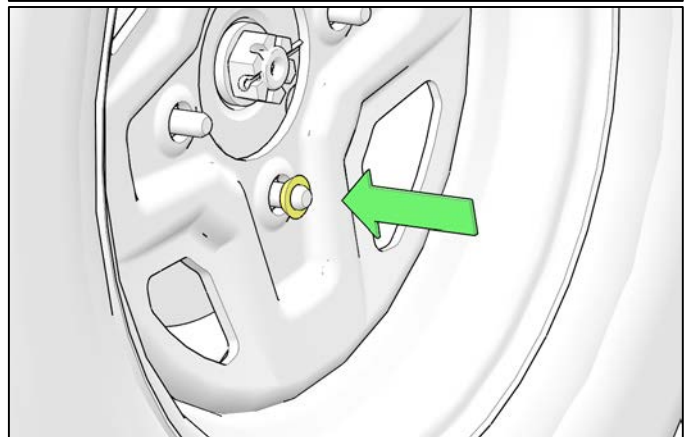
23. Install new cone washers, taper facing inward as shown.

Ensure that the rim, cone, and wheel studs are clean and free of any foreign substance or lubricants.

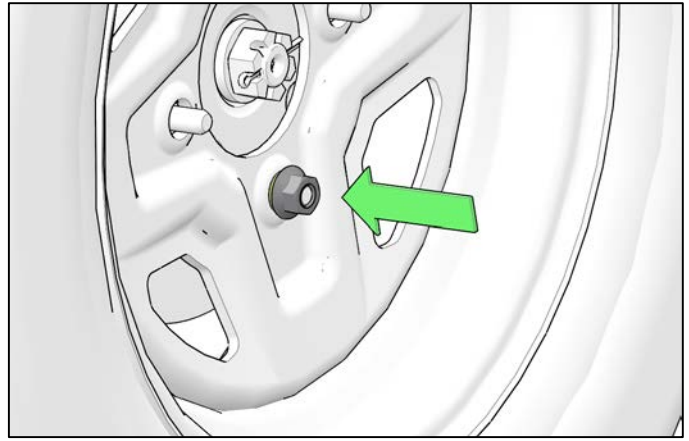
24. Install new lug nuts. With hand tools, lightly tighten the nuts.

To ensure cone washers fully seat in the wheel taper, use other hand to position and center wheel, if necessary.

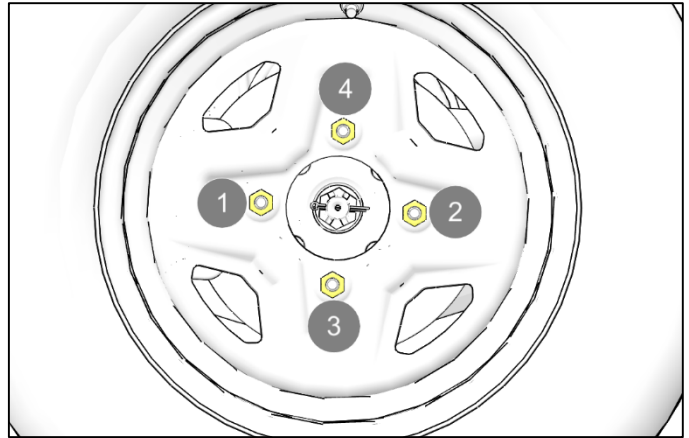
27. Torque lug nuts to specification in the sequence shown.

Wheel Lug Nuts  
**50 ft-lbs (68 Nm)**

A secondary dealer representative must verify that all sixteen lug nuts have been torqued to **50 ft-lbs (68 Nm)** using a torque wrench set to the correct specification.

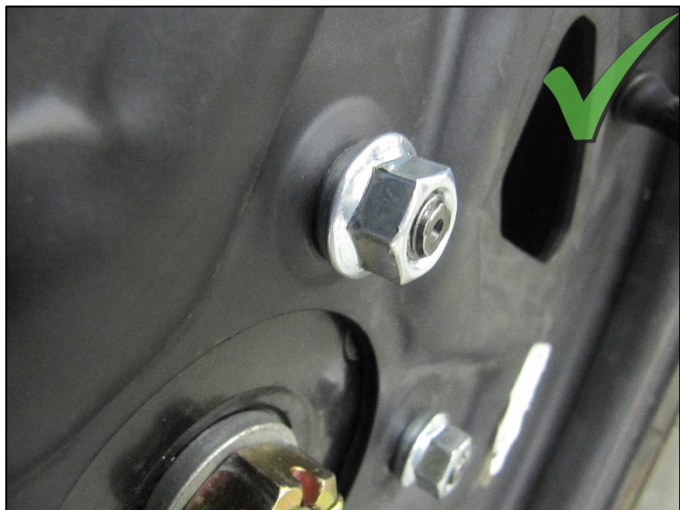
#### Front Wheels

**ACCEPTABLE** – Washer is installed correctly and flange nut does not make contact with the rim.

A secondary dealer representative must verify that all sixteen flange nuts are raised off of the rim, and do not make contact with the rim. Then mark each lug nut with a paint pen.

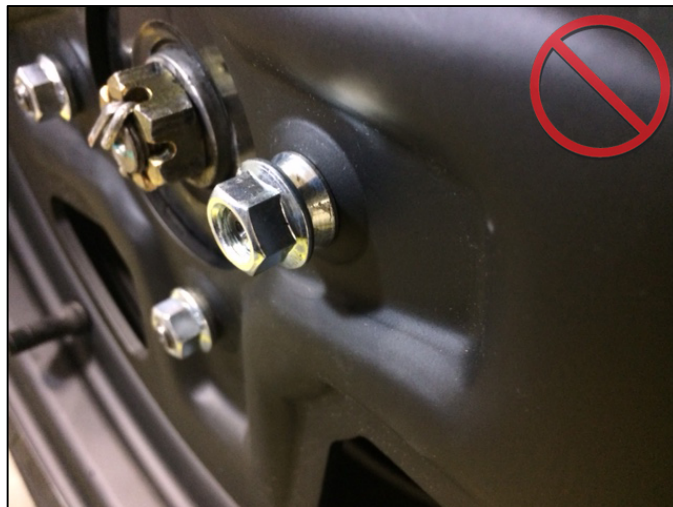
**UNACCEPTABLE** – Washer is installed backwards.

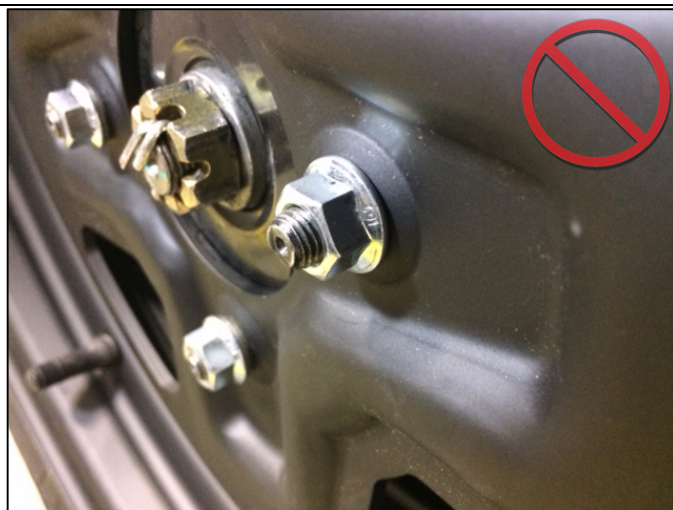
**UNACCEPTABLE** – Washer was not installed and flange nut is contacting rim.

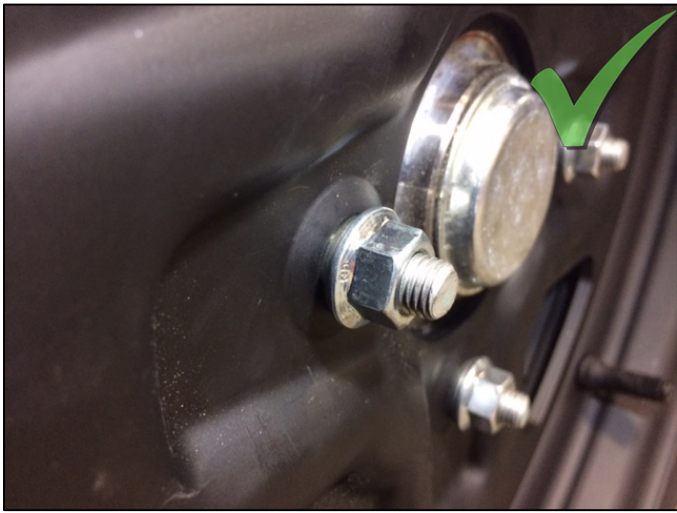
## Rear Wheels

**ACCEPTABLE** – Washer is installed correctly and flange nut does not make contact with the rim.

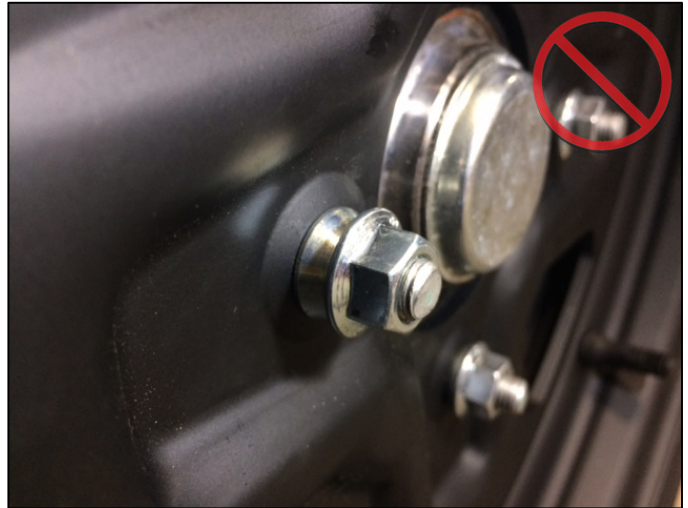
**UNACCEPTABLE** – Washer is installed backwards.

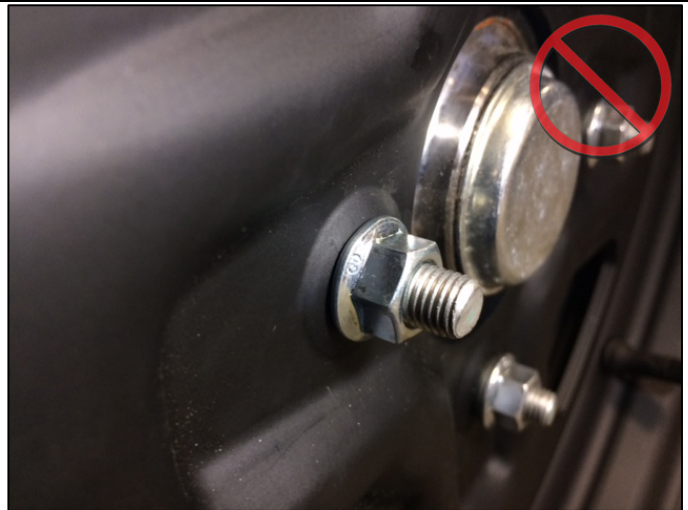
**UNACCEPTABLE** – Washer was not installed and flange nut is contacting rim.

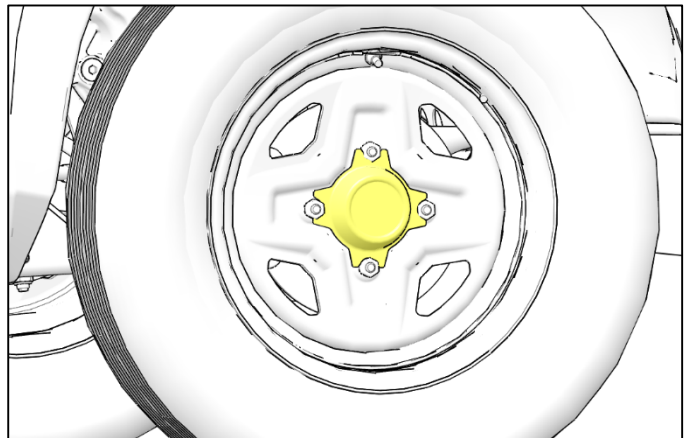
**eL XD Models only**

28. Reinstall wheel covers, if equipped.
29. **For eL XD models only:** Install new hub caps (P/N 5454794) by tucking each wing of the hub cap under each flange nut, one at a time.

Do NOT loosen lug nuts to install the new hub caps (P/N 5454794) hub caps MUST be installed AFTER lug nuts are installed and torqued to specification.
