Compliance Recall – USA ONLY

Code: 69R2

Subject	Head Curtain Airbag(s)
Release Date	June 26, 2017
Affected Vehicles	U.S.A.: Certain 2015-2017 MY Audi A7 <i>Check Campaigns/Actions screen in Elsa on the day of repair to verify that a VIN qualifies for repair under this action. Elsa is the <u>only</u> valid campaign inquiry & verification source.</i> <ul style="list-style-type: none">✓ Campaign status must show “open.”✓ If Elsa shows other open action(s), inform your customer so that the work can also be completed at the same time the vehicle is in the workshop for this campaign.
Problem Description	Due to a production issue at the supplier, a head curtain airbag may not unfold properly during deployment. This may result in an increased risk of injury to an unbelted passenger in a crash where the head curtain airbag deploys.
Corrective Action	Replace one or both head curtain airbags.
Parts Information	Dealers scheduling customer vehicle repairs, please contact the Parts Specialists via phone (800-767-6552, option#2), email (vwoaspecialservices@vw.com) or chat with the VIN to order and ensure that parts are on-hand when the vehicle arrives at the dealership for the scheduled repair

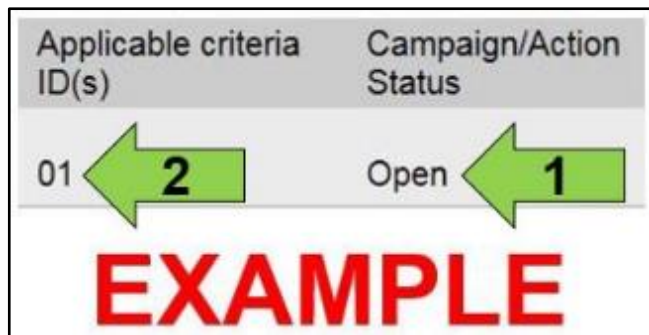
- Enter the VIN in Elsa and proceed to the "Campaign/Action" screen.

- Confirm the Campaign/Action is open <arrow 1>. If the status is closed, no further work is required.
- Note the Applicable Criteria ID <arrow 2> for use in determining the correct work to be done and corresponding parts associated.

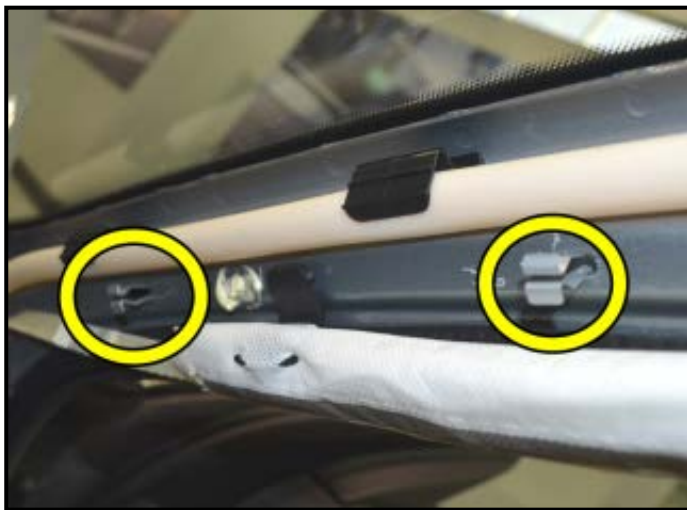
- Remove and discard clamps <circles> using Omega Clip Tool -T40280- (or equivalent).

These clamps <circles> MUST NOT be reused.

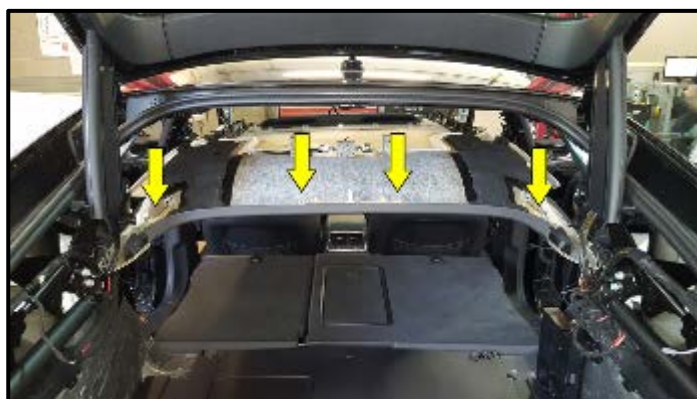
- Unclip the headliner at the rear from the body using the Pry Lever -80-200- <arrows>.
- Open the tabs with a screwdriver and unclip the rear section of the headliner from the body at the centering pin.

Use extreme care when removing the headliner from the body at clips so the headliner does not bend or crease. Damage to the headliner will not be covered under this action.

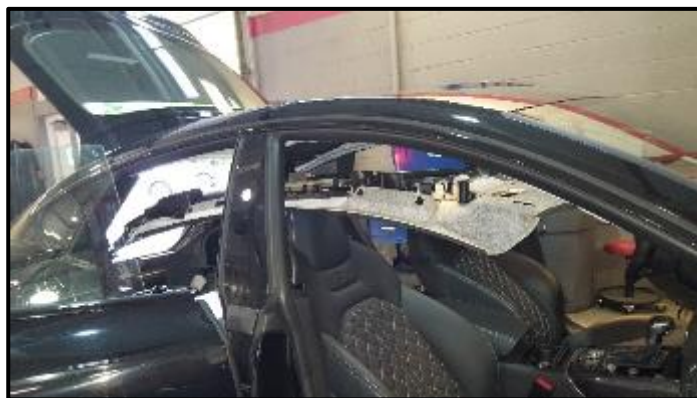
- With the help of a second technician, lower the headliner so it rests on the front seat headrests.

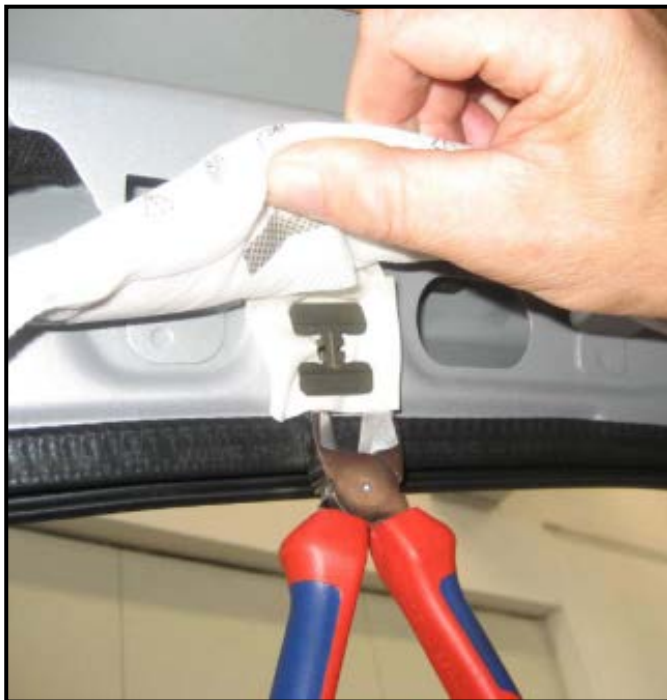
Pry off clips using side cutters. DO NOT cut the clips off as the pieces will remain in the roof member and cause rattling/noise issues.

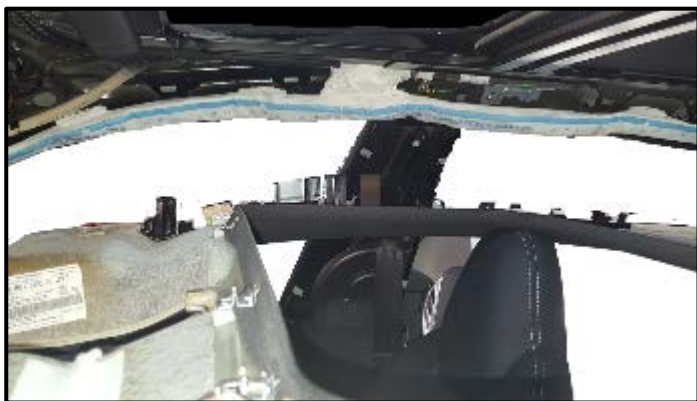
- Unwrap the head curtain airbag, making sure the blue strip is visible along the entire length. This will ensure that the head curtain airbag is not twisted.

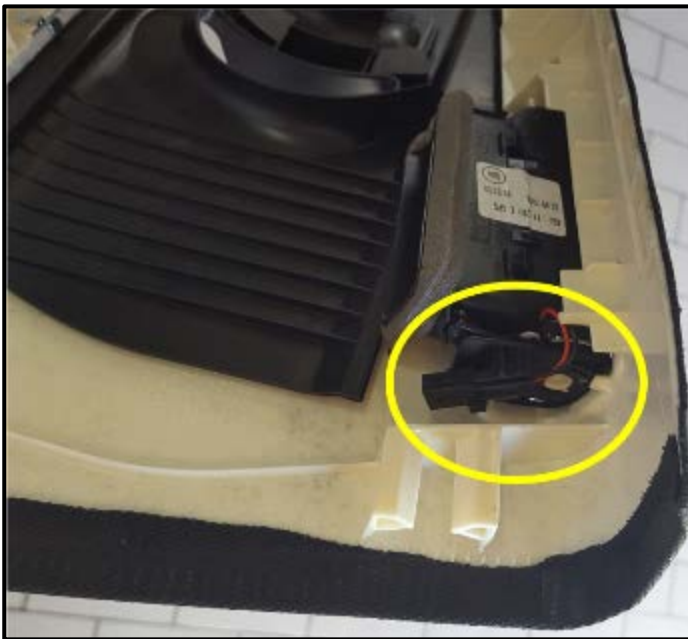
- Vehicles with rear heated seats: Connect the connector.
- Install rear seat bench <2>.
- Install child seat anchor guides and covers <6>.
- Before installing the upper B-pillar trim, ensure the vent connector is installed correctly.

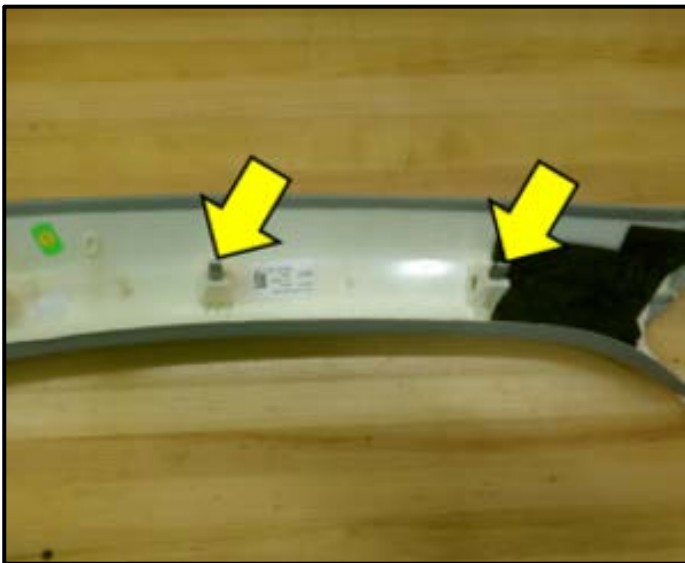
When A-pillar trim is being reinstalled it is necessary to remove the old clips from the body and use two new clips <arrows> and mount them in the trim panel prior to installing the trim onto the body. Doing so ensures that trim does not become loose in the event of head airbag deployment and injure the occupant(s).

- Insert two new clamps <arrows> into each A-pillar trim piece.
