**Bulletin Type.....: Safety Recall**

**Bulletin No.....: TS-S120**

**Bulletin Name.....: Fasteners And Bracket Of Leveling  
Valve Linkage System**

**Vehicle Model.....: TS45**

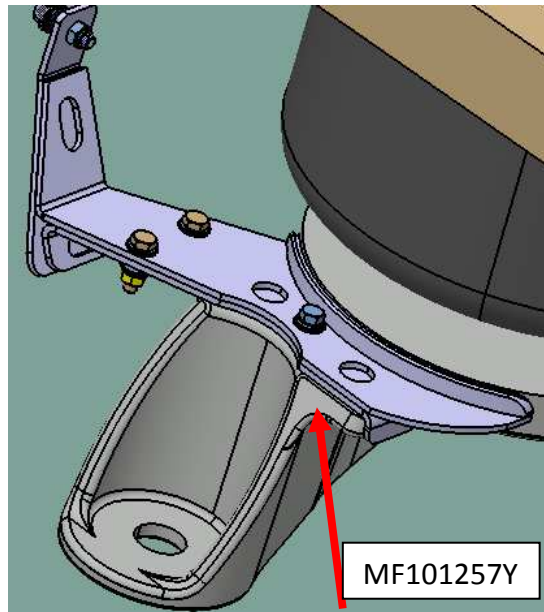
3- Dismount the current bracket's bolt which is marked with red arrow and mount the new bolt (MF101257Y) with using spring lock washer and washer.
