Southeast Toyota Distributors, LLC

VOLUNTARY SAFETY RECALL CAMPAIGN SET17A

20 INCH ROCKSTAR WHEEL - LUG NUT

CERTAIN 2013-2017 MODEL YEAR SEQUOIA AND TUNDRA

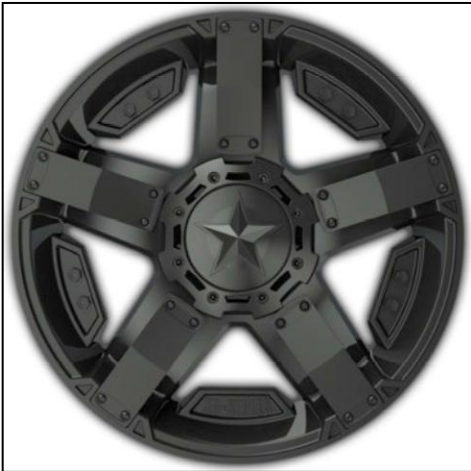
00041-34215 Wheel

Southeast Toyota Accessory Rockstar wheel.

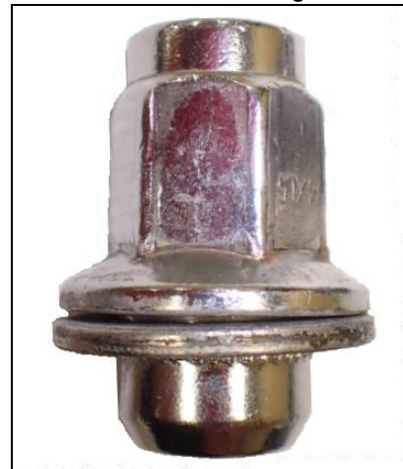
00041-34215-05 Lug Nut

SET either installed, or sold to dealers to install, an accessory 20 inch Rockstar wheel for 2016 - 2017 Toyota Tundra. Toyota dealers also installed these wheels on one 2013 Tundra, one 2014 Tundra, and one 2016 Sequoia. The upgrade included lug nuts. Some of the lug nuts were not manufactured to SAE specifications. It has been determined that the defective lug nuts may crack and detach if not properly torqued during service of the tire and wheel assembly, increasing the risk of a crash. There have been no accidents or injuries reported with regard to this condition, nor have there been any reports of wheel separation.

4. Install New lug nuts.

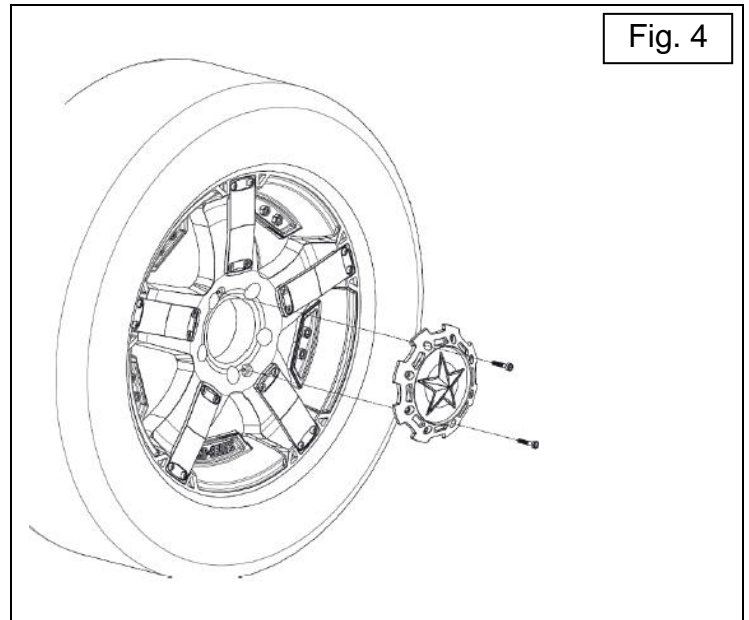
6. Reinstall Center Cap. Tighten the two alan screws. Fig. 3.
