# Keystone RV Company

## SAFETY ADVISORY # 17-287

### Raptor Outriggers

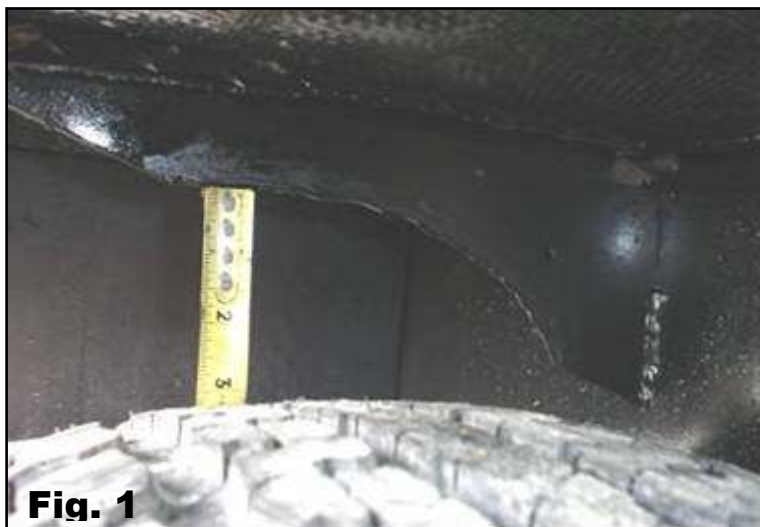
**Fig. 1**

Keystone is conducting a voluntary RECALL notification campaign in accordance with the National Highway Transportation and Safety Act. It has been decided the vehicles in this recall population may have been manufactured with tires that may come into contact with the outriggers. The tires and outriggers touching during travel may lead to an increased risk of loss of control and vehicle crash.

Using a reciprocating saw, cut a notch in the bottom side of the 3 outriggers located above the tires on the door side of the unit. Cut the notch to allow 3” of clearance between the tire and the outrigger, Figure 1.

Touch up /spray paint the outriggers as needed.
