## SAFETY ADVISORY # 17-285

### Voltage Generator Fuel Line

**Models Included:** 2017-2018 Voltage Models with Onan 5.5 Generator Option

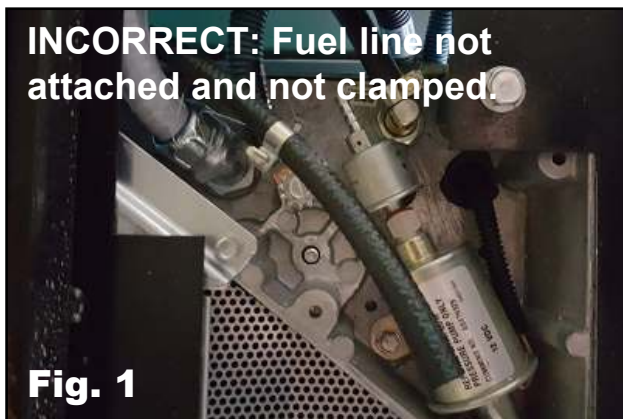
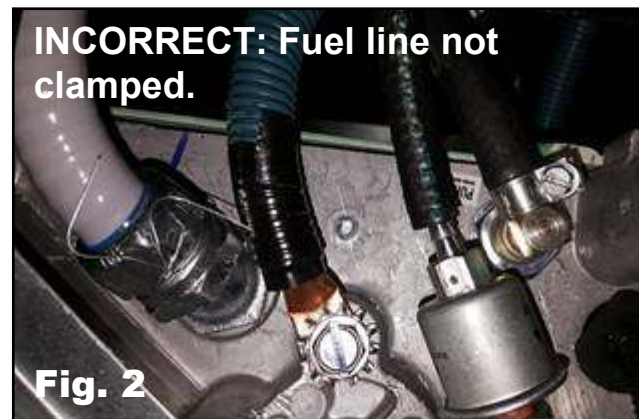
Look under the generator and inspect the incoming fuel line and clamp to the generator where the line attaches to the fuel filter. Verify the fuel line is fully engaged on the barb fitting and the clamp is in the proper position and it is tight. Incorrect installation Figures 1 & 2. See Figure 3 for correct installation.
