RECALL NOTE

A. VEHICLE INSPECTION PROCEDURE

Model Year	VIN Range	Build Date Range
2004 RX-8	JM1 FE**** 40 100053 – 138902	From April 10, 2003 through May 7, 2004

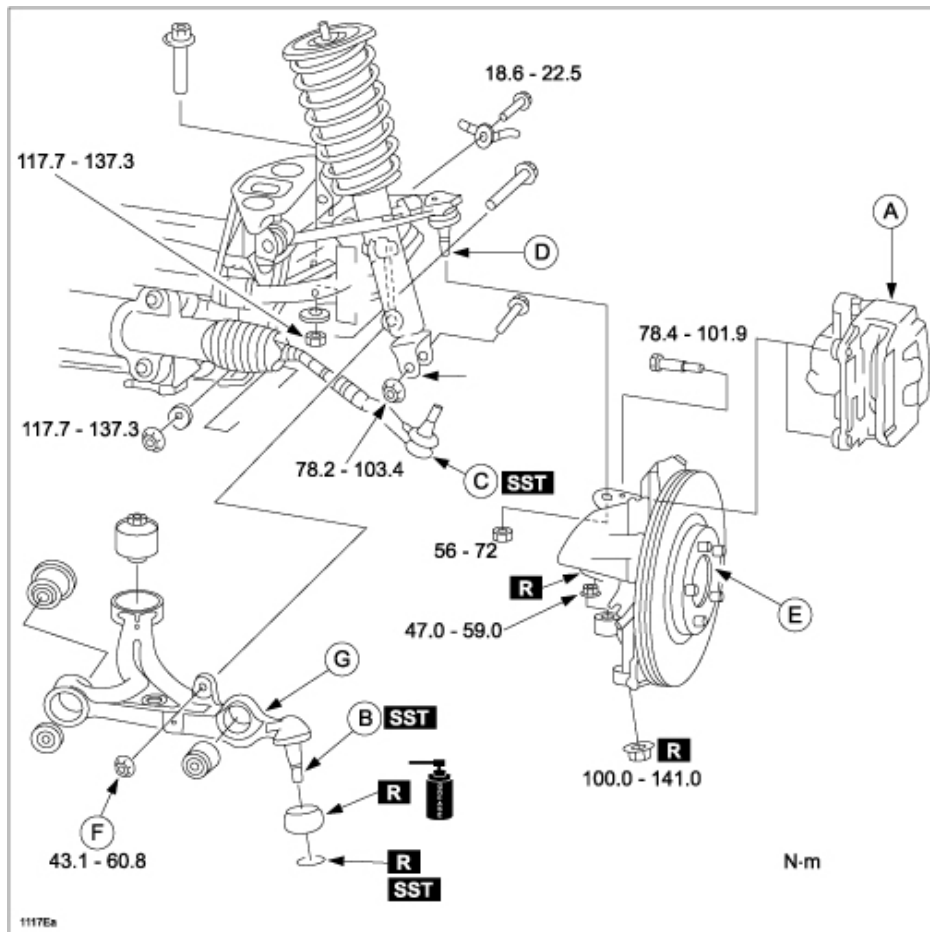
1. Disconnect the negative battery cable.
2. Lift the vehicle up.
3. Remove the front wheels (both-sides).
4. Remove the front lower arms (left side shown).

- a. Remove the caliper and mounting support (A).

NOTE: Remove the caliper and mounting support from the steering knuckle and suspend it with a cable in a location out of the way.

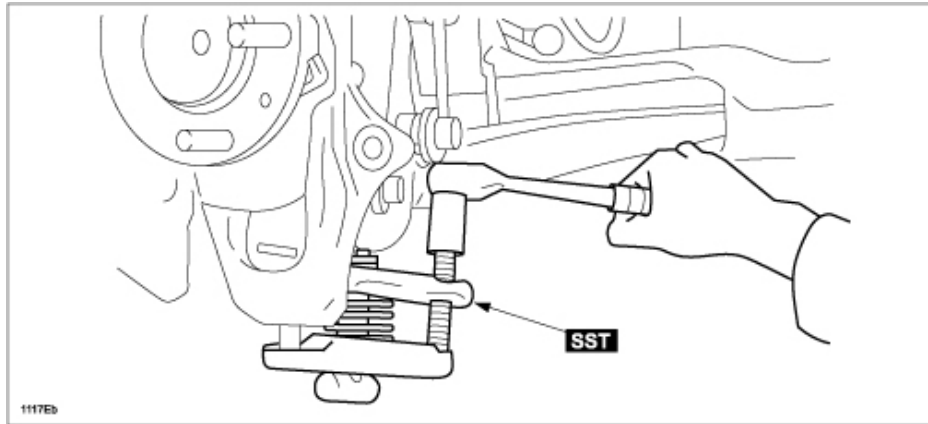
- b. Remove the front lower arm ball joint (B).

NOTE: Disconnect the front lower arm ball joint from the steering knuckle using the SST. When removing the front lower arm ball joint, the steering knuckle bushing may also come off. If it comes off, replace the steering knuckle.

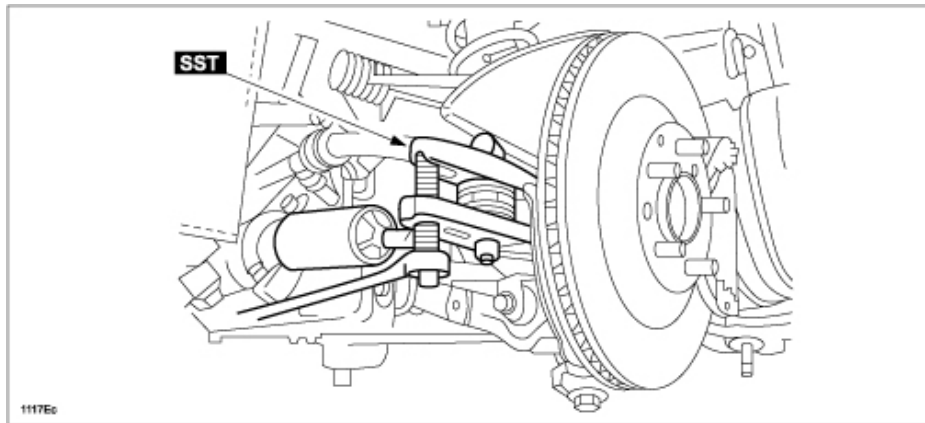
- c. Remove the tie-rod end (C).

- 1) Remove the outer ball joint locknut.
- 2) Detach the outer ball joint from the steering knuckle using the SST.

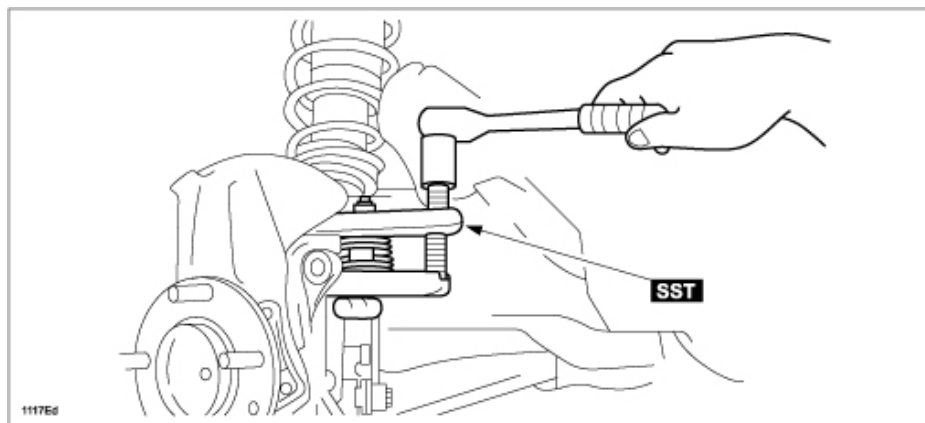
- d. Remove the front upper arm ball joint (D).

- 1) Loosen the bolts on the vehicle side.
- 2) Disconnect the upper arm ball joint using the SST.

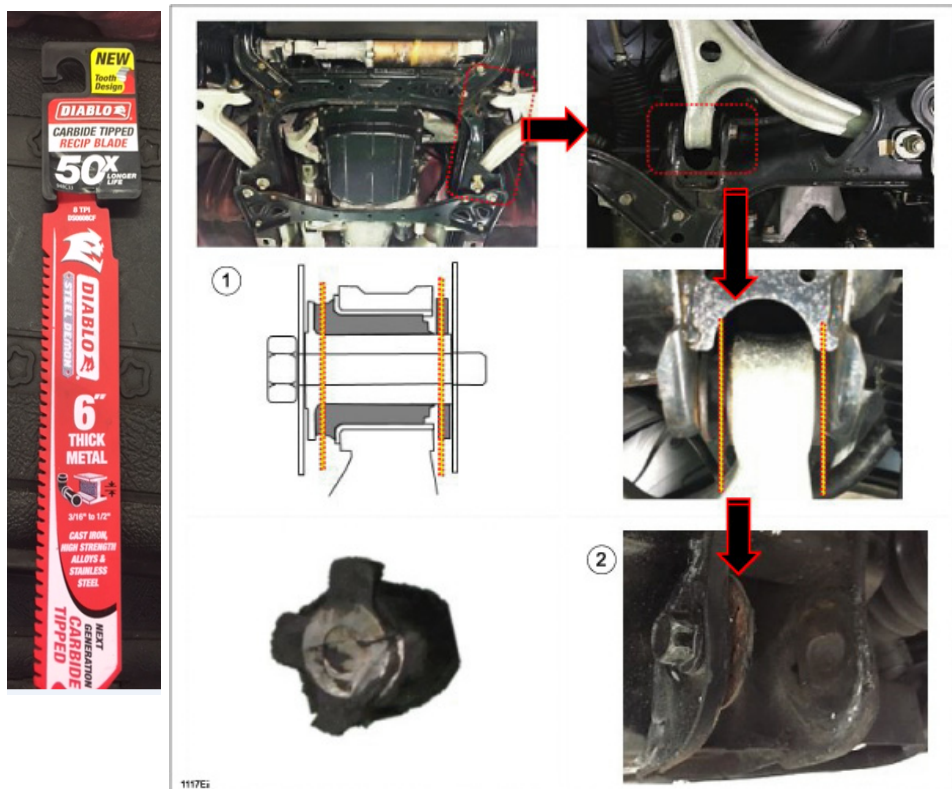
Special Removal Method Sawzall

- If the lower arm bolt cannot be removed due to severe rust, use one of the following special removal methods to remove the lower arm from cross member.
- Actual time spent to remove seized bolts will be allowed with proper time and RO documentation.

1. Use air assist saw (Sawzall) to cut the rubber bushing, collar and bolt. Recommended blade or equivalent.
2. remove the part of the bushing and bolt which remains at the cross member side using a screwdriver, file or grinder.

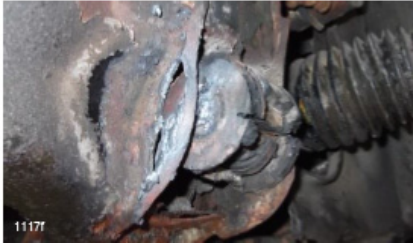
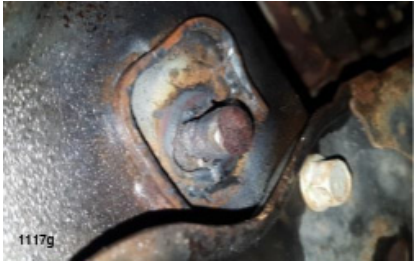
Cross member destroyed case #1	Cross member destroyed case #2

- DO NOT attempt to hit the bolt using a hammer since it may deform the cross member.
- DO NOT attempt to heat the bolt with a gas welding torch or gas cutting apparatus since it may destroy the cross member.

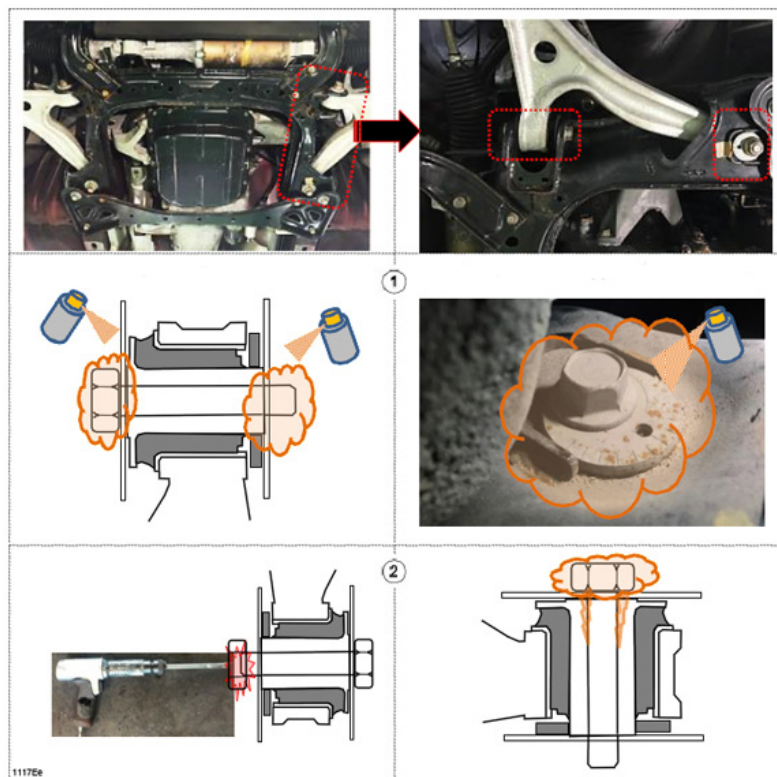
Special Removal Method Using Air Hammer

1. Apply a permeability lubricant on the adjusting bolt and wait 10 minutes (SeaFoam Deep Creep Multi-Use Penetrating Lubricant recommended).
2. Use an air hammer on the nut side of the bolt to push the bolt out, leaving the nut on the bolt to avoid hitting the cross member. If the bolt does not move, apply permeability lubricant again.
3. Wait 10 minutes, then use the air hammer on the bolt again.

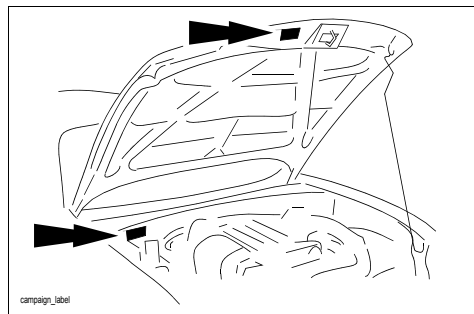
2. Affix it to the hood or bulkhead as shown:

1. Fill out a blue "Campaign Label" (9999-95-065A-06) with Campaign No: "1117E", your dealer code, today's date.
