RECALL CAMPAIGN 17V-377: REPLACE ENGINE OIL COOLER LINE

G12 (7 Series M760i)

The left engine oil cooler supply line (feed line) was incorrectly manufactured.

17 22 037 Removing and installing/replacing oil feed line for engine oil cooling (branch - engine oil cooler, left)

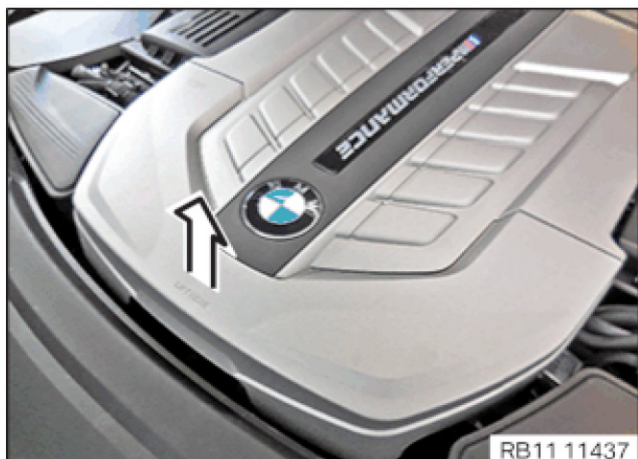
1–Opening up the acoustic cover

- Open up the acoustic cover in the direction of arrow.

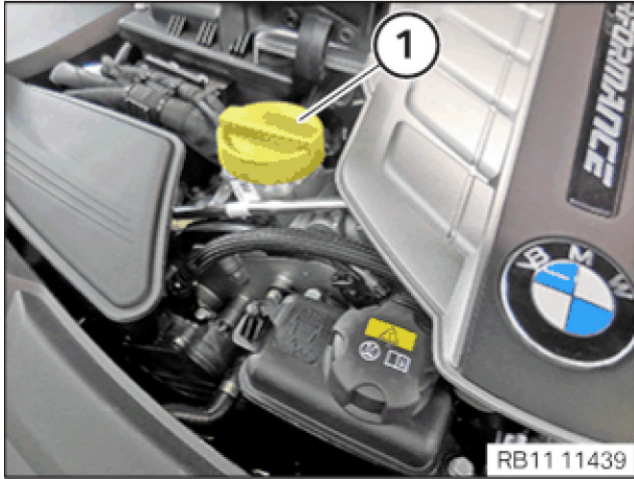
2–Opening the oil filler cap

- Open the oil filler cap (1).

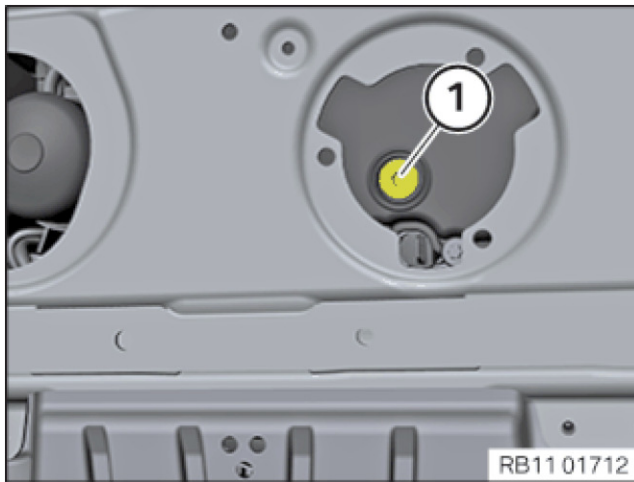
3–Releasing the oil drain plug

- Release the oil drain plug (1) from the oil sump.
- Drain the engine oil.

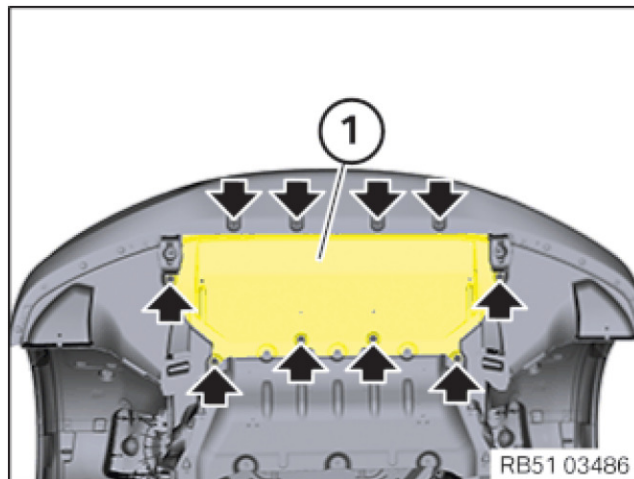
4–Removing the front underbody protection

- Release screws (arrows).
- Pull out the front underbody protection (1).

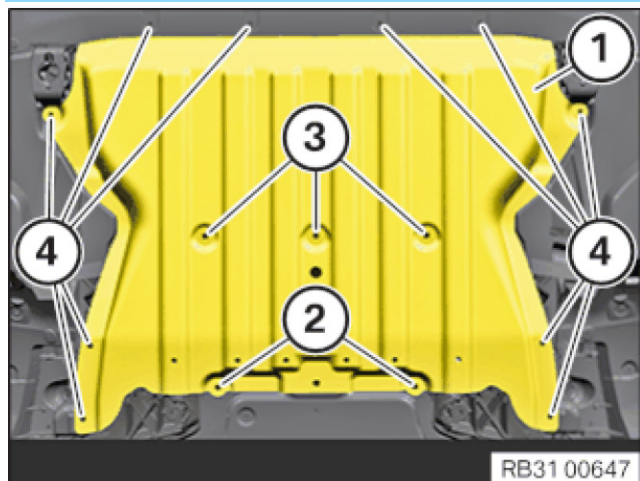
► **Removing the front stiffening plate**

- Release screws (2) to (4).
- Take off stiffening plate (1).

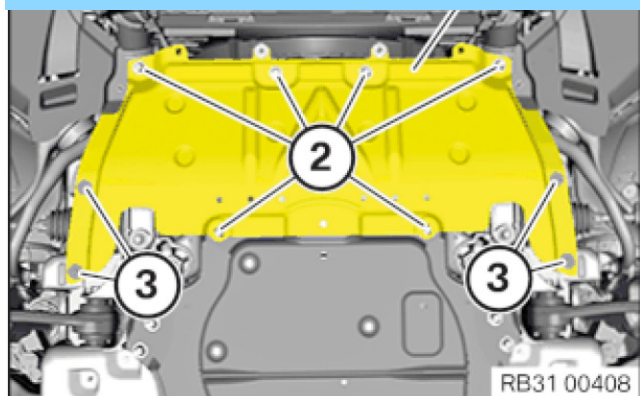
5-Removing the front stiffening plate

- Release screws (3).
- Release screws (2).
- Take off the front stiffening plate (1).

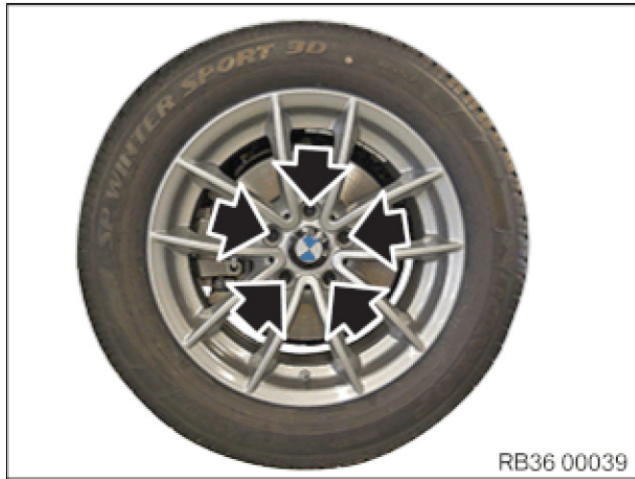
6–Removing the wheel

- In case more than one wheel is to be removed at the same time: Use chalk on each tyre to mark from which axle and from which side the wheel was located.
- Release the wheel bolts and take off the wheel.

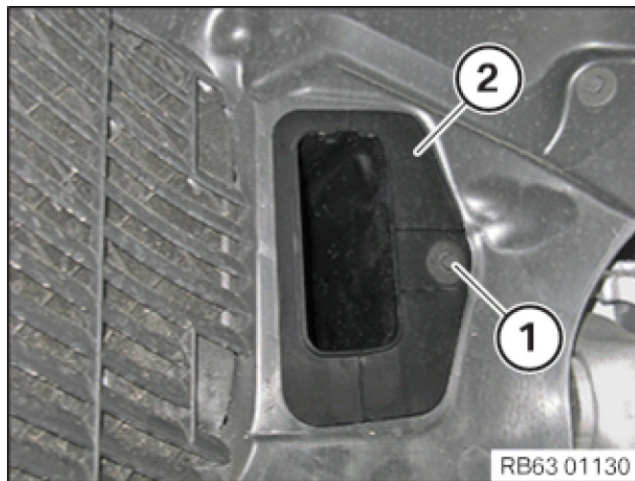
7–Removing the brake air duct

- Release the screw (1) and pull the brake air duct (2) out of the wheel arch cover.

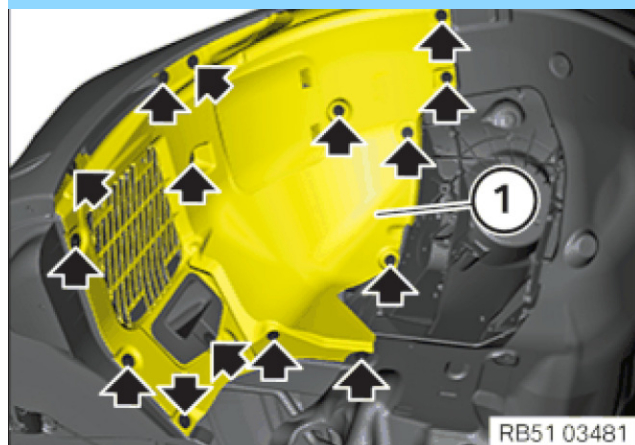
8–Removing the front wheel arch cover

- Release screws (arrows).
- Pull out the front wheel arch cover (1).

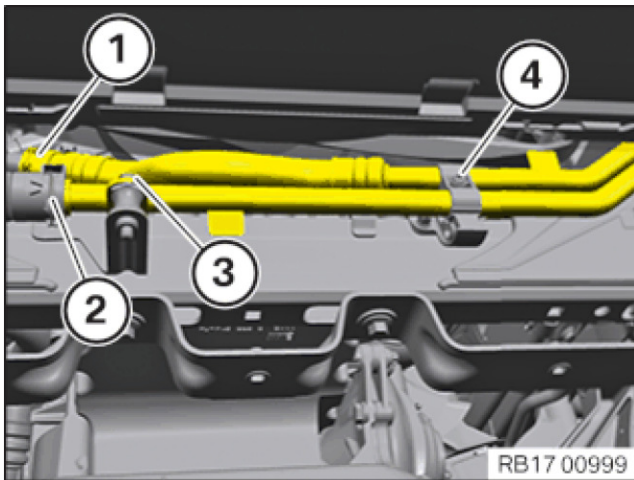
9–Removing the oil feed line and the left oil return line

- Unlock and pull off the oil feed line (1) at the separation point.
- Unlock and pull off the oil return line (2) at the separation point.
- Catch and dispose of escaping engine oil.
- Release the nut (3).
- Release the screw (4) and remove the holder.
- Uncover oil feed line and oil return line.

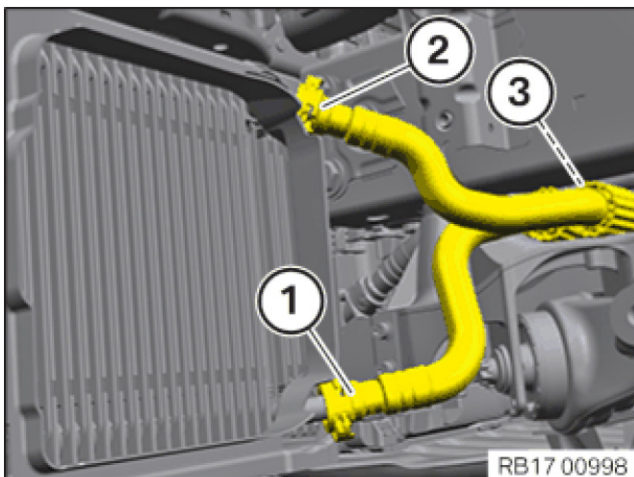
- Unlock and pull off the oil return line (1) from the left engine oil cooler.
- Unlock and pull off the oil feed line (2) from the left engine oil cooler.
- Lead the oil feed line and oil return line between the side member and the front axle support (3) and remove.

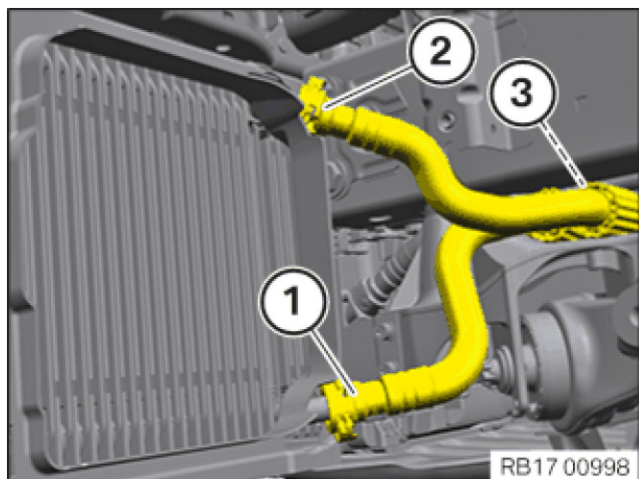
10-Installing the oil feed line and the left oil return line

- Lead the oil feed line and oil return line between the side member and the front axle support (3) and place.
- Connect the oil return line (1) to the left engine oil cooler and audibly engage it.
- Connect the oil feed line (2) to the left engine oil cooler and audibly engage it.

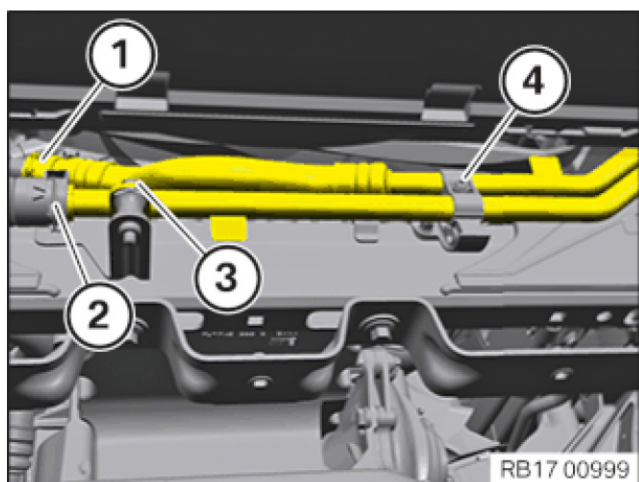
- Lay the oil feed line and oil return line and mount it to the holder.
- Connect the oil feed line (1) to the separation point and engage it audibly.
- Connect the oil return line (2) to the separation point and engage it audibly.
- Tighten the nut (3).

M6 nut		8 Nm
--------	--	------

- Mount the holder and tighten the screw (4).

Oval-head screw		5 Nm
-----------------	--	------

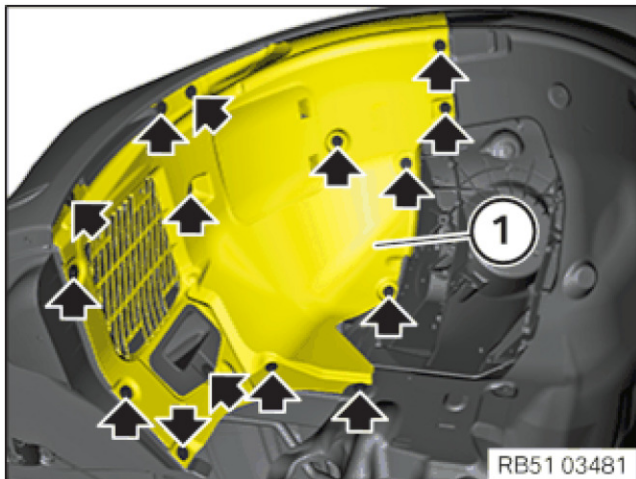
11–Installing the front wheel arch cover

- Insert the front wheel arch cover (1).
- Tighten the screws (arrows).

Screw		3 Nm
Plastic nut		2.6 Nm

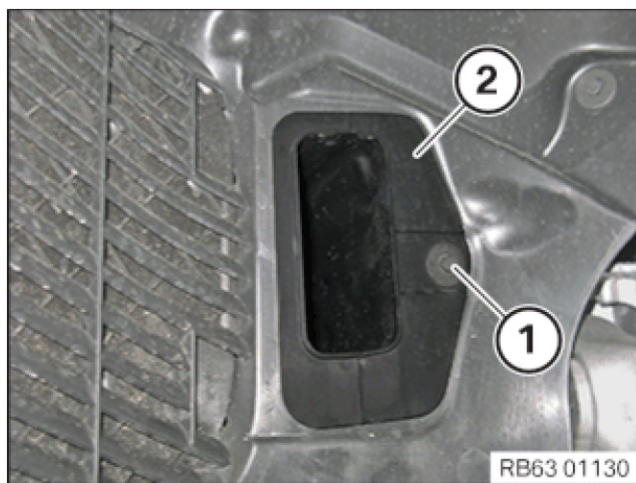
12–Installing the brake air duct

- Insert the brake air duct (2) in the wheel arch cover.
- Tighten the screw (1).

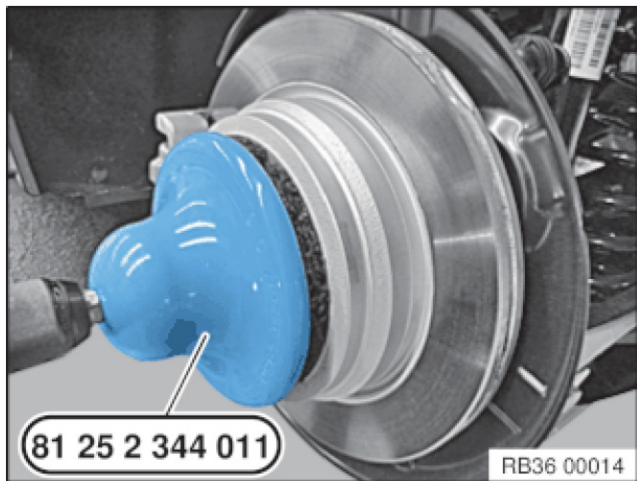
The contact surface between the brake disc and the wheel rim must be clean and free of oil and grease. Otherwise there is a danger that the wheel will loosen later.

- Degrease the contact surface with universal cleaner (see BMW Group Parts).
- If there is grease residue near the area of the wheel bolt holes, remove and clean the brake disc.

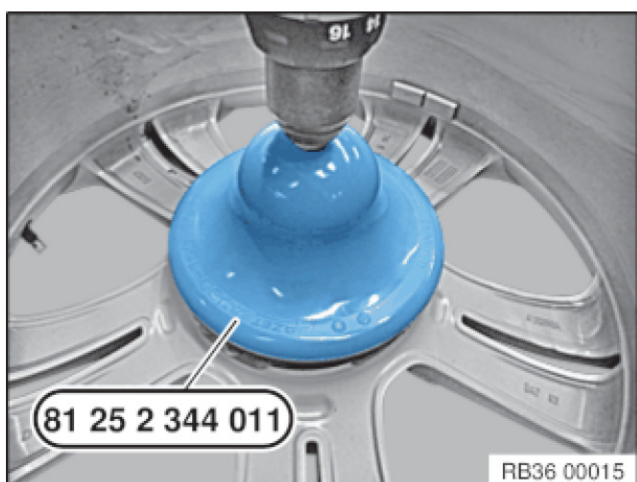
- Free the contact surface with a drill and the special tool **2 344 011** from dirt, grease residue and corrosion.

- Degrease the contact surface with universal cleaner (see BMW Group Parts).

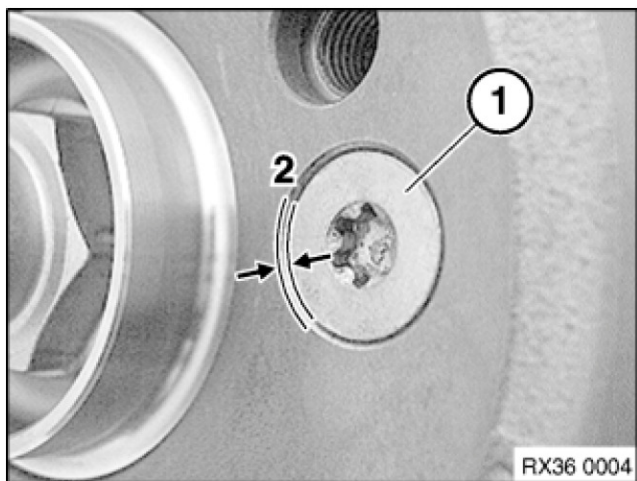
- Check that mounting bolt for the brake disc (1) is firmly seated.

The mounting bolt for the brake disc (1) must never protrude on the contact surface (2) between the brake disk and the rim.

M8	Renew the screw.	Tightening torque	16 Nm
----	------------------	-------------------	-------

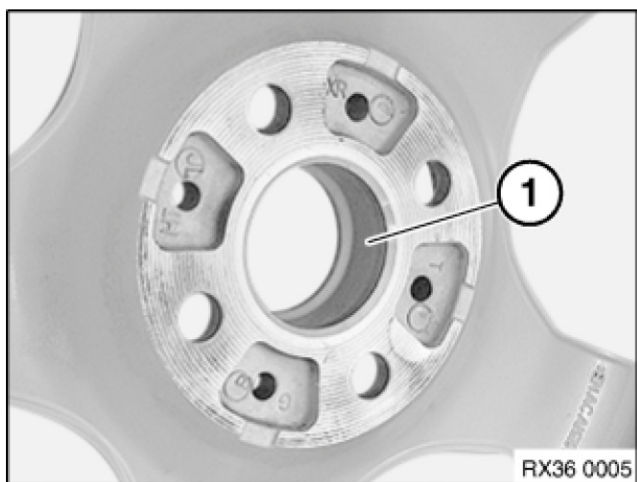
- Thinly grease the wheel centring (1) in the wheel rim; see further information for more about the grease for wheel centring.

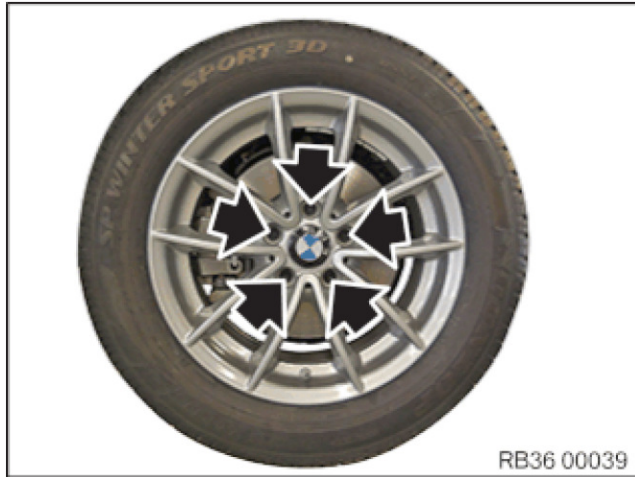
- Clean wheel bolts.
- Check the wheel bolts and the thread for damage; if need be, renew the wheel bolts.
- Apply and tighten the wheel bolts (arrows).

M 14 / S W 17			
		Screw in the wheel bolts and manually tighten them crosswise to centre the wheel rim.	
		Tighten the wheel bolts crosswise with a calibrated torque wrench to the specified tightening torque.	140 Nm
		- Check all wheel bolts in the same sequence or re-tighten them to the specified tightening torque.	
			140 Nm

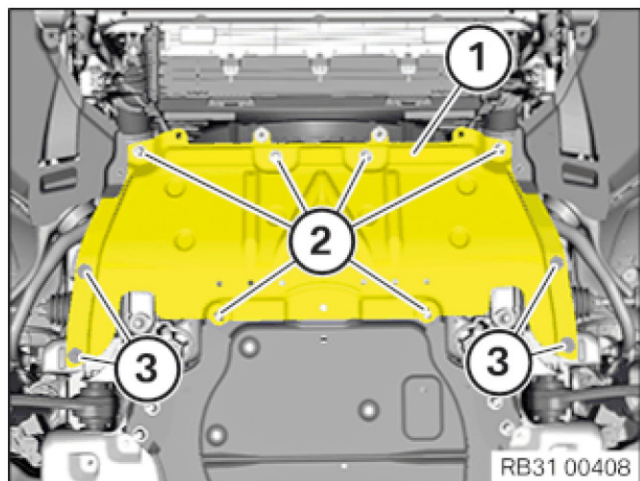
14-Installing the front stiffening plate

- Renew the screws (2).

- Position stiffening plate (1).
- Tighten the screws (2).

M8	Renew screws.	Jointing torque	15 Nm
		Angle of rotation	90°

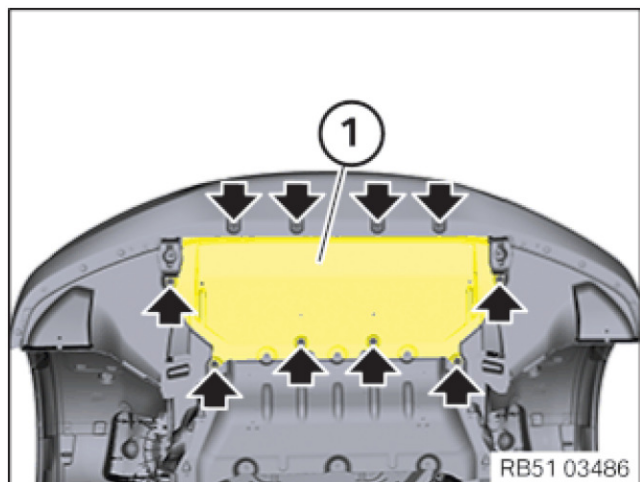
15-Installing front underbody protection

- Insert the front underbody protection (1).
- Tighten the screws (arrows).

Screw		Tightening torque	3 Nm
-------	--	-------------------	------

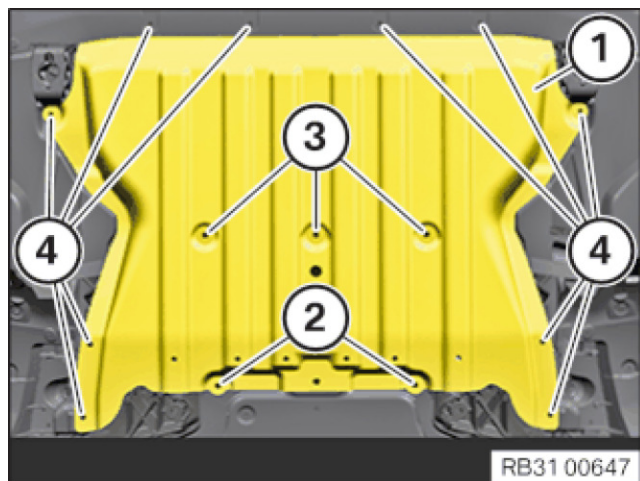
▷ **Install the front stiffening plate**

- Renew the screws (2).
- Position stiffening plate (1).
- Tighten the screws (2).

M8	Renew screws.	Jointing torque	15 Nm
		Angle of rotation	90°

- Tighten the screws (3).

- Tighten the screws (4).

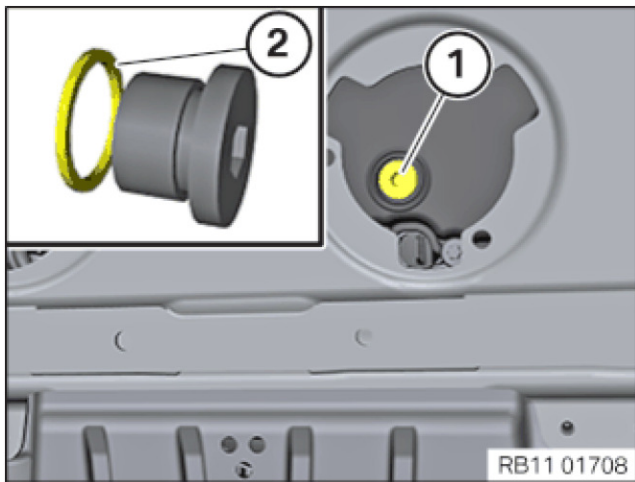
16–Tightening the oil drain plug

- Renew the sealing ring (2).
- Position the oil drain plug (1) at the oil sump and tighten.

M12x1.5	Renew the sealing ring		20 Nm
---------	------------------------	--	-------

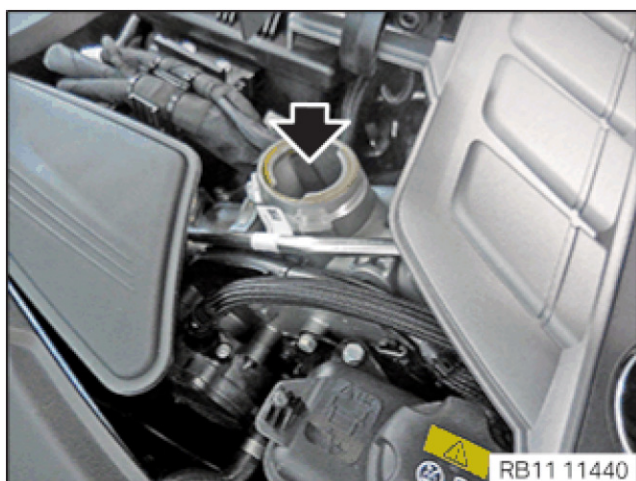
17–Filling up engine oil

- Fill the engine oil in the oil filler neck (arrow).

Capacity, engine oil change with oil filter element		12.0 l
---	--	--------

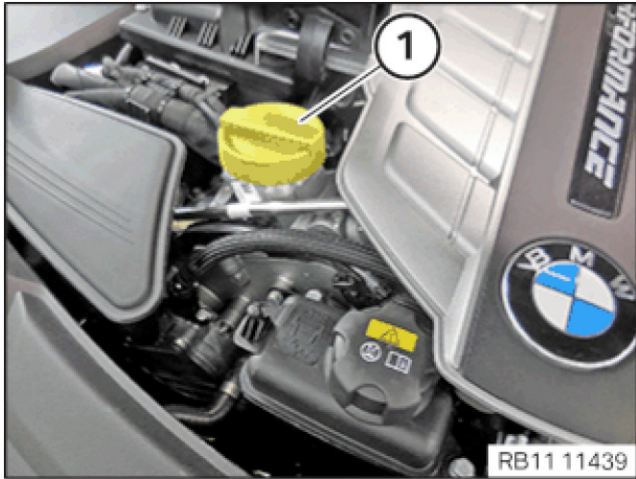
18–Closing the oil filler cap

- Close the oil filler cap (1).

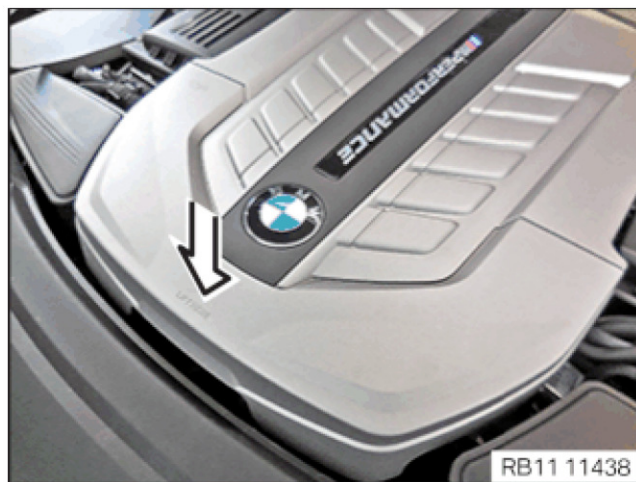
19–Closing up the acoustic cover

- Close up the acoustic cover in the direction of arrow and clip in using light pressure.
