RECALL CAMPAIGN 17V-377: REPLACE ENGINE OIL COOLER LINE

G12 (7 Series M760i)

The left engine oil cooler supply line (feed line) was incorrectly manufactured.

17 22 037 Removing and installing/replacing oil feed line for engine oil cooling (branch - engine oil cooler, left)

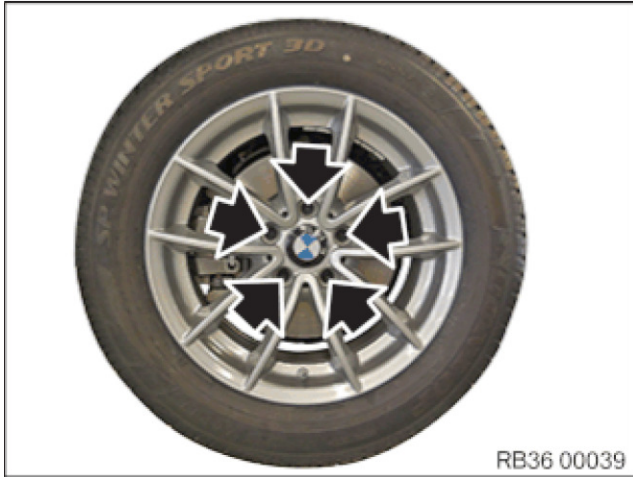
6–Removing the wheel

- In case more than one wheel is to be removed at the same time: Use chalk on each tyre to mark from which axle and from which side the wheel was located.
- Release the wheel bolts and take off the wheel.

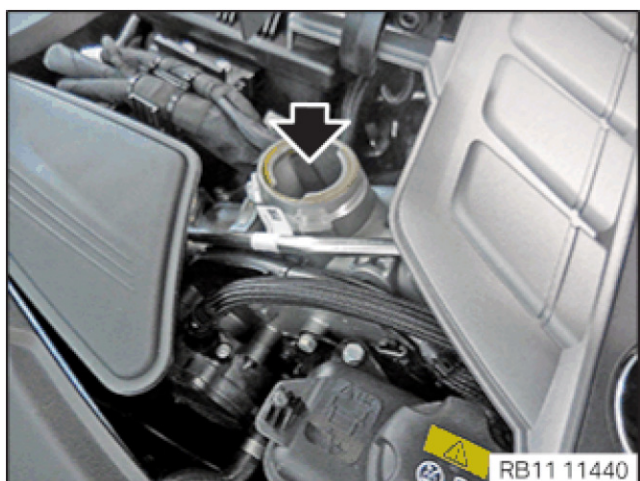
17–Filling up engine oil

- Fill the engine oil in the oil filler neck (arrow).

| Capacity, engine oil change with oil filter element | | 12.0 l |
