RECALL CAMPAIGN 17V-377: REPLACE ENGINE OIL COOLER LINE

G12 (7 Series M760i)

17 22 037 Removing and installing/replacing oil feed line for engine oil cooling (branch - engine oil cooler, left)

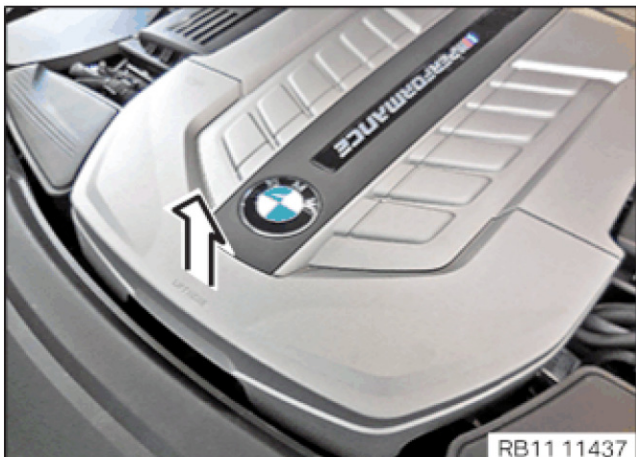
1–Opening up the acoustic cover

- Open up the acoustic cover in the direction of arrow.
