RECALL: THIS MODIFICATION HAS TOP PRIORITY AND MUST BE PERFORMED IMMEDIATELY TO ENSURE CUSTOMER SAFETY

REMEDY FOR FUEL SEEPAGE AT THE FUEL TANK FILLER NECK INSERT AND FUEL LEVEL SENSOR – INSTALLATION OF NEW FUEL FILLER NECK INSERT AND SEALS

AFFECTED MODELS: 2016 and 2017 690 DUKE

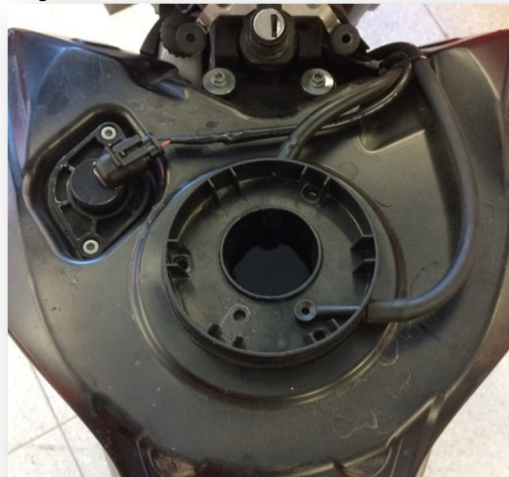
FIG. 1: Displays the tank with the attachment parts removed.

1. Remove the rider and passenger seat, then remove the tank cap.
2. Remove the tank spoiler right and left sides, then remove the tank cover.

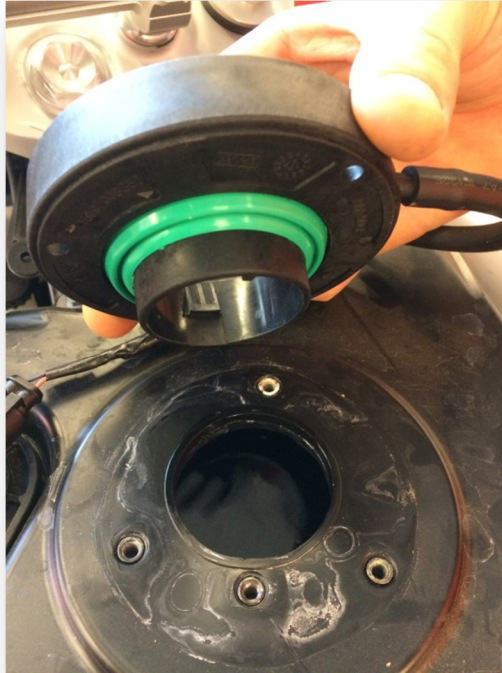
FIG. 2: Displays the new filler neck insert with new the seal.

3. Remove the old filler neck insert and gasket.
4. Install the new seal on the new filler neck insert.
5. Connect the vent hoses.

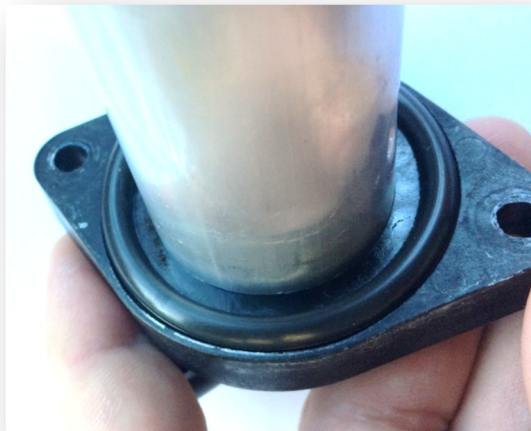
FIG. 3: Displays the new seal on the fuel tank sensor.

6. Remove the fuel level sensor.
7. Remove the original seal.
8. Install the new seal as shown.

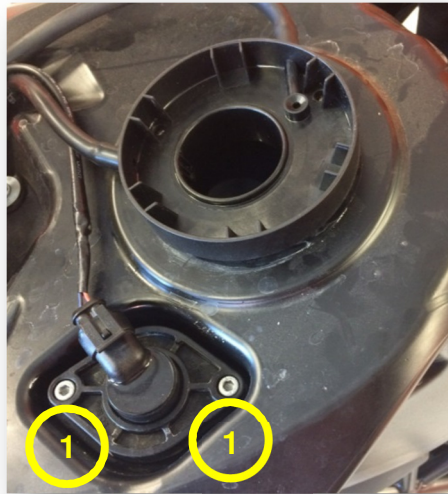
FIG. 4: Displays the new filler neck and assembled fuel level sensor.

9. Tighten both of the fuel level sensor mounting bolts (1) to 3 Nm.

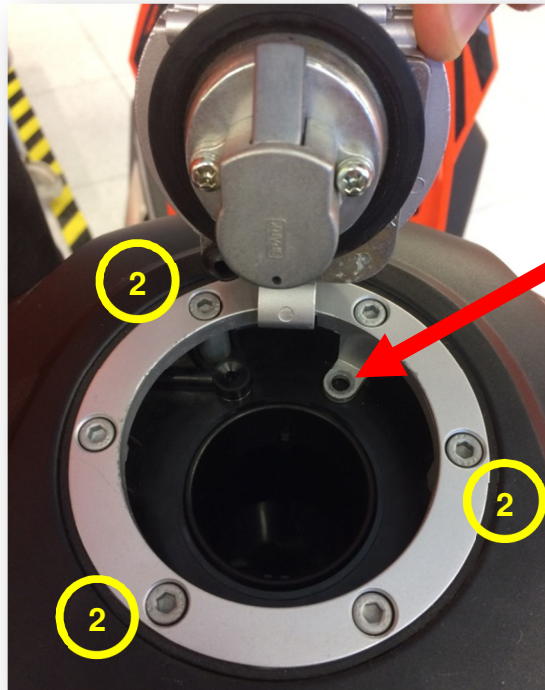
FIG. 5: Displays the installed gas cap. The fourth screw must be removed.

10. Install the tank cover and both spoilers.
 11. Install the tank cap screws (2) to 3 Nm.
 12. Take the motorcycle for a brief test ride.

NOTE: The fourth screw is eliminated and must not be mounted in the location pointed out by the arrow.
