**June 23, 2017**

06923 Version 1

## Non-Compliance Recall: 2018 Odyssey 3<sup>rd</sup> Row Center Seatbelt Tongue

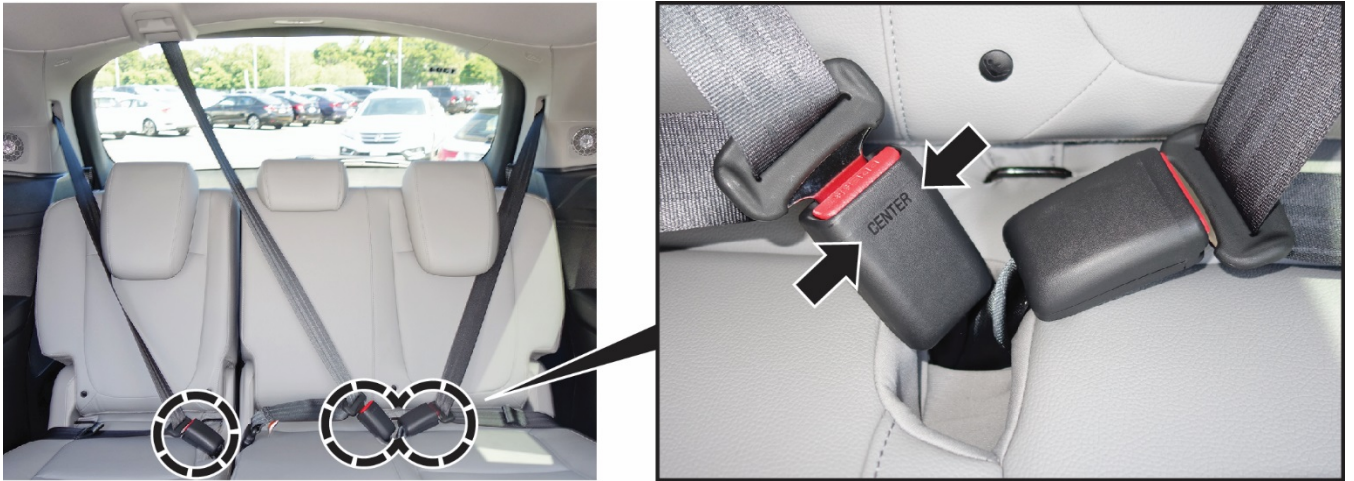
1. Latch all three 3<sup>rd</sup> row seatbelts and confirm they all buckle or latch into their corresponding buckles.

NOTE: The center seat belt buckle is labeled "CENTER".

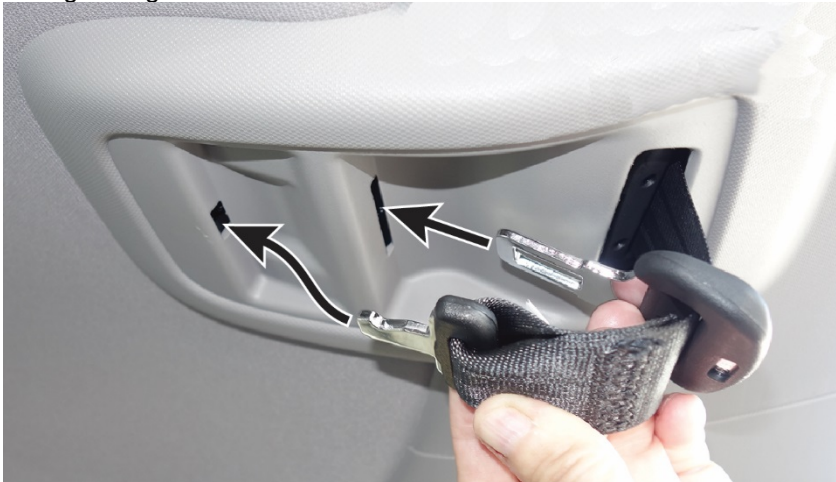
- If the center seatbelt did not latch, go to REPAIR PROCEDURE.
- If all 3 seatbelts latched securely, the vehicle is OK. Unlatch the seatbelts and reinstall the center seatbelt in the ceiling storage slots.

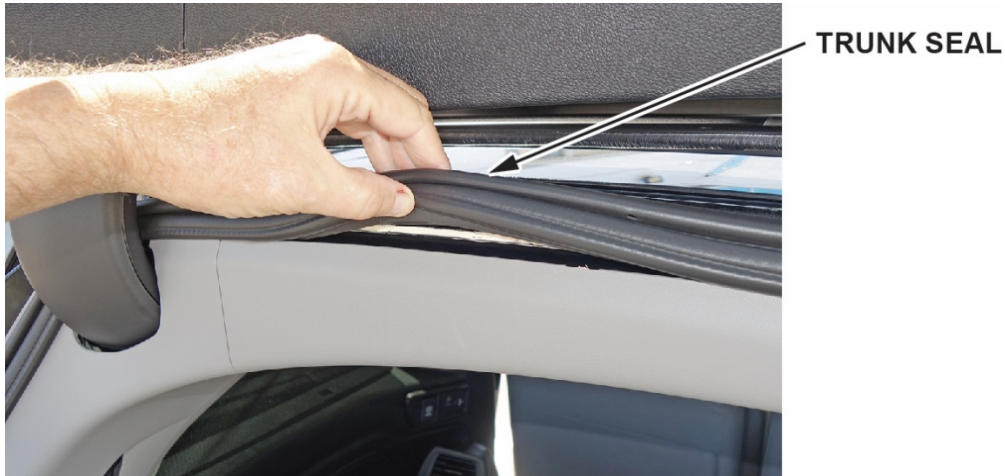
1. Partially remove the trunk seal above the rear hatch opening.

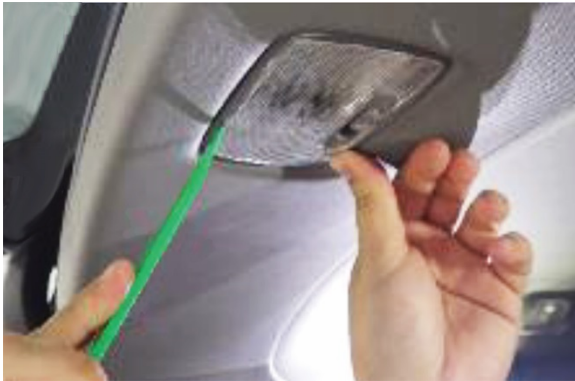
2. Remove the cargo light lens.

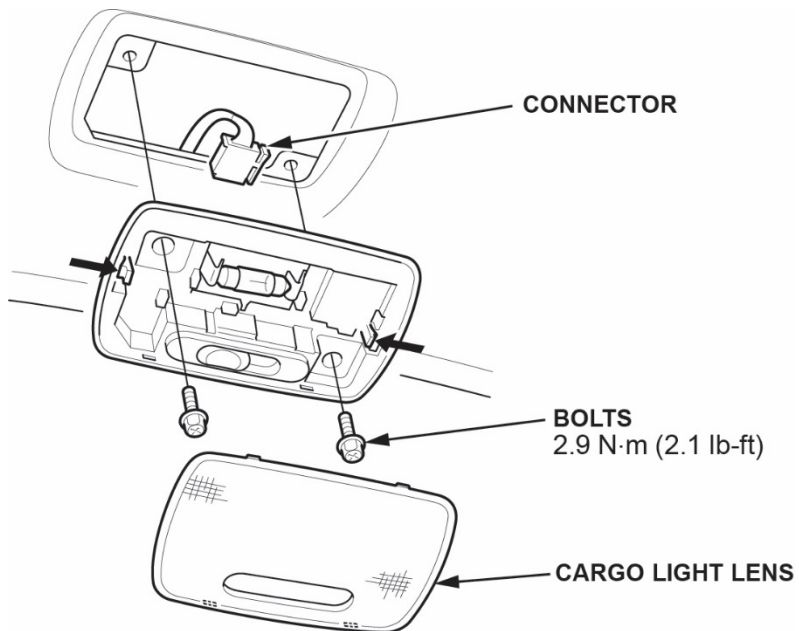
3. Remove the bolts and disconnect the cargo light connector.

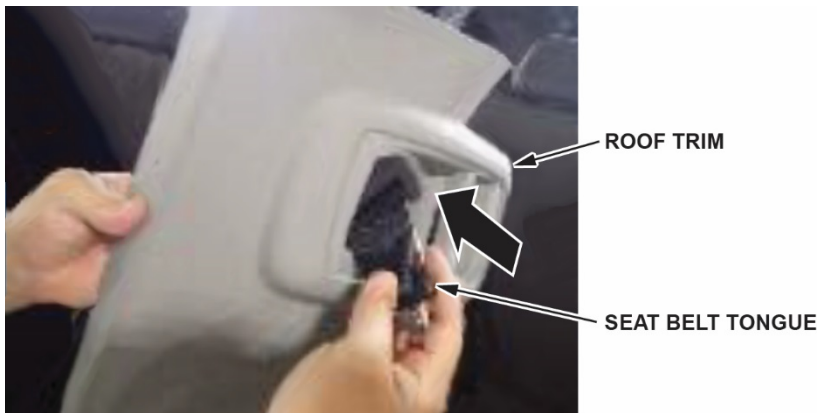
5. Push the tongue and anchor through the roof trim.

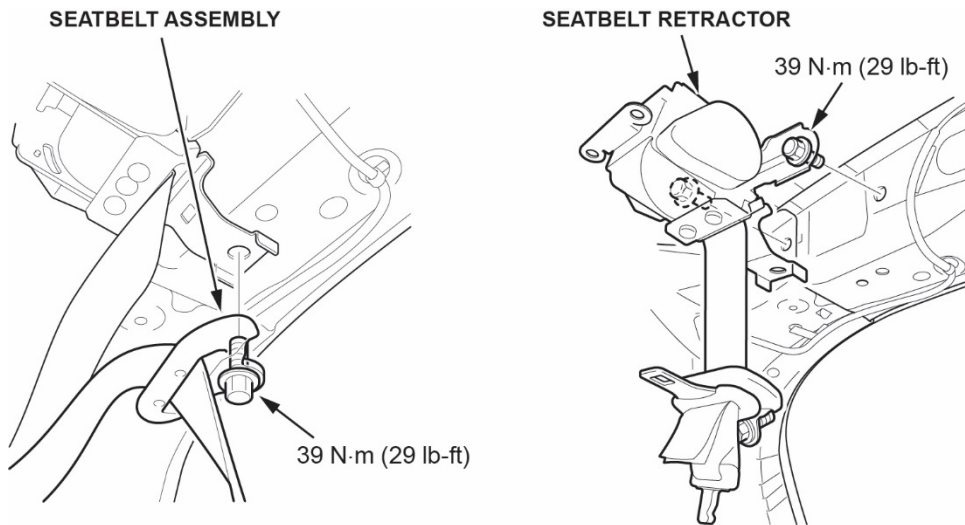
7. Remove the center seatbelt assembly anchor bolts.

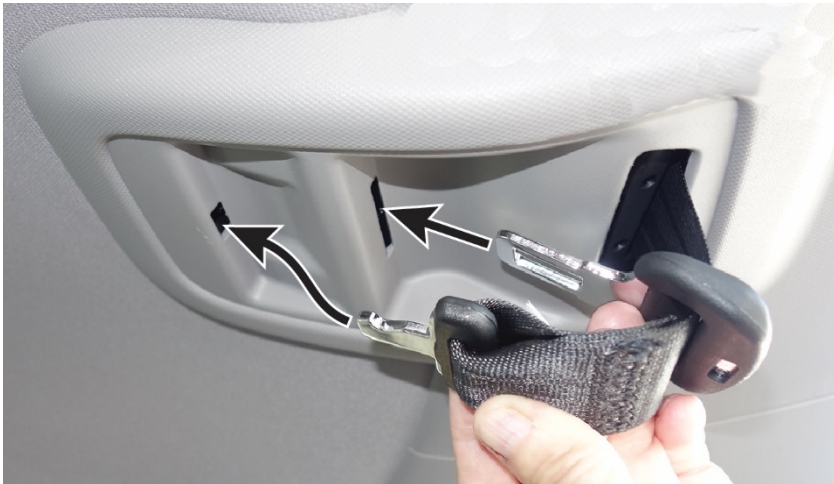
8. Remove the seatbelt retractor.
9. Install a new seatbelt retractor, torque the bolts to **39 N·m (29 lb-ft)**.
10. Confirm the center seatbelt securely latches into the center buckle.
11. Install all removed parts in reverse order of removal.
12. Unlatch the seatbelts and reinstall the center seatbelt in the ceiling storage slots.
