June 30, 2017

06981 Version 1

Safety Recall: 2017 MDX Hybrid Fuel Feed and Purge Hose Mis-Installation

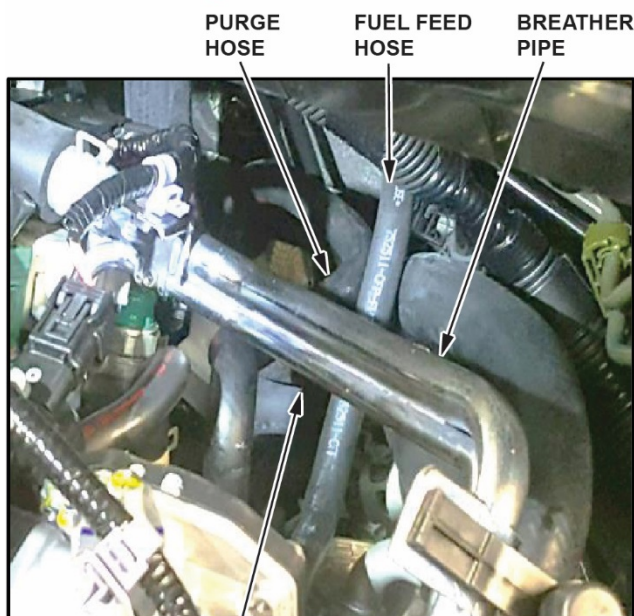
GOOD

Good condition: Fuel feed hose and purge hose routed underneath the breather pipe.

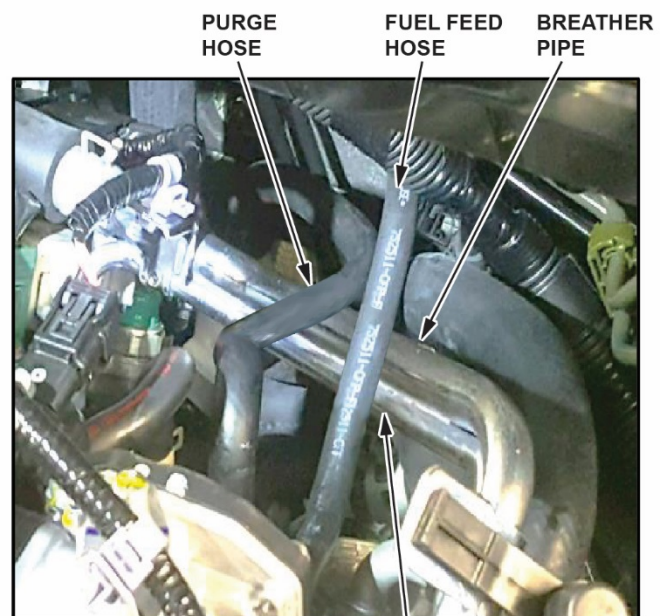
NO GOOD

No good condition: Fuel feed hose and purge hose routed over the breather pipe.

No – Go to REPAIR PROCEDURE.

7. Install the new purge and fuel hoses in reverse order of removal. Make sure the hoses are routed **underneath** the breather pipe.
8. Install the engine cover.

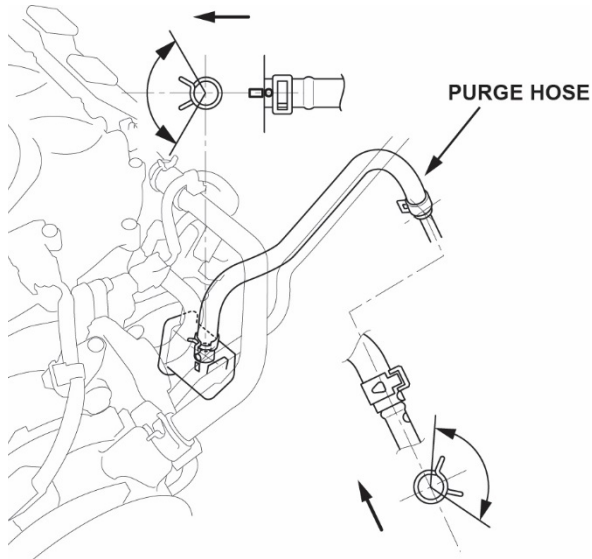
1. Remove the engine cover.
2. Disconnect and remove the purge hose.

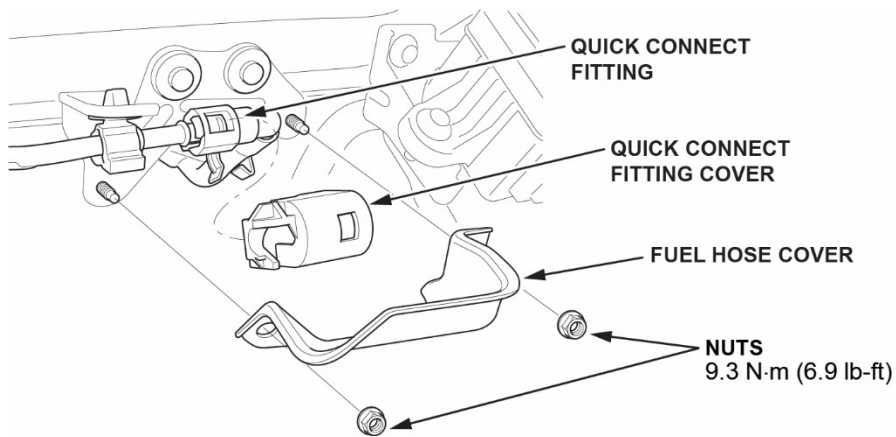
3. Relieve the fuel pressure using the i-HDS.
4. Remove the fuel hose cover.
5. Remove the quick connect fitting cover on the frame side, then disconnect the quick connect fuel line.

NOTE: A disconnected quick connect fitting can be reused, but the retainer on the mating line cannot be reused once it has been removed from the line. Replace the retainer only if needed.

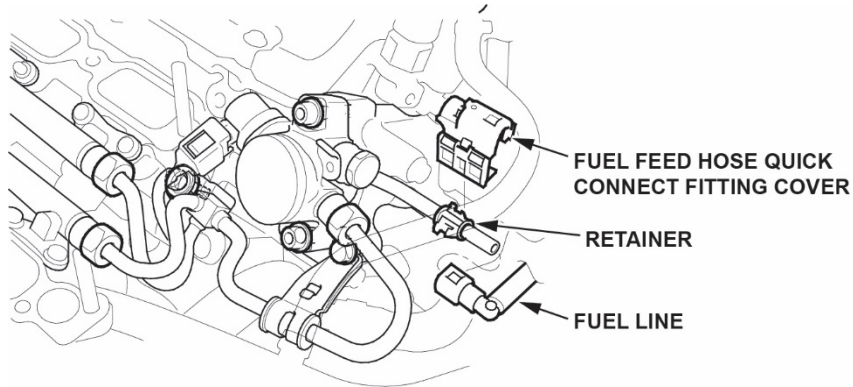
6. Remove the fuel feed hose quick connect fitting cover on the engine side, then disconnect the fuel line.

NOTE: A disconnected quick connect fitting can be reused, but the retainer on the mating line cannot be reused once it has been removed from the line. Replace the retainer only if needed.
