December 8, 2017

07860 Version 4

Safety Recall: 2017 CR-V Rear Fuel Feed Pipe LeaksSupersedes 17-062, dated August 25, 2017, to revise the information highlighted in **yellow****AFFECTED VEHICLES**

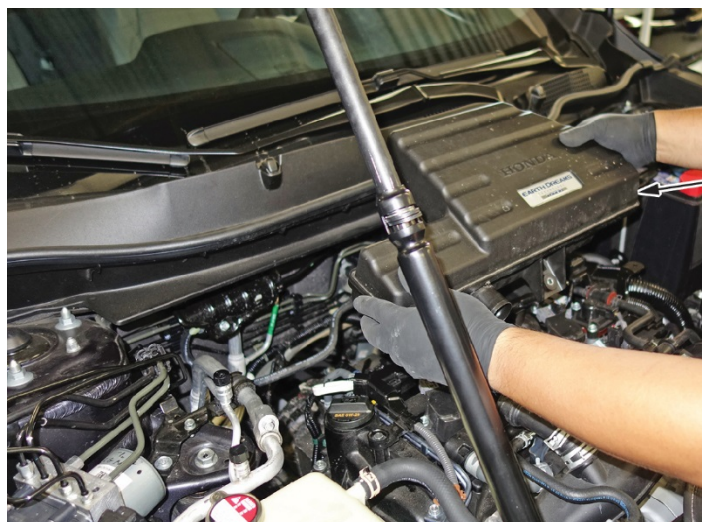
INTAKE AIR RESONATOR
2 BOLTS
12 N·m (9 lb-in)

- Flammable - Keep away from fire. If fuel ignites, it will cause a serious incident.
 - Relieve the fuel pressure before disconnecting the fuel line to avoid the risk of spraying pressurized fuel.
 - Disconnect the 12 volt battery negative terminal before disconnecting the electrical connector to reduce the risk of a fire caused by sparks.
 - Do not apply brake fluid, engine coolant, plant-based oil, or alcohol-based oil to the O-ring. Incorrect fluid or oil may cause the material to deteriorate or other damage.
1. Relieve the fuel pressure. Refer to the service information.
 2. Do the battery disconnection procedure to disconnect the negative battery cable. Make sure to isolate it so it doesn't unintentionally spark.
 3. *1.5 L Models only:* Remove the intake air resonator.

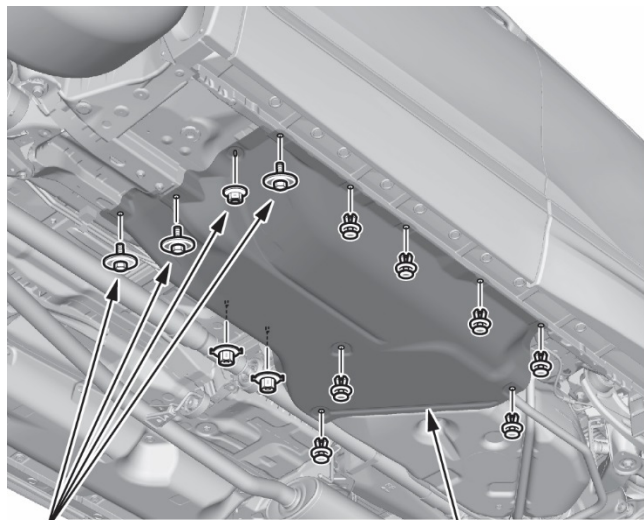
**MIDDLE FLOOR
UNDERCOVER**

BOLTS AND NUT
9.4 N·m (6.9 lb-in)

10. Remove the middle floor undercover to access the fuel feed pipe connection.

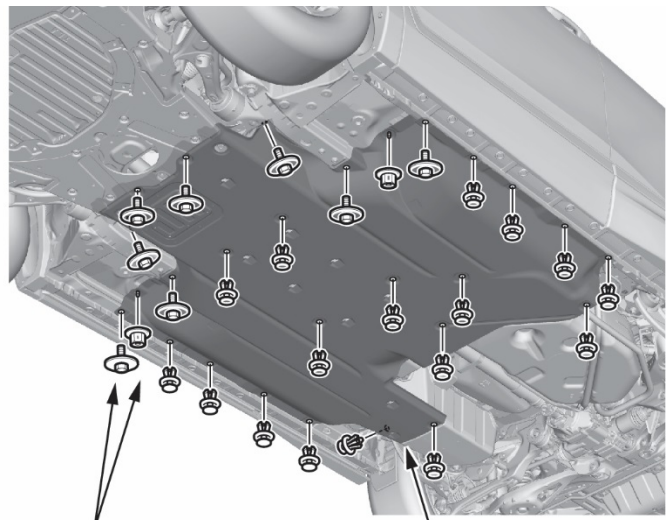
MIDDLE FLOOR UNDERCOVER
(EX 2WD, EX-L 2WD,
Touring 2WD ONLY)

BOLTS AND NUTS
9.4 N·m (6.9 lb-in)

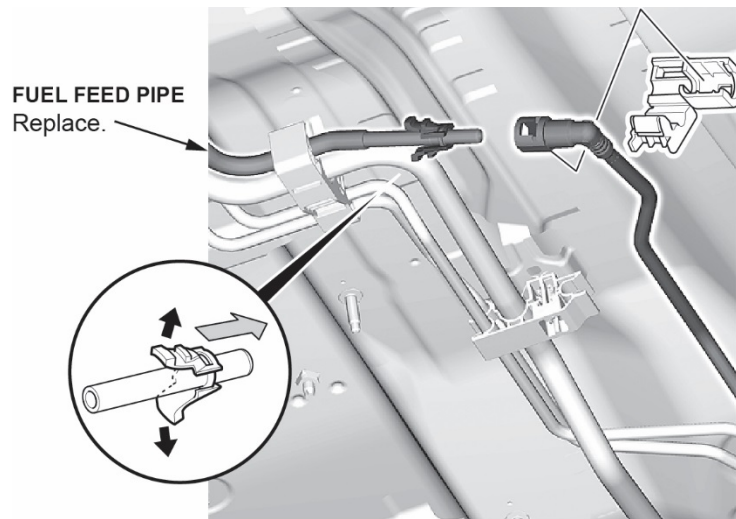
FUEL FEED PIPE
Replace.

11. Disconnect the fuel feed pipe quick-connect fitting and disconnect the fuel feed pipe.

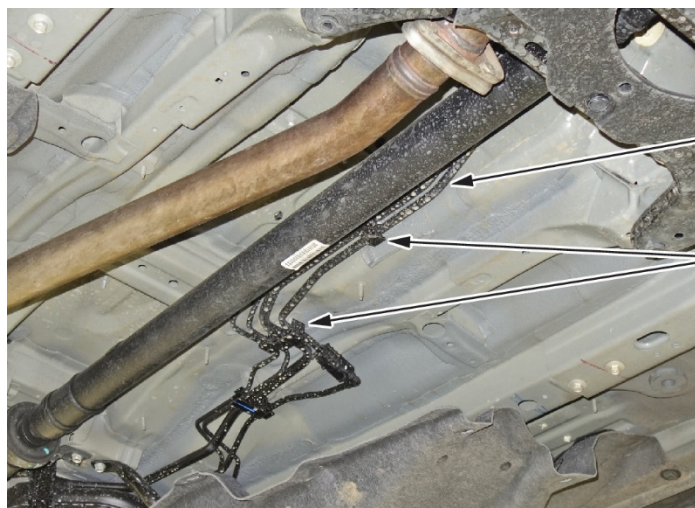
**FUEL LINE
HOLDERS**

FUEL FEED PIPE
Replace.

12. Remove the fuel feed pipe from the holders.

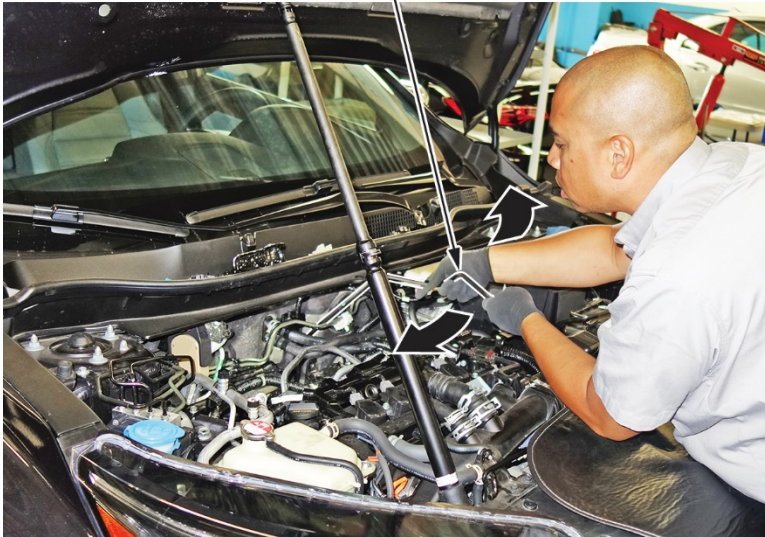
NOTE: You may have to twist the fuel feed pipe to remove it from the vehicle.

FUEL FEED PIPE
Replace.

13. Remove the fuel feed pipe from the engine compartment.
