August 25, 2017

07233 Version 3

Safety Recall: 2017 CR-V Rear Fuel Feed Pipe Leaks

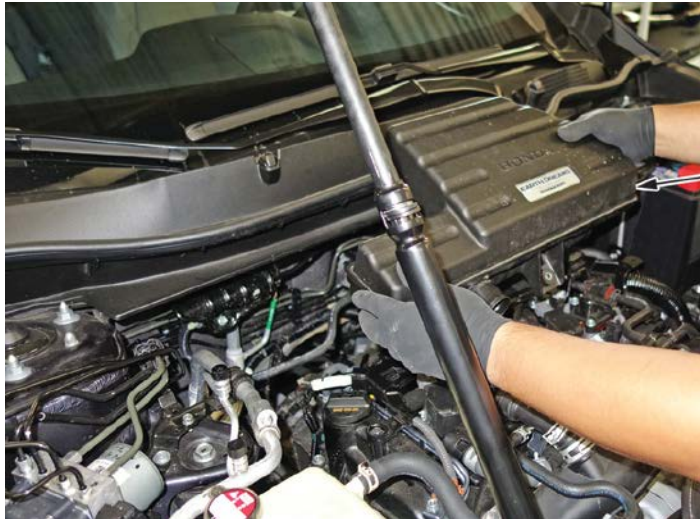
INTAKE AIR RESONATOR
2 BOLTS
12 N·m (9 lb-in)

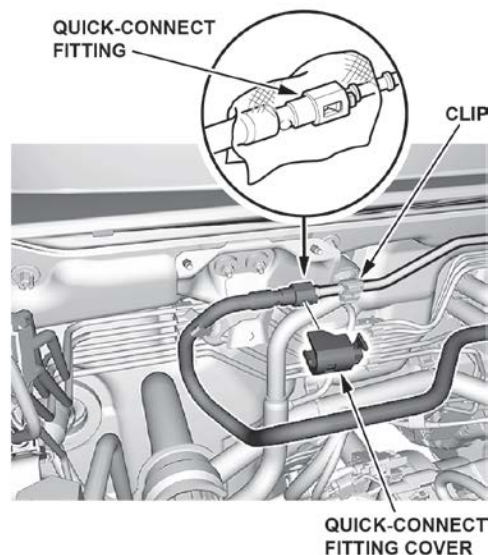
4. Remove the fuel hose cover, then disconnect the fuel feed pipe quick-connect fitting.

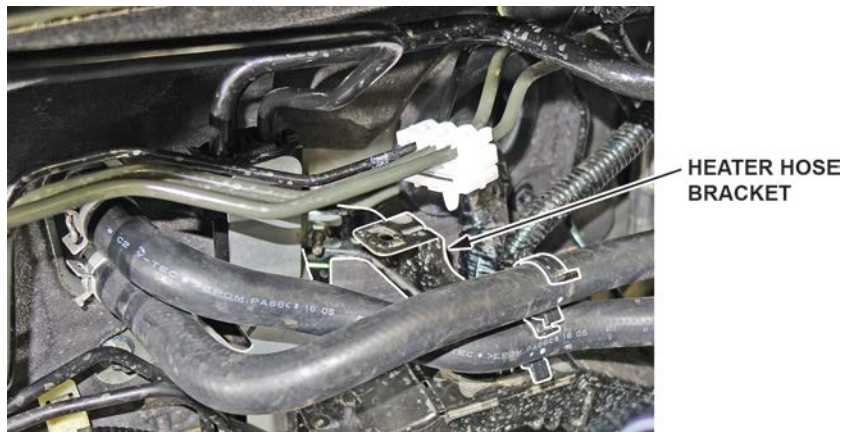
6. Remove the heater hose bracket at the firewall.

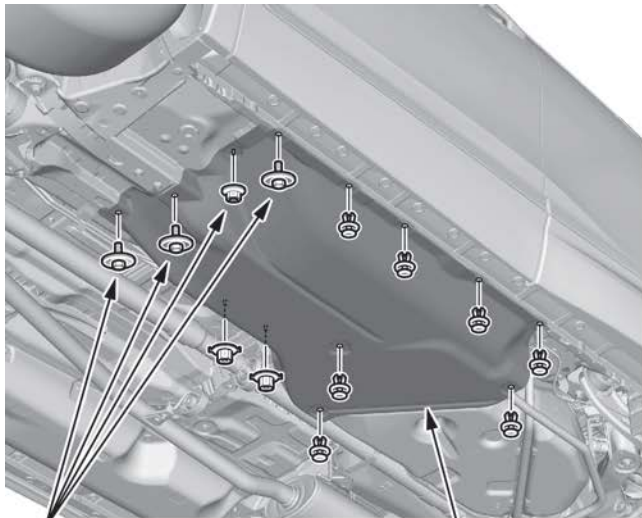
BOLTS AND NUT
9.4 N-m (6.9 lb-in)

MIDDLE FLOOR UNDERCOVER

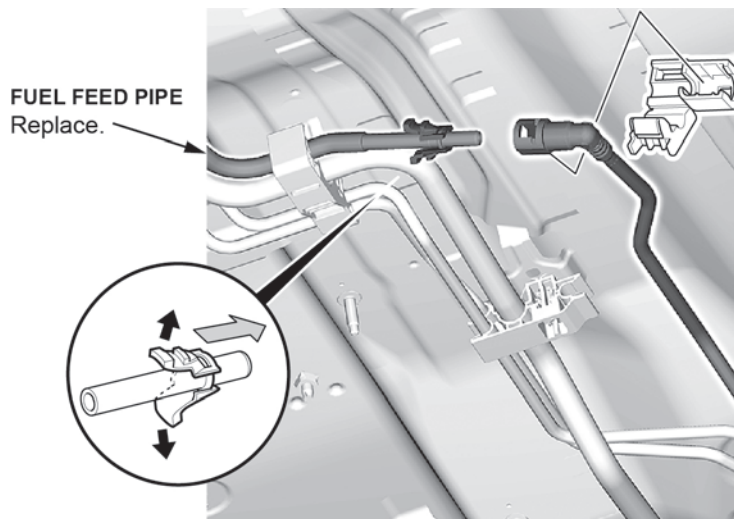
11. Disconnect the fuel feed pipe quick-connect fitting and disconnect the fuel feed pipe.

FUEL FEED PIPE
Replace.

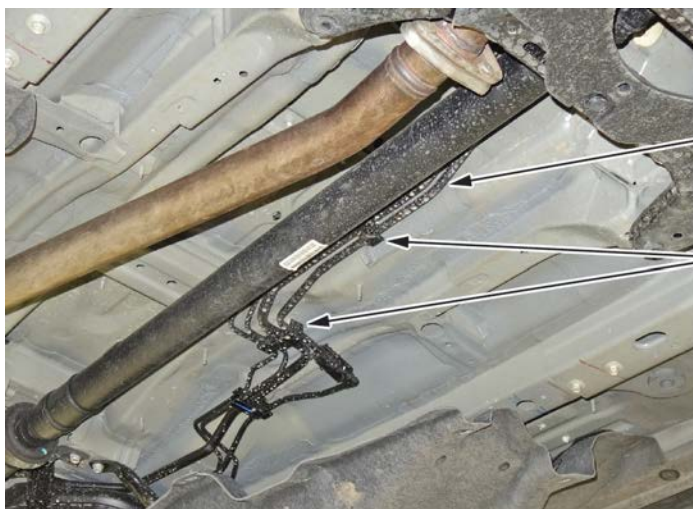
12. Remove the fuel feed pipe from the holders.

FUEL FEED PIPE
Replace.

FUEL LINE
HOLDERS

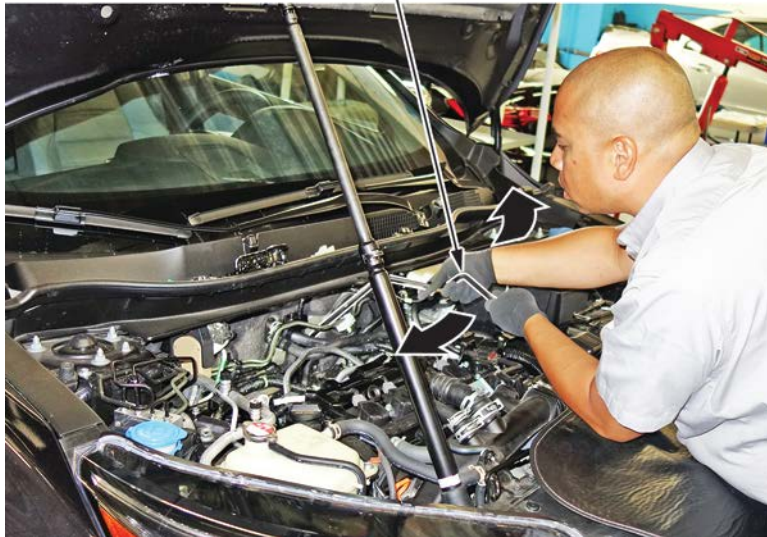
13. Remove the fuel feed pipe from the engine compartment.

NOTE: You may have to twist the fuel feed pipe to remove it from the vehicle.

FUEL FEED PIPE
Replace.
