## SAFETY ADVISORY # 17-293

### Avalanche 370 Slide Ram

**Models Included:** 2016 - 2018 Avalanche, Model 370RD

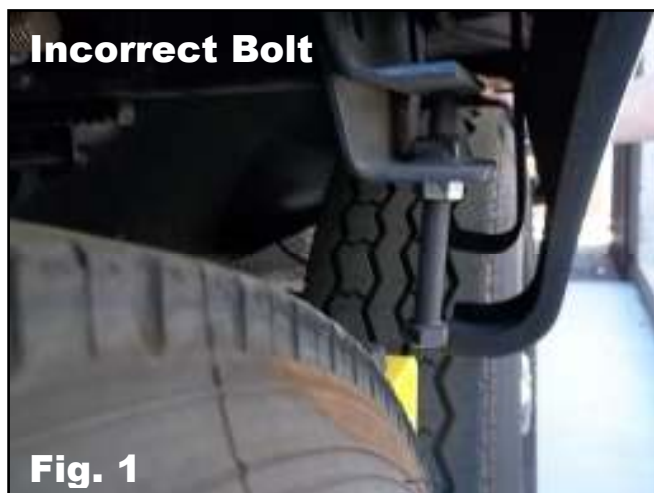
If there is less than 2 3/4" of space between the bolt head and tire replace the bolt with the part number provided above. See Figure 1 for incorrect bolt and Figure 2 for correct bolt. Using a ratchet and 3/4" socket, remove the existing bolt. Start the new bolt by hand and finish with the ratchet, install the bolt firmly against the adjustment plate.
