# SAFETY RECALL BULLETIN

SUBJECT: <b>WINDSHIELD WIPER MOTOR – SAFETY RECALL CAMPAIGN</b>			No: <b>SR-17-003</b>
			DATE: <b>July 2017</b>
			MODEL: <b>2007–2013 Outlander</b>
CIRCULATE TO:	<input checked="" type="checkbox"/> GENERAL MANAGER	<input checked="" type="checkbox"/> PARTS MANAGER	<input checked="" type="checkbox"/> TECHNICIAN
<input checked="" type="checkbox"/> SERVICE ADVISOR	<input checked="" type="checkbox"/> SERVICE MANAGER	<input checked="" type="checkbox"/> WARRANTY PROCESSOR	<input checked="" type="checkbox"/> SALES MANAGER

This bulletin provides directions for replacing the windshield wiper motor. This bulletin is meant to be used in conjunction with bulletin SR-16-009, “Windshield Wiper Link – Safety Recall Campaign.” SR-16-009 must be performed where indicated before this bulletin can be resumed.

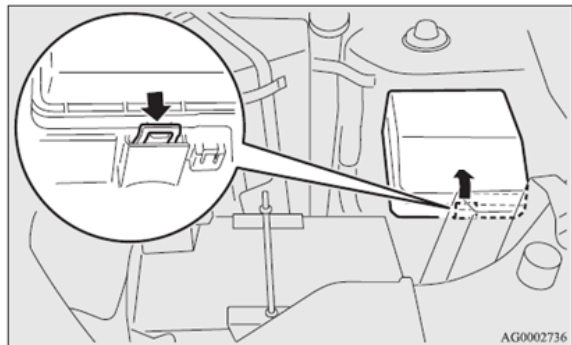
1. Obtain the Fuse Remover from the engine compartment fuse box.

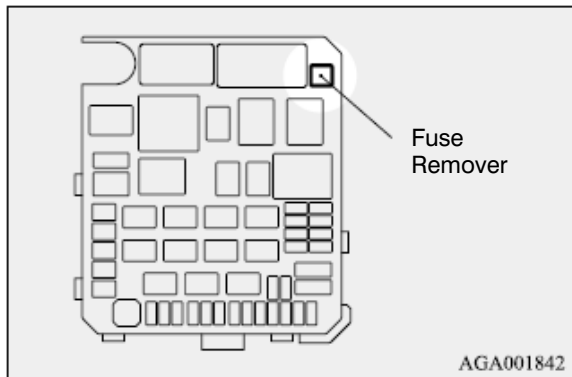
- a. Open the hood.
- b. Unlock the fuse box cover by pushing on the lock lever.

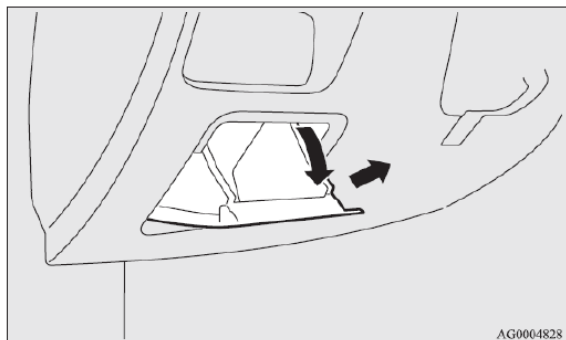
2. Locate the side box inside the vehicle.

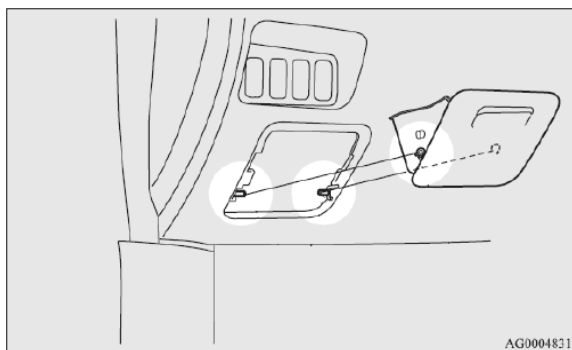
3. Open the side box.

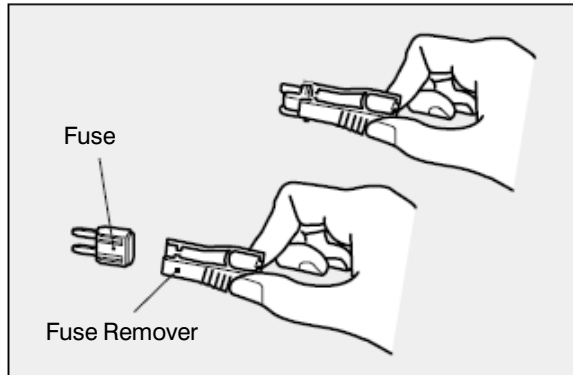
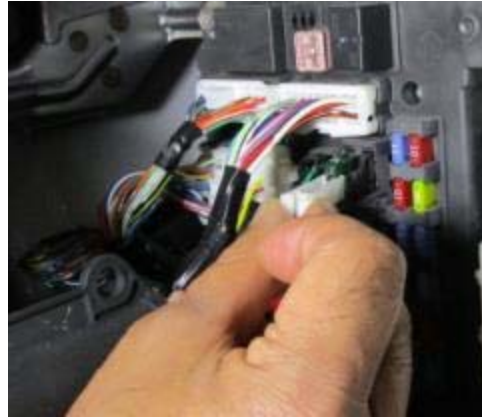
### How to Use Fuse Remover

5. Using the Fuse Remover, locate and remove the green (30 A) Wiper Fuse.

A Fuse Remover **MUST** be used to remove fuses. Use of other tools such as pliers can potentially result in thermal incidents.

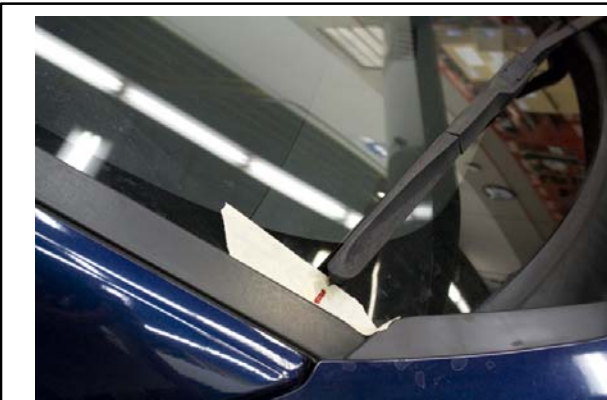
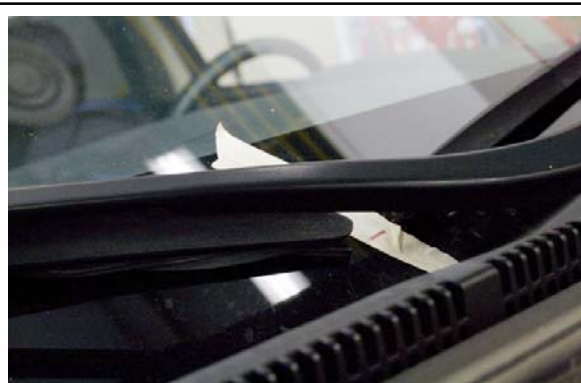
Before marking the windshield wiper positions, lift the wiper blade from the windshield and set it back down to ensure that they are resting in their intended positions.

6. Attach masking tape to the windshield and mark the wiper blades' positions as shown.

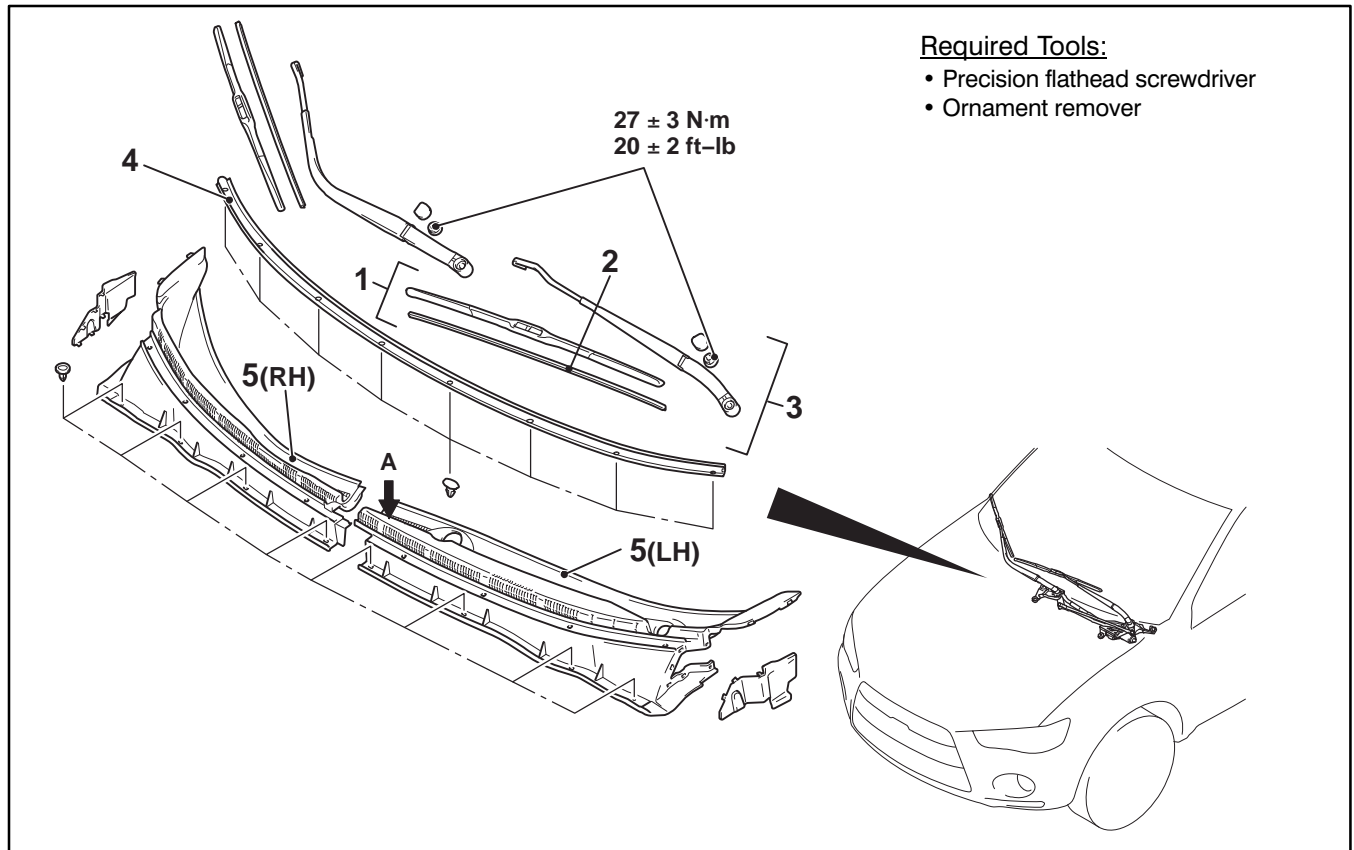
8. Remove front deck garnish.

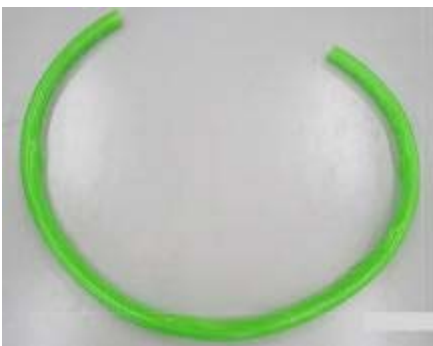
1. Hose Length: Approx. 33 in. (85 cm)

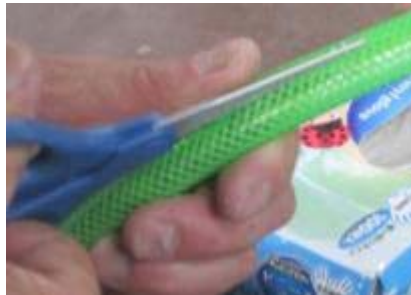
2. Cut entire length of hose

Cross Section of hose

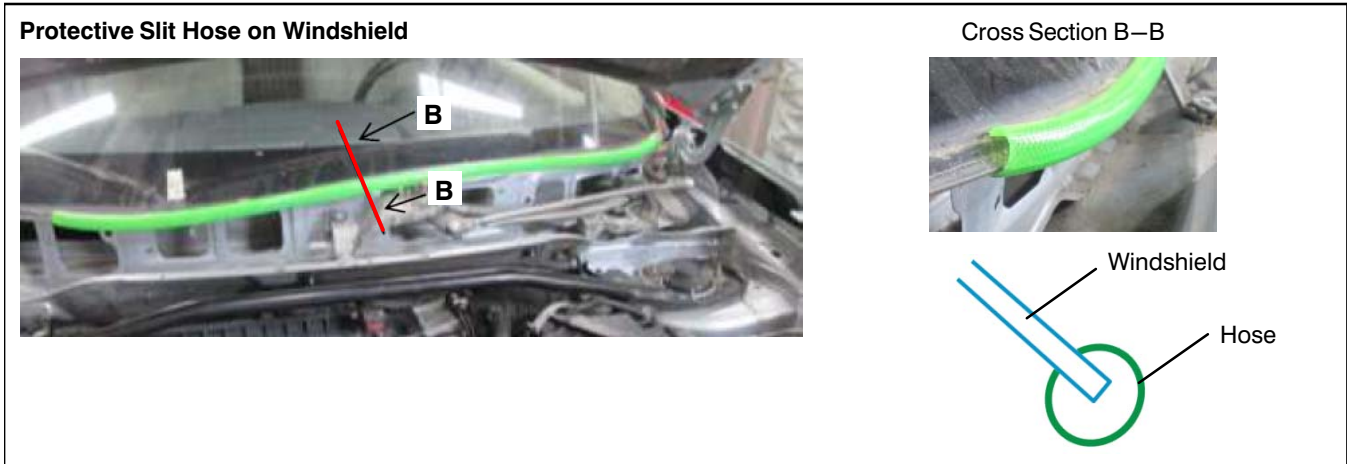
- b. Cover the edge of the windshield with the protective slit hose.

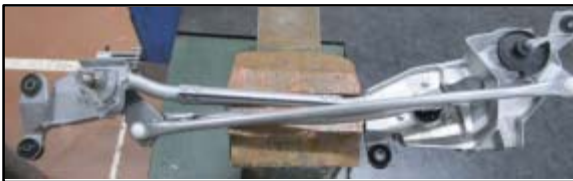
- 11. Unbolt the wiper link assembly, disconnect the wiper motor connector, and remove the wiper link assembly from the vehicle.

**CAUTION** Clamp the wiper link assembly at the connection pipe only.

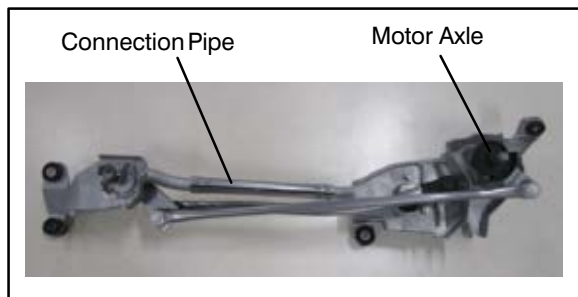
- 12. Place the wiper link assembly in a vice with the motor axle pointing up.

**CAUTION: Clamp ONLY the connection pipe section.**

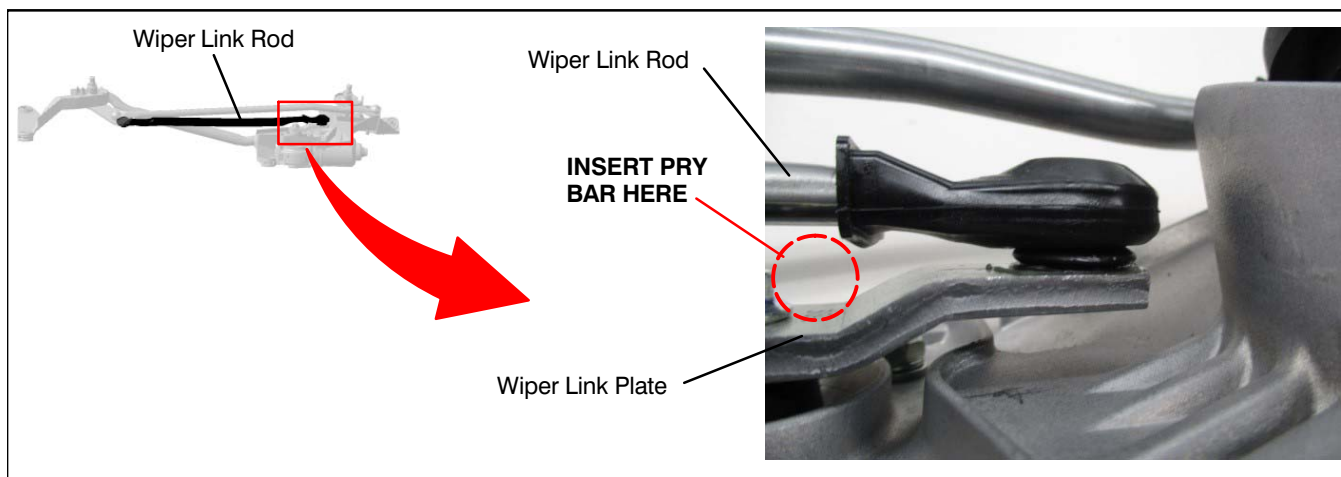
13. Use a pry bar or similar device to separate the wiper link rod from the wiper link plate. Insert the pry bar and lift using leverage in area shown below.

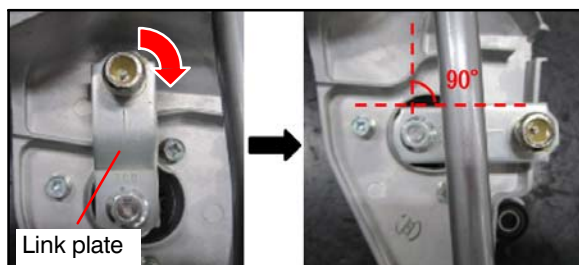
**CAUTION**

Turn the link plate slowly to avoid internal damage to the wiper motor.

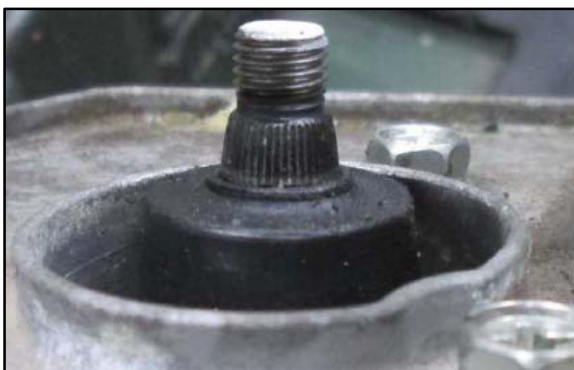
19. Hold the link plate in place with an adjustable wrench while removing the link plate nut.

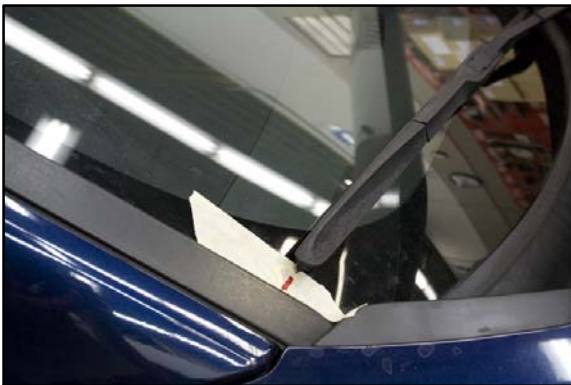
- 25. Turn the ignition switch to “ACC” or “ON”.
- 26. Switch the windshield wiper switch to “LO” and back to “OFF” to move wiper link to initial position.
- 27. Remove protective slit hose from windshield.
- 28. Install the passenger side wiper arm at the marked position.
  - a. Tighten nut to  $20 \pm 2$  ft–lb ( $27 \pm 3$  Nm).

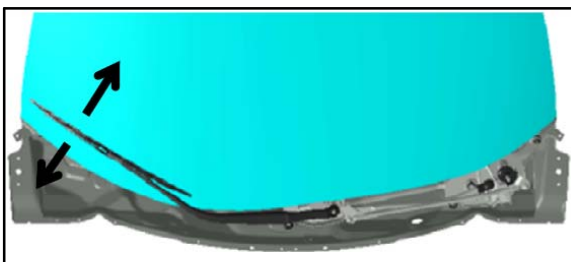
- 29. Confirm wiper operation in wiper “INT” mode for 10 cycles. If either of the following abnormal behavior is observed, perform the appropriate correction.
  - a. Abnormal behavior 1: Wiper blade moves up briefly then stops.
    - (1) Correction procedure: Turn link plate clockwise.
  - b. Abnormal behavior 2: Wiper blade moves down briefly during the start of wiper operation.
    - (1) Correction procedure: Turn link plate counterclockwise.
