Recall 17V-481 COMPLIANCE RECALL Retrofitting Reflectors

Service Information No. SI 77 001 18

COMPLIANCE RECALL: Retrofitting reflectors

00 60 327 Retrofitting Reflectors for Aluminium, Vario, and Touring case

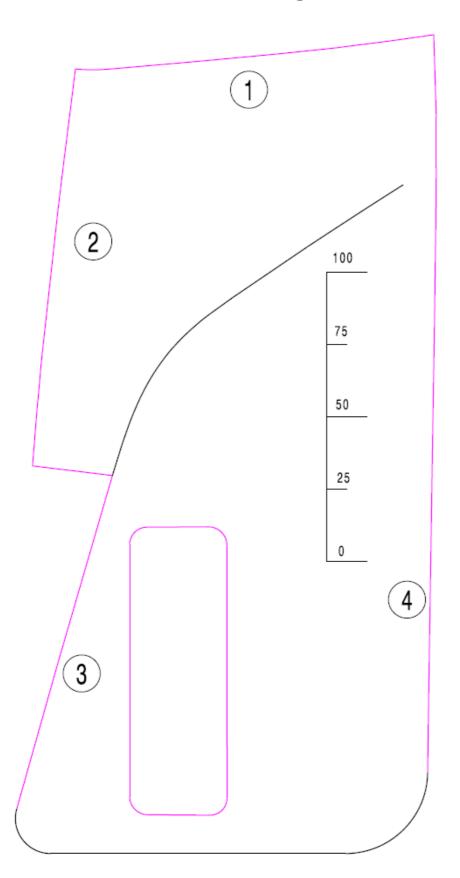
- Print the template on pg. 7, Check the size of the template. If necessary, change the print size setting.
- Place the template **(arrow)** on the outside of the case contours **(1)** to **(4)**.
- Note: the area where the reflector mounts must be clean. Apply the left reflector **(5)**.
- Apply the right reflector in the same way.
