## SIB 65 13 17

### RECALL CAMPAIGN 17V-495: REPLACE DRIVER'S AIR BAG MODULE (PSDI-X) EXPANSION

BMW is conducting a Voluntary Safety Recall of BMW X3 (F25) and M6 (F12/F13) vehicles involving the driver's air bag module (PSDI-X).

Due to a supplier production error, air bag gas inflators were incorrectly welded. This issue is related to supplier production and not the propellant used.

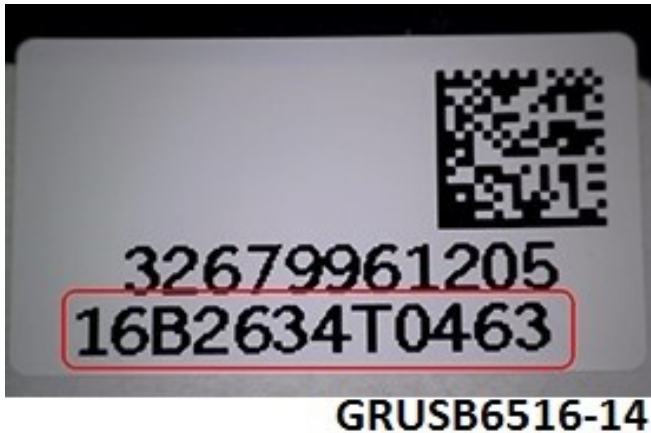
Follow ISTA Repair Instructions for removal/installation of air bag assembly:

- REP 32 34 020 – Removing and installing/replacing air bag unit
- REP 32 34 030 – Removing and installing/replacing air bag unit (sports steering wheel)
- REP 32 34 030 – Removing and installing/replacing air bag unit (M sports steering wheel)

Note: Before installing the replacement part, the new air bag module's serial number must be documented by the technician on the repair order so it can also be entered into the warranty claim's comment section.

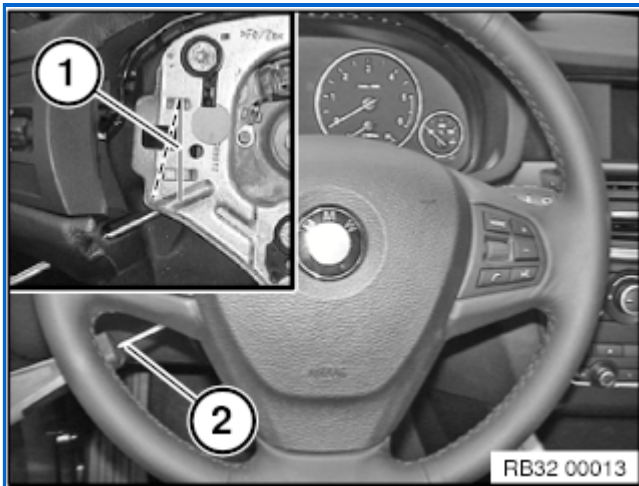
Insert Torx screwdriver T25 (2) at an angle into concealed opening on reverse side of steering wheel until a spring resistance is felt (approx. 1.5 cm).

Press spring leg (1) inward until airbag is unlocked.

Repeat procedure on other side.
