SAFETY ADVISORY # 17-296

CrossRoads Propane Manifold

Keystone is conducting a voluntary RECALL notification campaign in accordance with the National Highway Transportation and Safety Act. It has been decided the vehicles in this recall population may have a propane manifold under the kitchen slide that can come into contact with the main floor of the unit causing damage to the propane line. If the propane manifold comes into contact with the main floor when the slide room is retracted and/or during travel, there is an increased risk of damage to the manifold which may result in a propane leak leading to an increased risk of fire, personal injury and property damage.

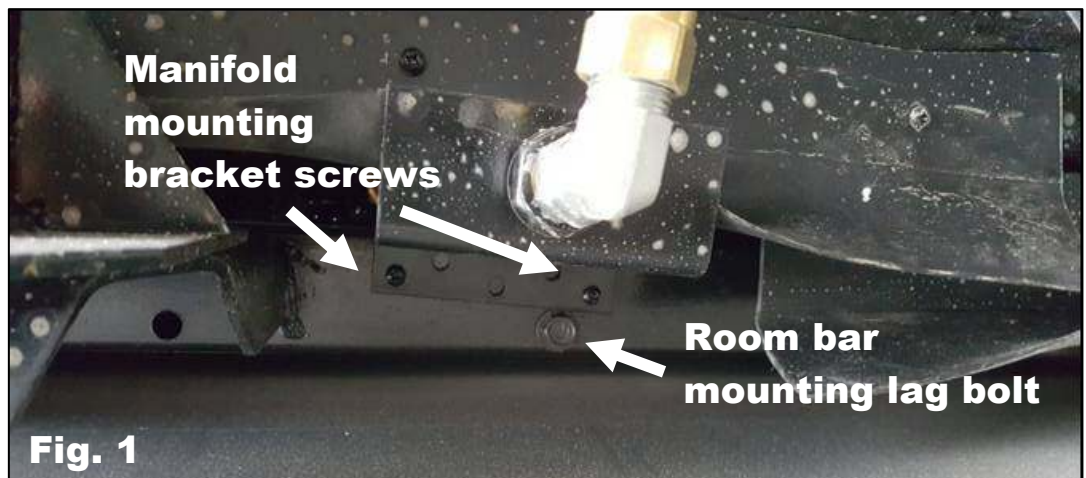
Locate the kitchen slide on the off door side. Open the room and inspect the propane manifold under the slide for damage. Remove the mounting screws for the manifold from the room bar, Figure 1.

Remove the sealant from around the propane lines, Figure 2, in the floor and move the manifold bracket towards the skirt metal $\frac{1}{4}$ " to $\frac{1}{2}$ " to provide adequate clearance, Figures 3. If the room bar mounting lag bolts are in the way of moving the manifold, remove the lag and place it in the next hole closest to the manifold, Figure 1

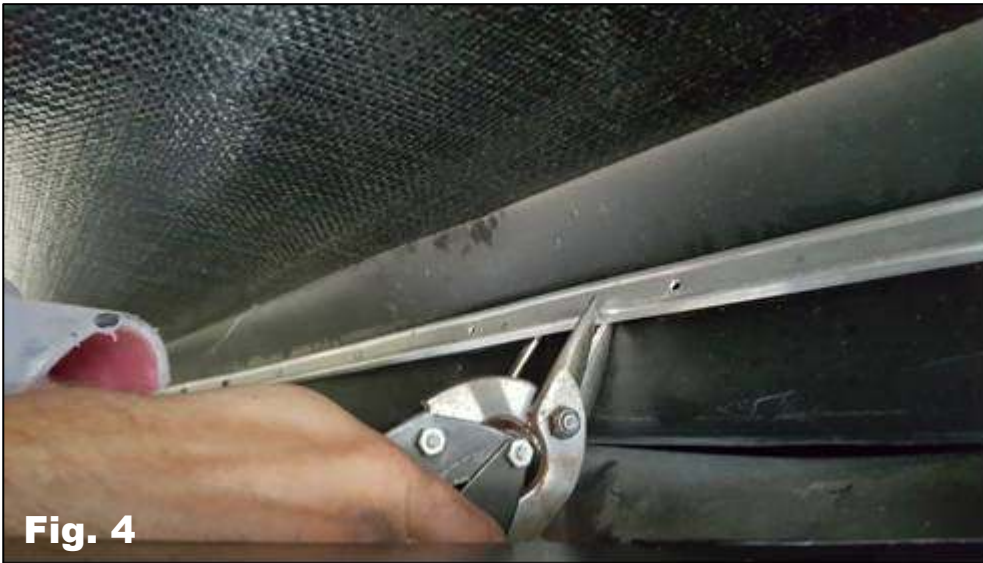
Inspect the room opening where the mill finish metal trim holds the wipe seal in place. The trim will need to be removed where it makes contact with the propane manifold on the slide. Remove approximately 6" – 8" of the trim and add a screw to each end where it is cut (Figure 4), and one screw in the middle of the cut-out to hold the wipe seal, Figure 5.
