Pioneer RD210 & BH250 Securing LP Hose to frame

Description

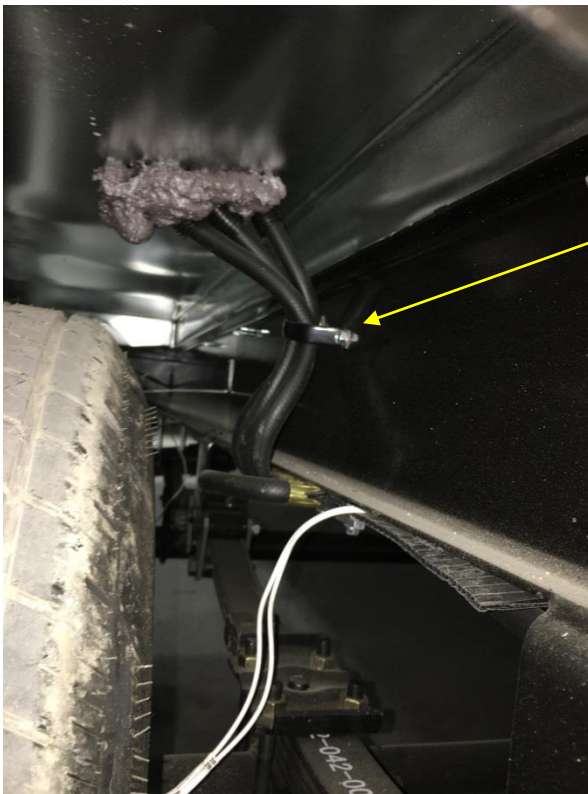
1. LP hoses clamped to frame – no repair required file claim for inspection only.

D clamp securing
Hoses. No repair
required.

File Recall Inspection warranty claim using warranty code 99.01.34.L, for 0.10 hours.
