# SAFETY RECALL BULLETIN

## NHTSA RECALL 17V-534 Transport Canada Recall 2017-438

AUTOCAR Industries, LLC SAFETY RECALL MDTT-1701

Autocar and Dana have determined that a safety defect exists in the steer knuckle and tie rod connection of the steer axle in certain 2016 model-year Xpert and Xspotters.

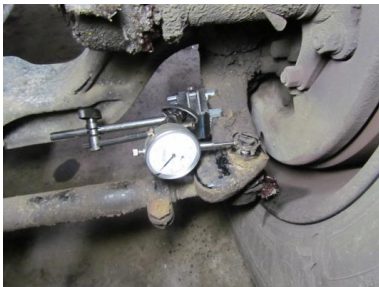
1. Block the forward and rear of at least one of the drive axle tires so the vehicle cannot move during this procedure.
2. With a flexible, magnetic base dial indicator, mount the base of the indicator on the tie rod arm so that the indicator tip can be centered on the threads of the stud just above the nut.

Dial Indicator Mounting Position

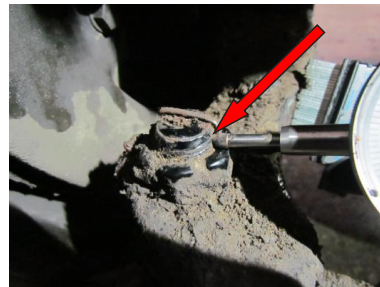
Dial Indicator Tip Must be Placed on The Stud

3. With someone in the cab of the truck turning the steering wheel (engine off) just enough to cause movement in the wheels, document how much movement is found on each side of the steer axle. Record results on the supplied form.
4. The next step is to remove the cotter pins and check for proper nut torque. Put a paint mark across one side of the nut and top of the stud. With a torque wrench and a 1 ¼" socket, torque the nut in a clockwise (tighten) direction until the nut just starts to rotate or you reach 130 ft. lbs. **Important: Do not exceed 170 ft. lbs.** Record your findings on the recall form.

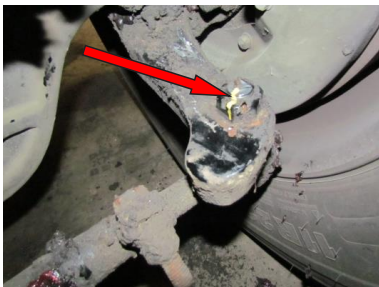
Paint Mark to Identify Nut Rotation

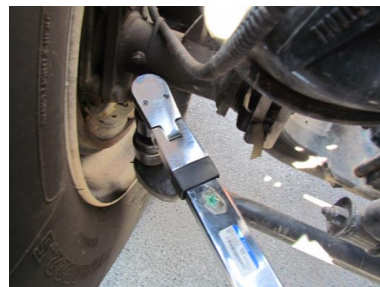
Check Nut Torque – Do Not Exceed 170 ft. lbs.

5. If there is no rotation of the nut at 130 ft. lbs. install a new cotter pin and return the truck to service.

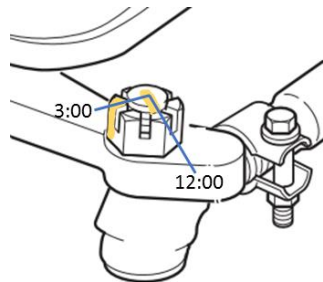
Record Rotation on Nut

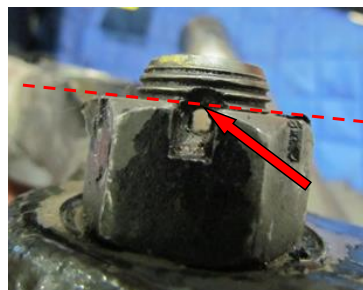
- Important:** Any tie rod stud with movement after proper nut torque and alignment will require the replacement of that knuckle and tie rod.
- Important:** One last check. After the nut has been aligned with a slot in the nut, the cotter pin hole **CAN NOT** be above the top of the nut as shown below. Any cotter pin hole that is above the top of the nut surface will require the replacement of the knuckle and tie rod end.

Cotter Pin Hole at Maximum Height
