INSTRUCTION TO SERVICE

ITS: 6628	
SECTION:	526 Seating & Stanchions
WRITTEN BY:	James Ashdown
SUBJECT:	Part A – RECARO Seatbelt Inspection Part B – RECARO Seatbelt Replacement Section I - Applicable to Ergo M AM80 Section II - Applicable to Ergo M and MCII AM71/72 (TETHER BAR MOUNTED)

Issue: RECARO seatbelt buckles may be locked in a latched position which does not allow the latch plate (tongue) to engage. This prevents the driver from securing the seatbelt.

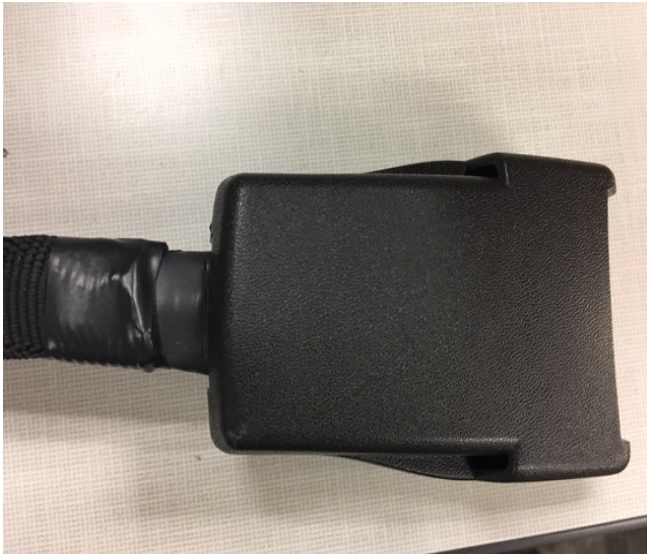
Figure 1 – New Style Buckle – Do Not Replace

1. Inspect RECARO seatbelt buckle for Julian Code. If a new style buckle is found, do not replace. If an older style buckle is found, find the Julian Code in the area indicated. Refer to Figures 1 and 2.

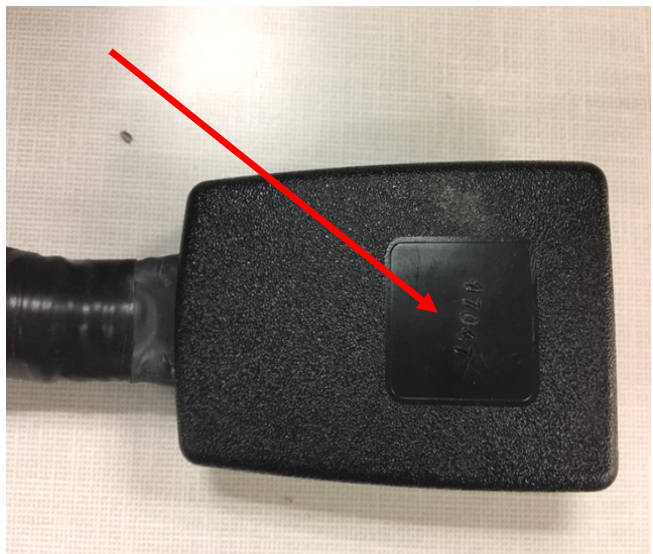
Figure 2 – Older Style Buckle with Julian Code

2. Replace older style buckle only if Julian Code falls between:

16335 (Dec. 1st 2016) to 17178 (June 27th 2017)

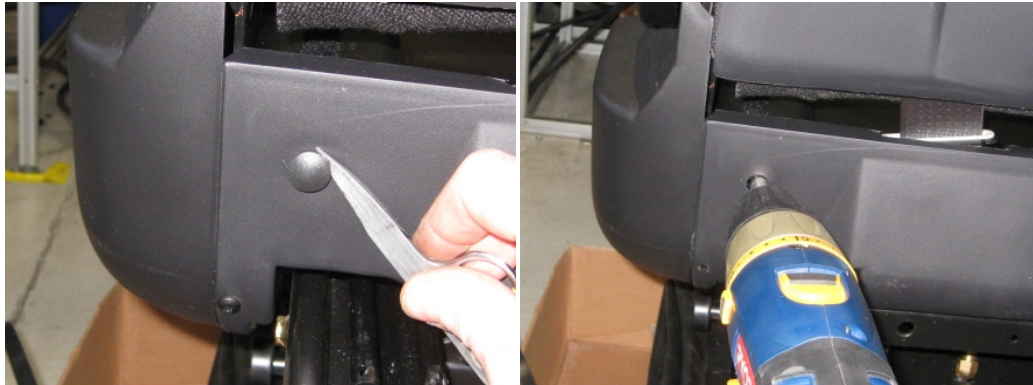
- Phillips #2 screwdriver
 - Large Flat head screwdriver
 - Side cutters
 - Small pick
 - 5/8" hex wrench/socket
 - Torque wrench
1. Remove hole plugs from lower rear trim panel using small pick. Save for re-use. Remove rear lower trim panel using Phillips #2 screwdriver. Set aside caps, screws, and panel.

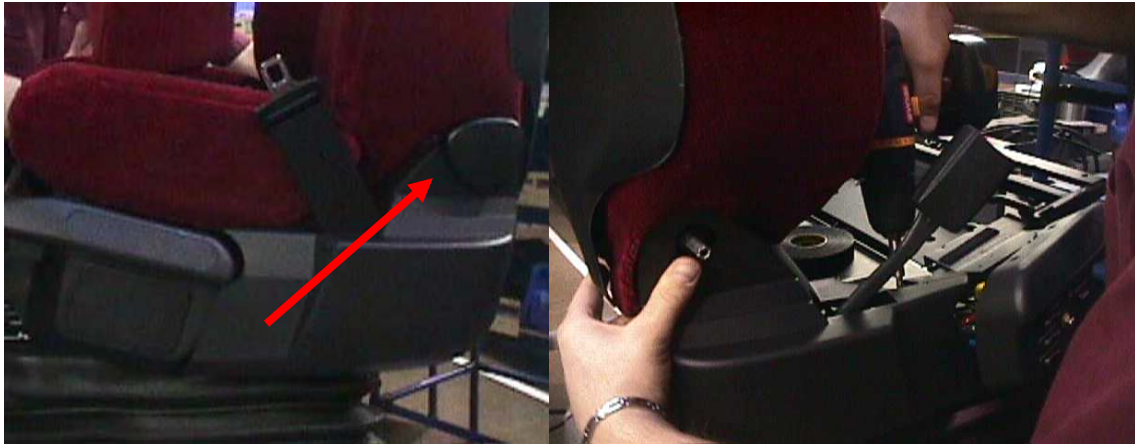
2. Remove hand wheel from the recliner on the same side as the buckle by prying gently with a large flat head screwdriver. Remove rear side trim panel using Phillips #2 screwdriver. Move to the side to gain access to the seat belt buckle bolt.

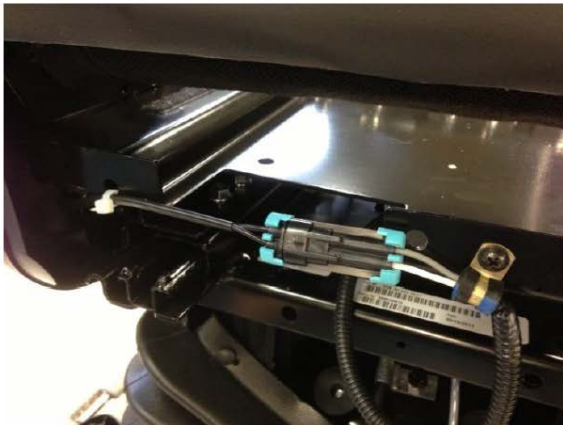
3. Disconnect the electrical connector from the seat belt buckle to the jumper harness, if the seat is equipped with a seat belt alarm. Cut the small zip tie with side cutters, ensuring the wire harness is not damaged.

Buckle on LH side of seat

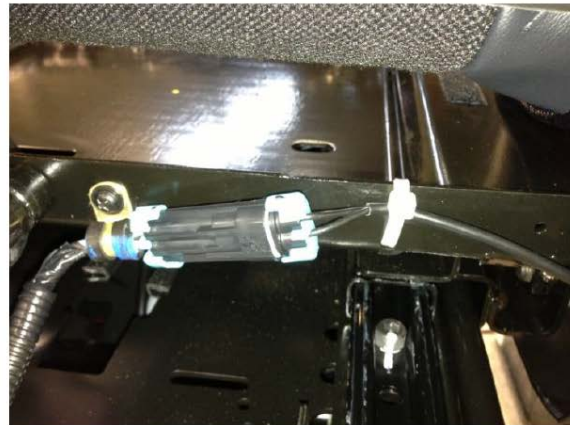
Buckle on RH side of seat

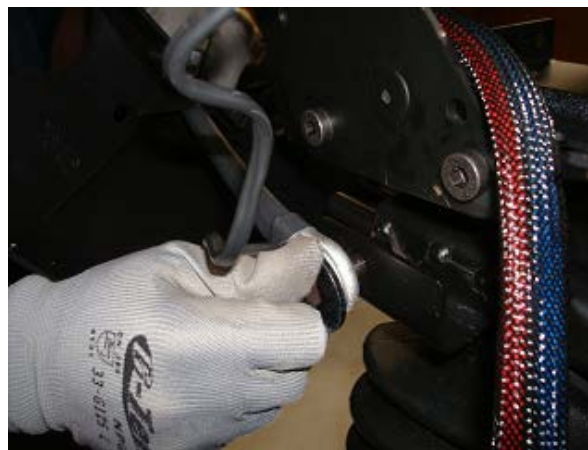
4. Using a 5/8" socket, remove the seat belt buckle bolt from the J bracket. (Option shown below is on the left hand side, the buckle can be installed on the left or right side.)

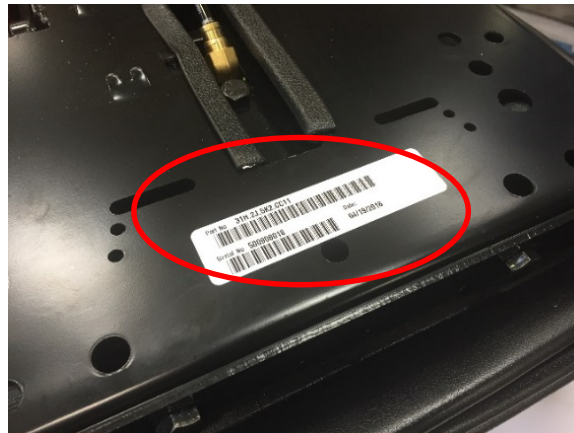
5. Remove the buckle and hardware from the seat. Set aside to return to RECARO. Record to serial number of the seat to tag the buckle. The serial number is located on the white 4X1 sticker located on the top rear plate of the suspension.

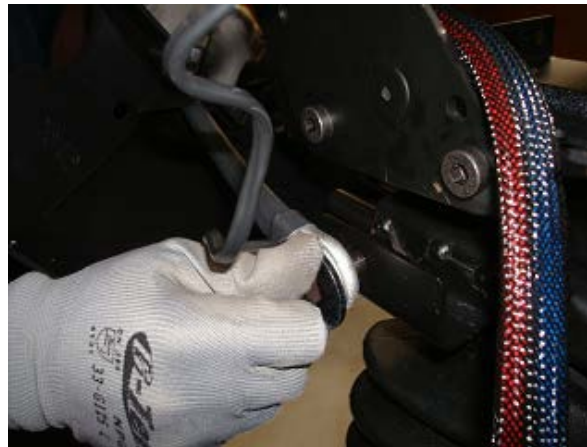
6. Obtain the new buckle and route the end of the buckle through the opening in the side rear trim panel. Place large washer & buckle on J bracket and hand start bolt. If the seat does not require a seat belt alarm, cut the wire off as close to the base of the heat shrink tubing as possible. If it does require an alarm, ensure the washer does not pinch the wire harness. Torque to 50 +/- 4 Nm.

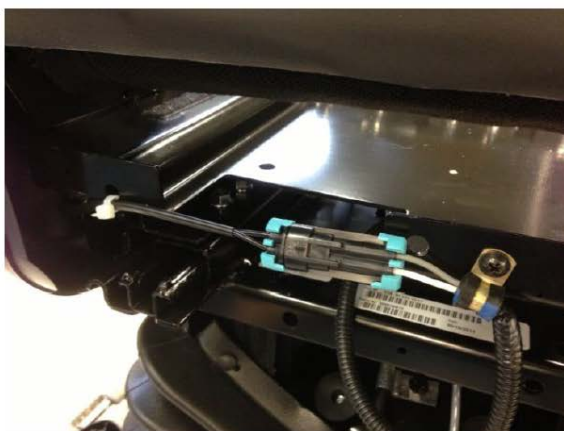
7. Connect the seat belt alarm on the buckle to the jumper harness on the seat. Loop the small zip tie around the cushion frame to ensure the wire harness is routed the same as it was previously.

Buckle on LH side of seat

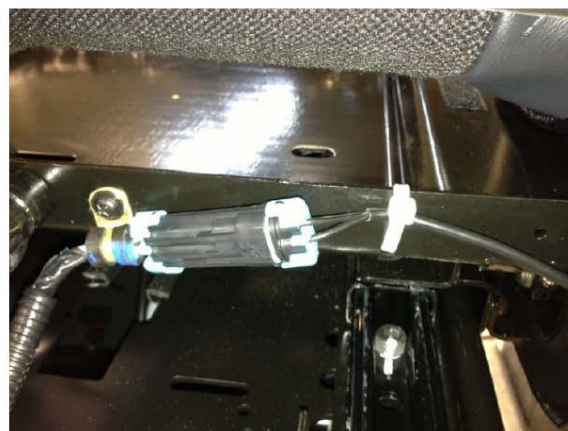
Buckle on RH side of seat

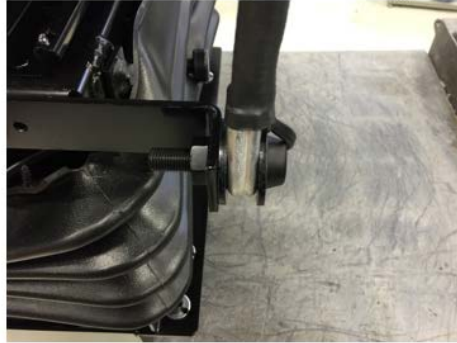
3. Using a 5/8" socket, remove the seat belt buckle bolt from the tether bar. (Option shown below is on the left hand side, the buckle can be installed on the left or right side.)

Standard LH belt, tether configuration (buckle side close to suspension)

Standard N/C buckle

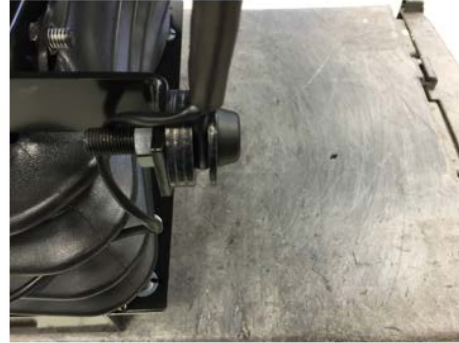
Standard N/O buckle

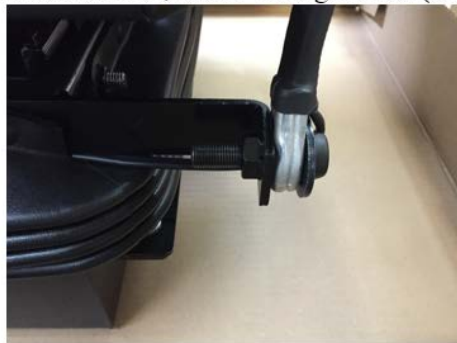
Shifted LH belt, tether configuration (buckle side extended away from suspension)

Shifted tether bar N/C buckle

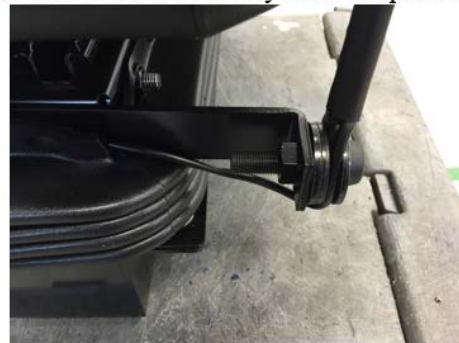
Shifted tether bar N/O buckle

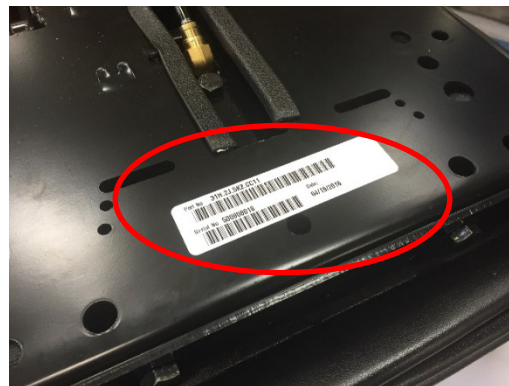
- Remove the buckle and hardware from the seat. Set aside to return to RECARO. Record to serial number of the seat to tag the buckle. The serial number is located on the white 4X1 sticker located on the top rear plate of the suspension.

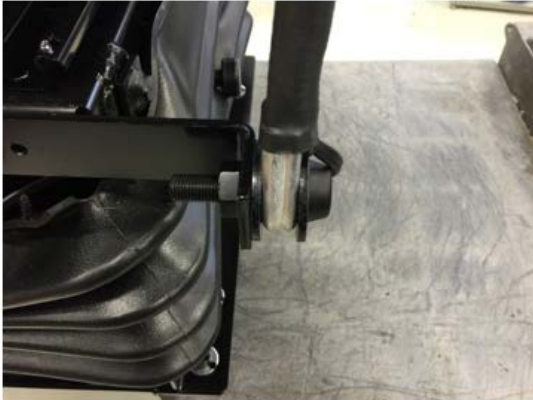
- Install seatbelt buckle (N/C standard-30822807E-01, N/O-30987307E) with bolt (30819307) and washer (30822707) under the head of the bolt and one of the following (ensuring the wire harness does not get pinched between any of the washers):

Standard LH belt, tether configuration (buckle side close to suspension)

Standard N/C buckle

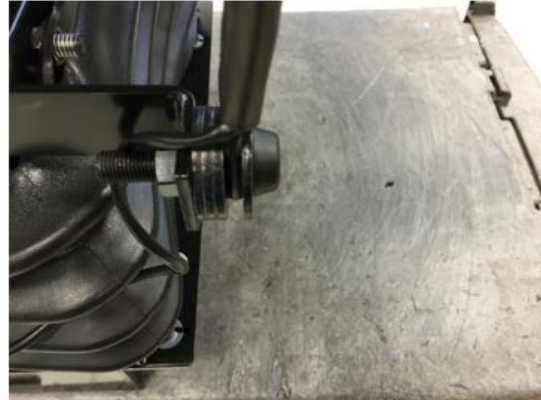
Standard N/O buckle

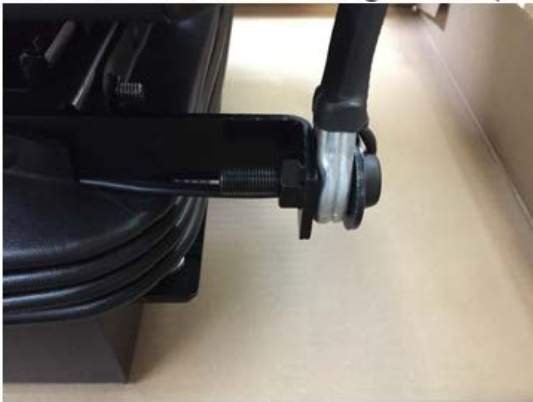
Shifted LH belt, tether configuration (buckle side extended away from suspension)

Shifted tether bar N/C buckle

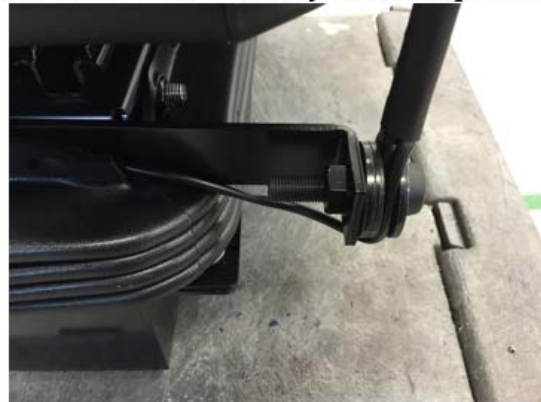
Shifted tether bar N/O buckle

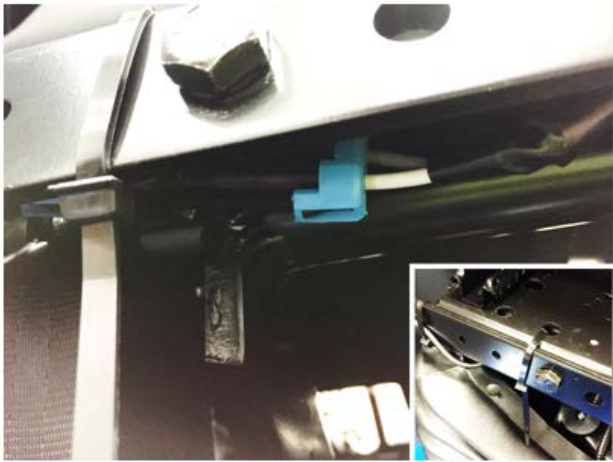
6. Connect the seat belt alarm on the buckle to the jumper harness on the seat. Loop the small zip tie around the cushion frame to ensure the wire harness is routed the same as it was previously. Secure the buckle wire high on the back side of the tether bar with a zip tie at the 90° bend of the bar. Angle the routing of the buckle wire down toward the bottom edge of the tether bar and secure with a second wire tie as close to the suspension as possible. Clip off the excess ends of the wire ties.

Example of left hand, normally-closed buckle

7. Torque the buckle bolt to 50 +/- 4 Nm. Replace the bolt cap.

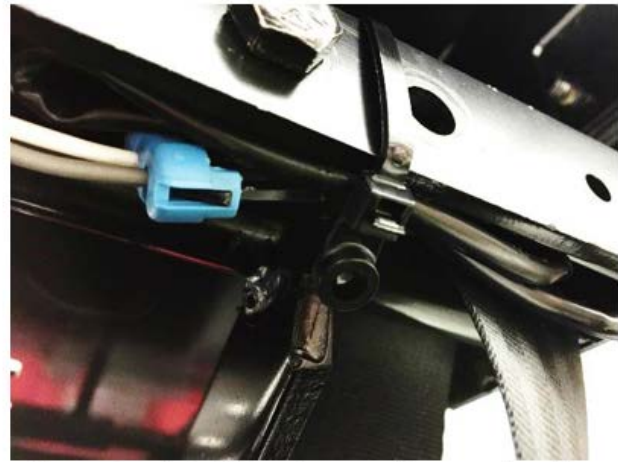
Example of right hand, normally-open buckle
