2016 MAZDA6 OCCUPANT CLASSIFICATION SYSTEM HARNESS CONCERN SAFETY RECALL

A. VEHICLE INSPECTION PROCEDURE

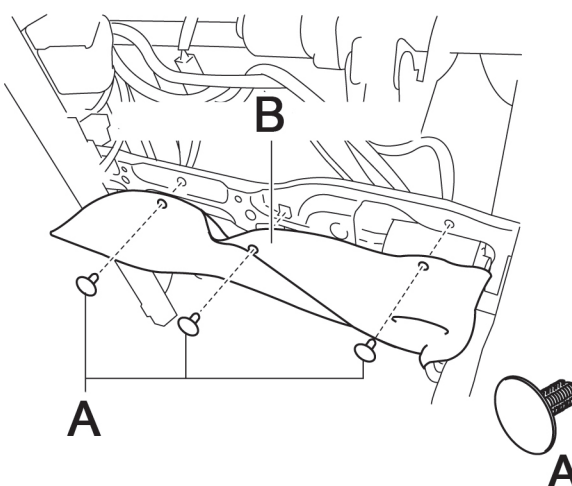
With Power Seats Remove fasteners (A) and outer trim (B)	Without Power Seats Detach hook (C) as shown (1), (2), (3).

A line drawing of the seat frame with the outer trim (B) being removed. Fasteners (A) are shown being removed from the trim. A separate drawing of a fastener (A) is shown below.

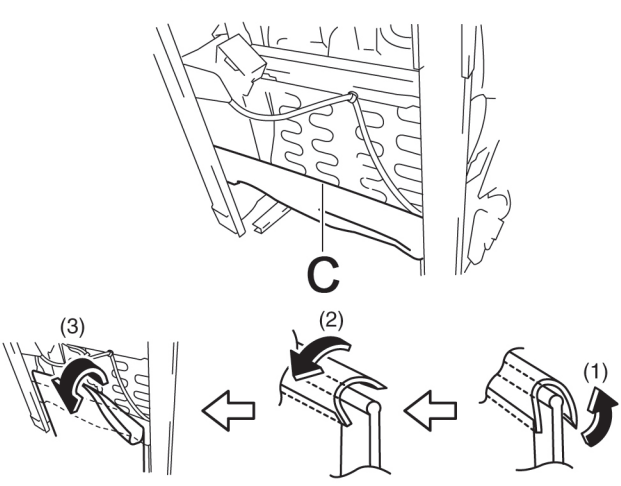
A line drawing of the seat frame with a hook (C) being detached. Three numbered steps (1), (2), and (3) illustrate the process of detaching the hook. Step (1) shows the hook being lifted, step (2) shows it being moved, and step (3) shows it being detached.
Use the Trim Fastener and Molding Remover remover tool.

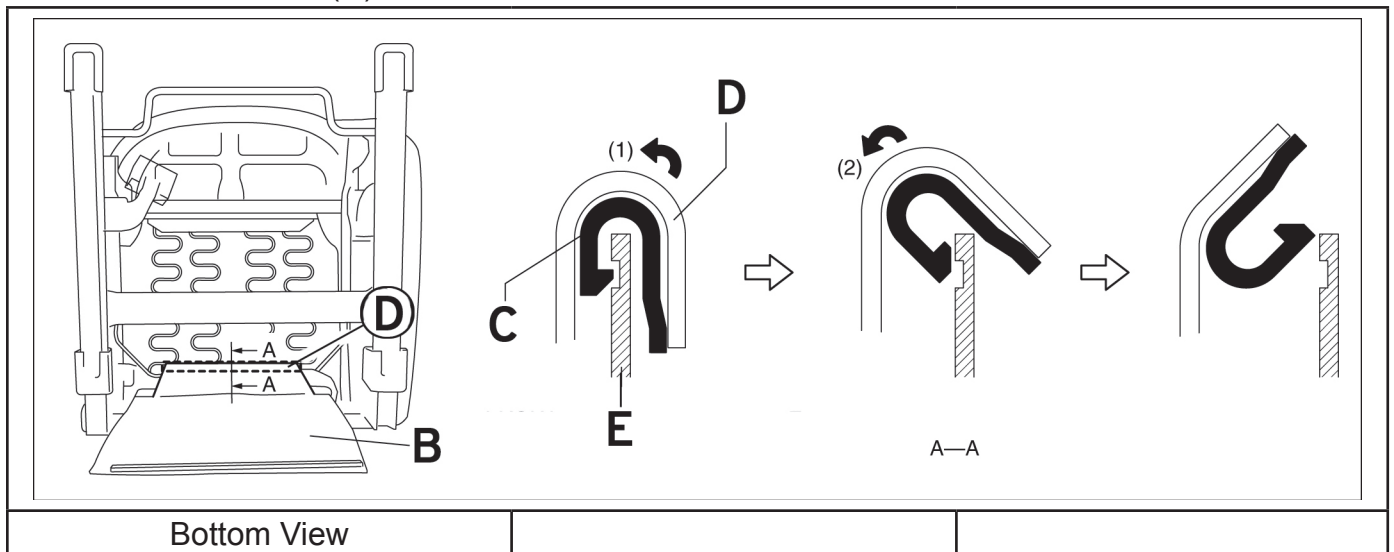
4. Remove the inner trim (D) from the bottom back of the cushion.

Move the hook (C) in the order of arrows (1) and (2). Set the inner trim (D) away from the front seat cushion frame (E). If it is difficult to remove the hook of the inner trim because of its tension, roll and grab the outer trim (B) and gently pull down to reduce the tension of the inner trim.

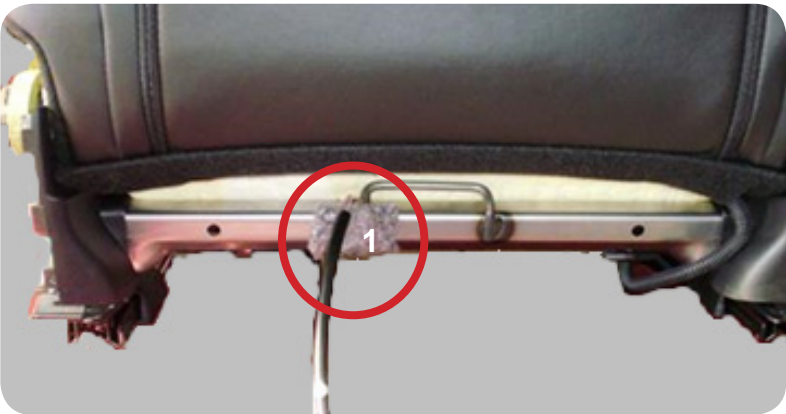
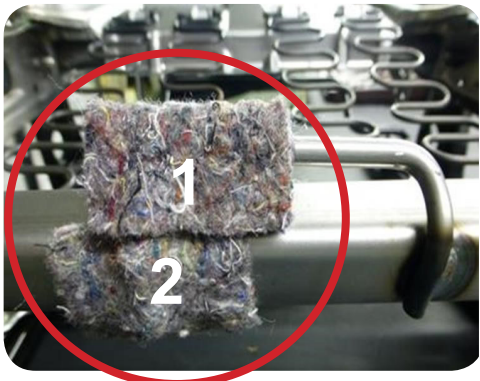
5. Check the number of the felt pad(s).
 - a. One pad is found - Proceed to step 6.
 - b. Two pads are found - Proceed to step 12 (trim installation).

One pad	Two pads
Some portions of the cushion have been removed for sample view.

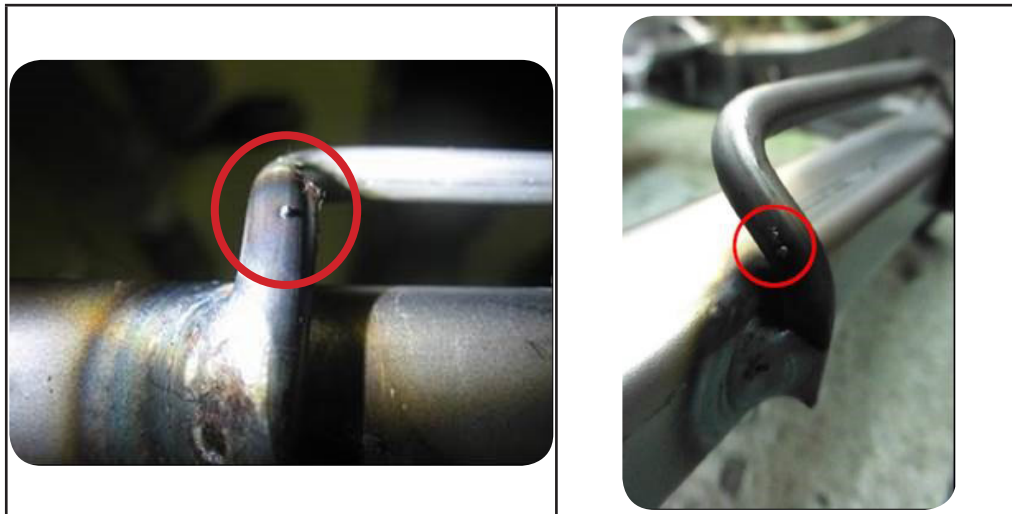
6. Check the seat frame bar for weld spatter.

Note: If weld spatter is found, the wiring harness may be damaged at step 8.

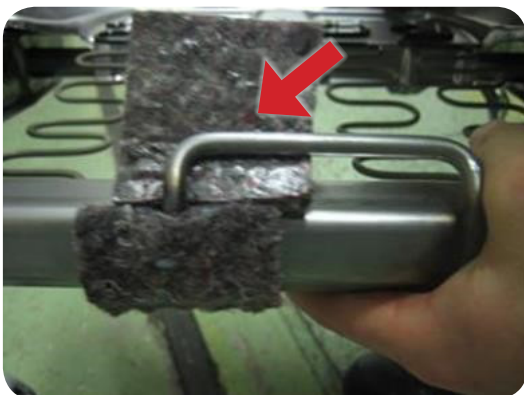
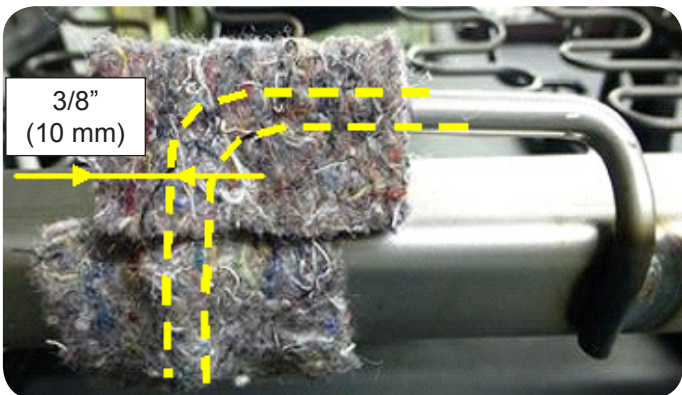
7. Apply the felt pad.

Wrap the bar with additional pad.	The upper pad should cover the lower pad.

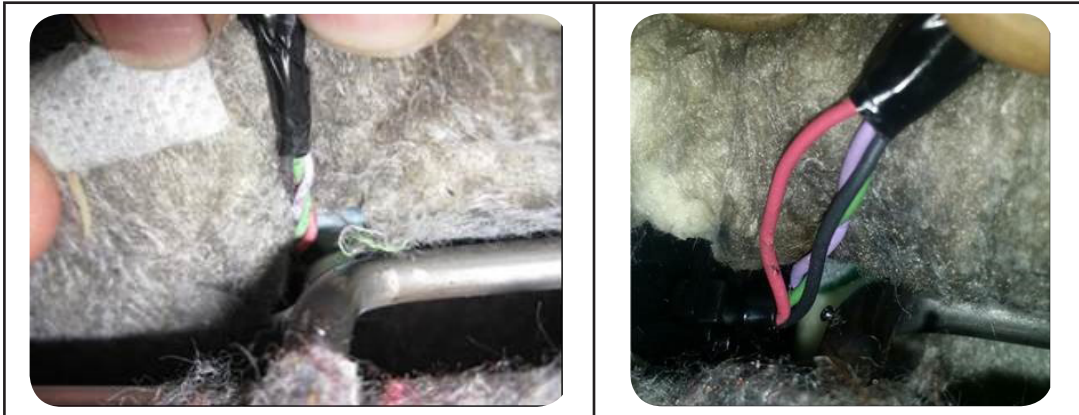
8. Check wire harness insulation for damage on all four (4) colored wires. Use the table below to determine repair action.

Wire image	Condition	Action

Good Condition No wire damage is found.	Proceed to step 12 (trim installation)

Wire insulation is scratched. (wire strands are not exposed)	Proceed to step 9 (wrap wire with insulating tape)

Wire insulation is scratched and pin hole(s) is/are visible.

Lead wire strands are exposed.	Replace the front passenger seat cushion with occupancy sensor. Refer to MGSS online Workshop Manual FRONT SEAT CUSHION TRIM REMOVAL/INSTALLATION. Then proceed to C. CAMPAIGN LABEL INSTALLATION.

Lead wire strands are broken.

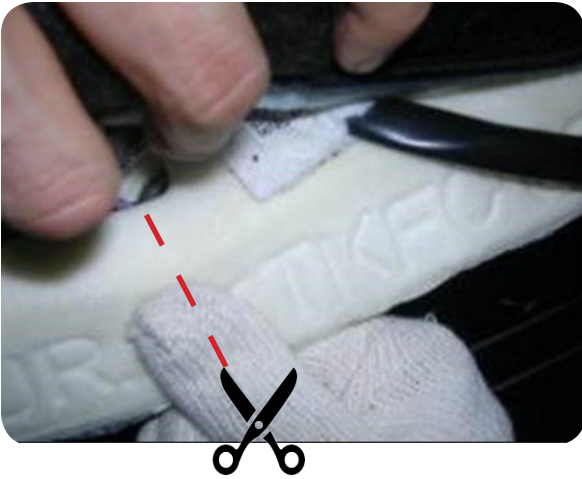
9. Turn the cushion pad over and cut it to gain access to the wires.

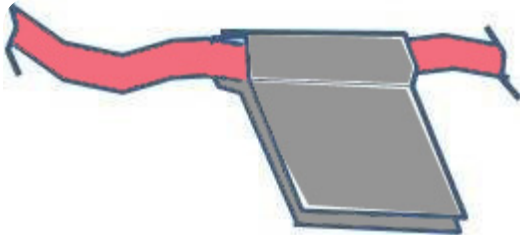
10. Wrap the scratched portion of each individual wire separately using a strip of the electrical insulating tape.

NOTE: Remove moisture, oil, and dust from the area to be taped.

CAUTION: Do not tape all 4 wires together until each wire has been taped individually.

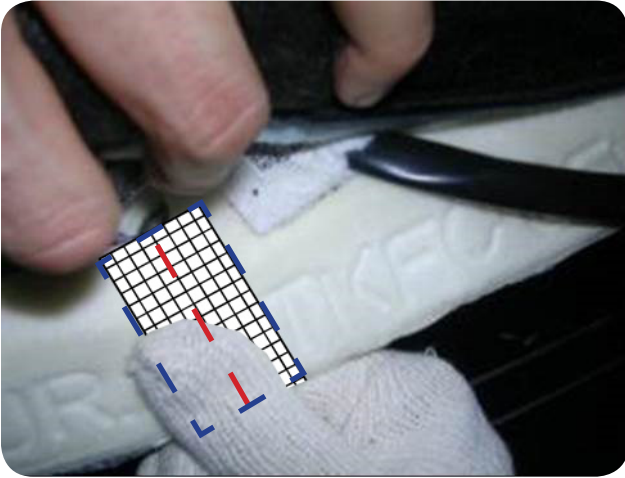
11. Repair the slit of the cushion pad using a strip of cushion pad tape.

NOTE: Remove moisture, oil, and dust from the area to be taped.

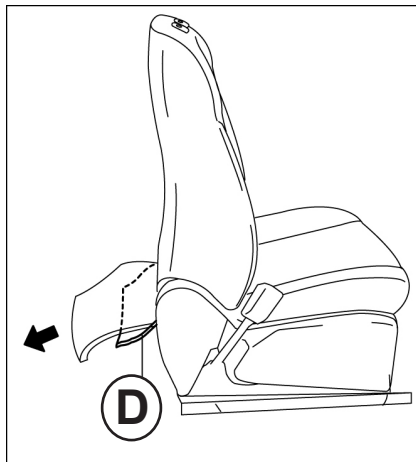
a. Pull the inner trim (D) in the direction of the arrow shown. Remove the wrinkles on the front seat cushion trim.

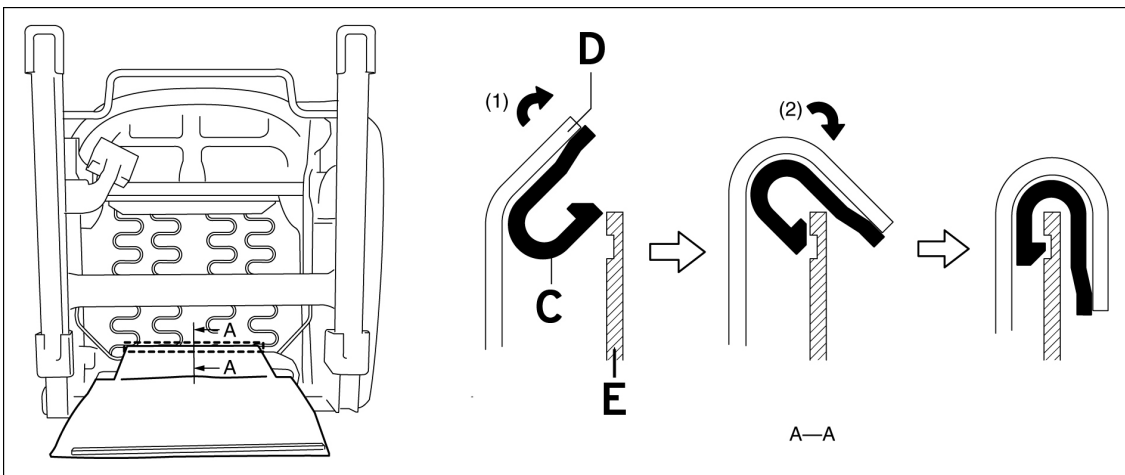
b. Move the hook (C) in the order of arrows (1) and (2) shown. Install the inner trim (D) to the front seat cushion frame (E).

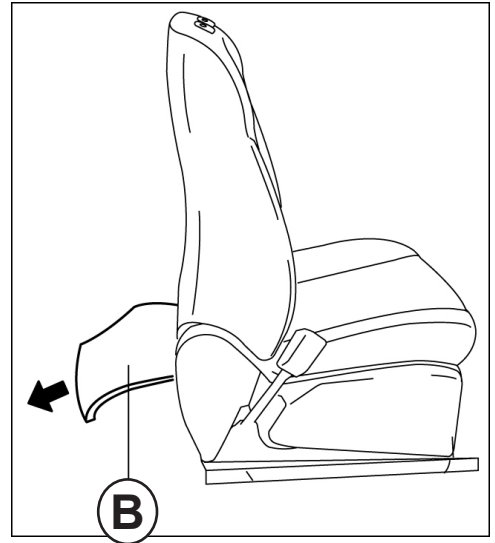
c. Pull the outer trim (B) in the direction of the arrow shown. Remove the wrinkles on the front seat cushion trim.

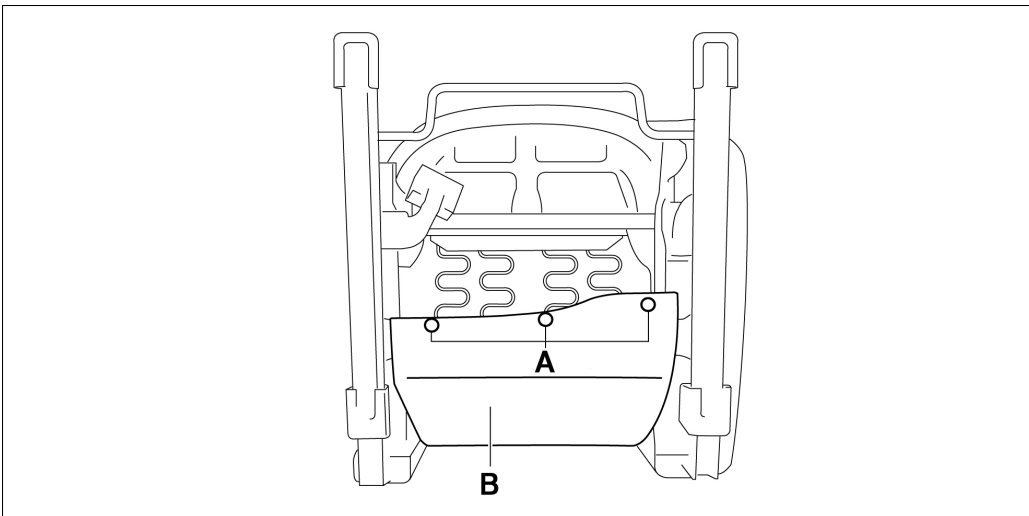
d. With Power Seat System

Install the fasteners (A) and the outer trim (B) to the front seat cushion frame.

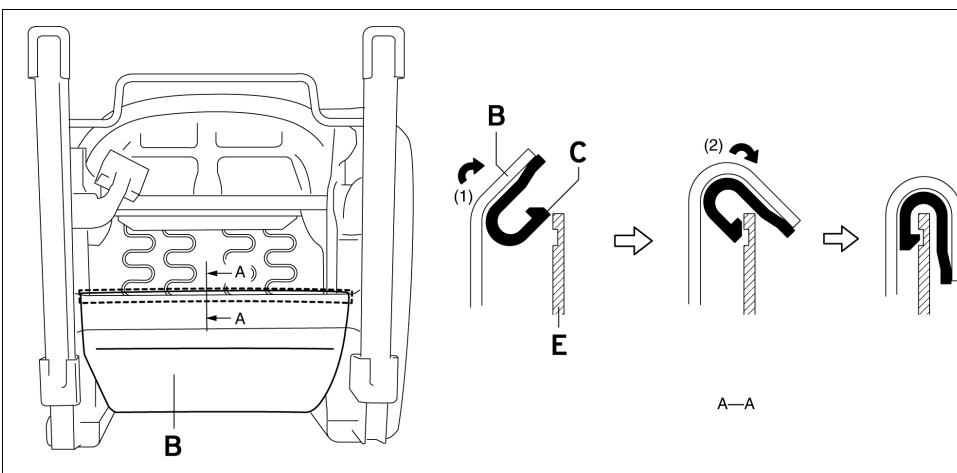
e. Without Power Seat System

Move the hook (C) in the order of arrows (1) and (2) shown. Install the front seat cushion trim (B) to the front seat cushion frame (E).

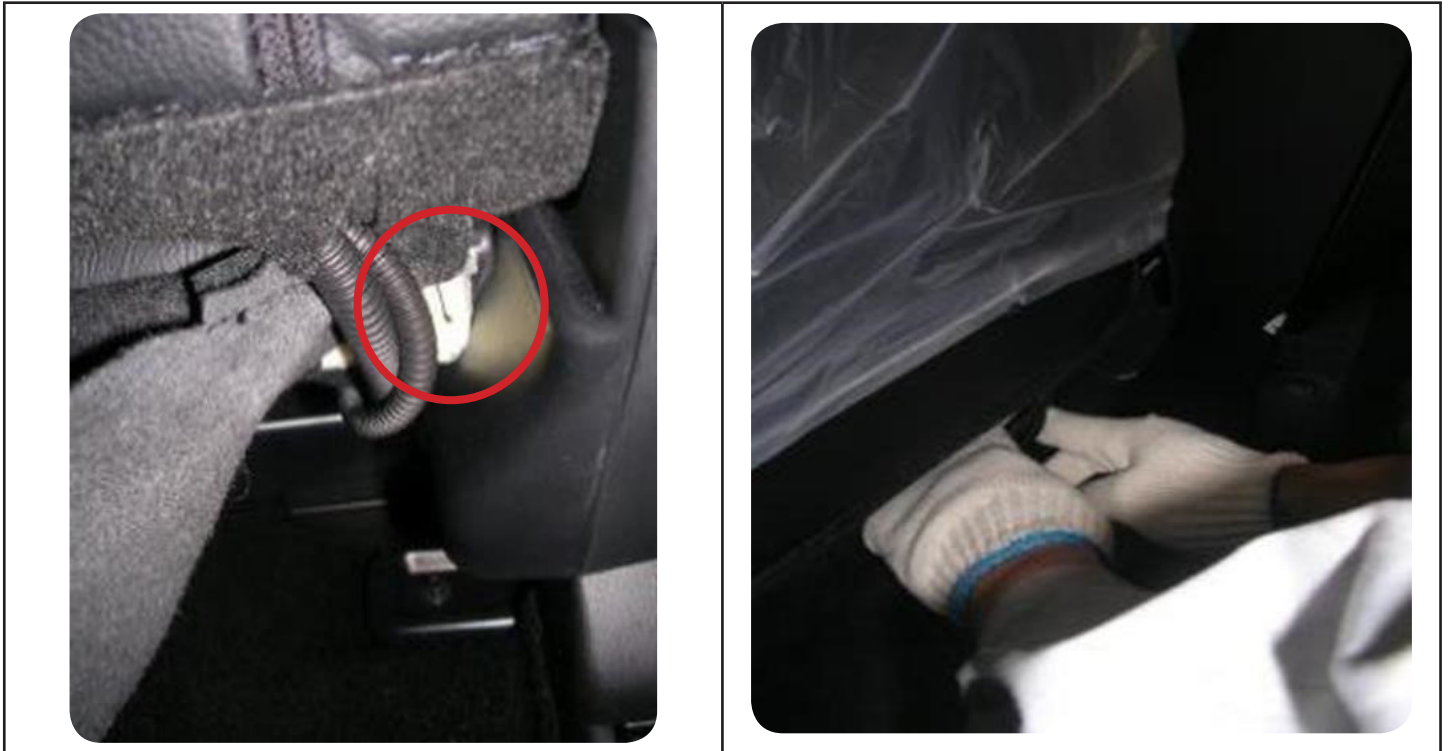
13. Confirm that the cushion pad is not exposed. Correct if necessary.

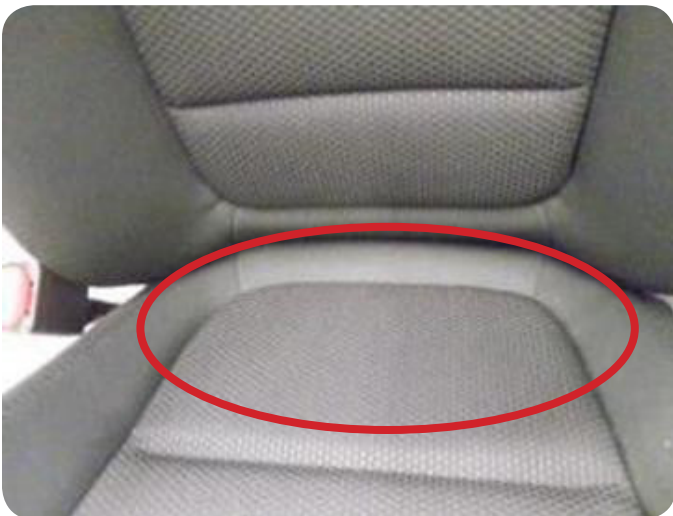
14. Check for wrinkles on the surface of the seat cushion and correct if necessary. Correct seat surface position if necessary.

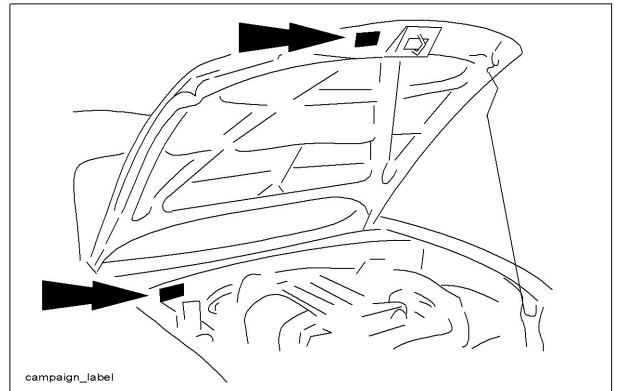
2. Affix the Campaign Label to the hood or bulkhead as shown:
