Dealer Service Instructions for:

Safety Recall T59 / NHTSA 17V-572

Brake Booster Water Shield

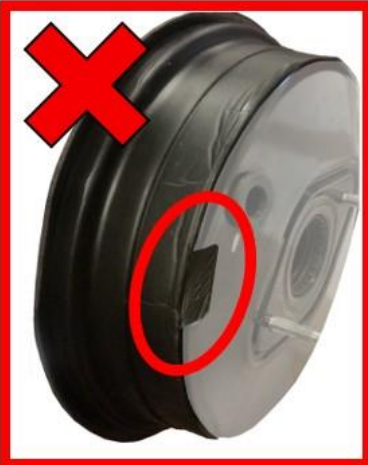
**INCORRECT**

1 Tab edges **must** be flush with edges of the brake booster.

FIGURE 1 – Brake Booster Water Shield

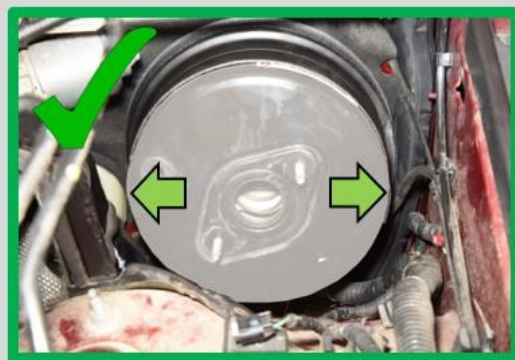
**CORRECT**

2 Tabs **must** be positioned at three o'clock and nine o'clock positions with booster installed in vehicle.

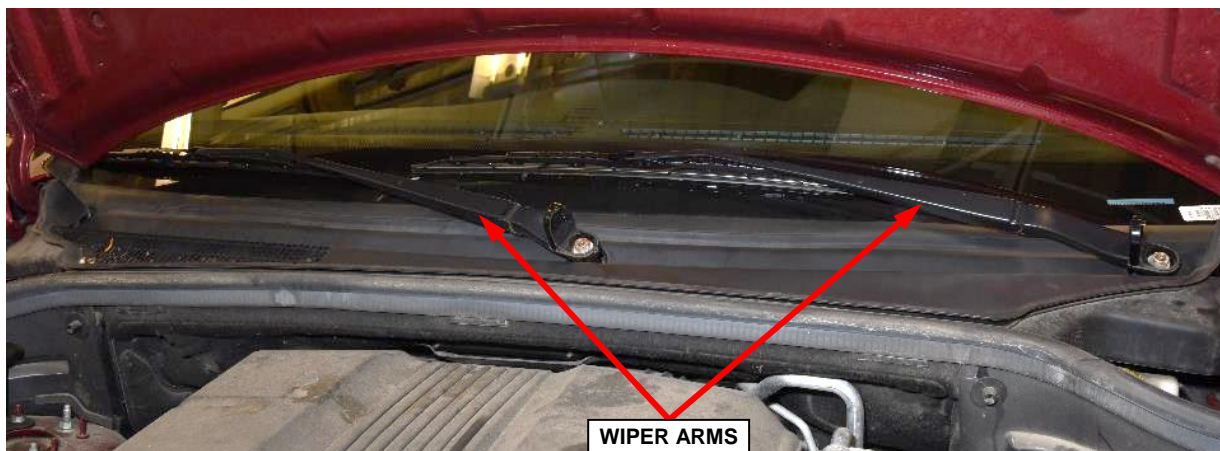
Figure 3 – Front Wiper Arms

4. Use a slight rocking action to disengage the front wiper arm from the pivot shaft then remove and save the wiper arm (Figure 3).

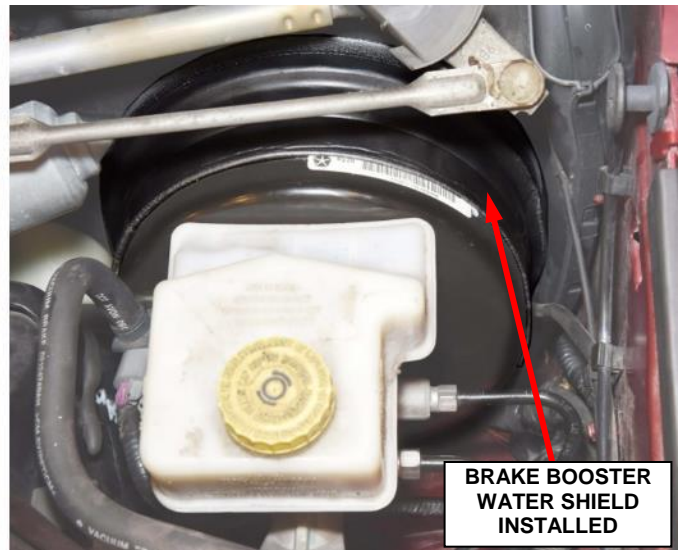
Figure 8 – Inspect Brake Booster for Water Shield

12. Inspect the brake booster for the presence of a water shield (Figure 8).

- **YES** >>> A water shield is installed on the brake booster. Continue with **Step 13** inspection of water shield for proper installation.
- **NO** >>> A water shield is **not** installed on the brake booster. Proceed to **Section B. Test Brake Booster.**

WATER SHIELD MISSING

WATER SHIELD INSTALLED

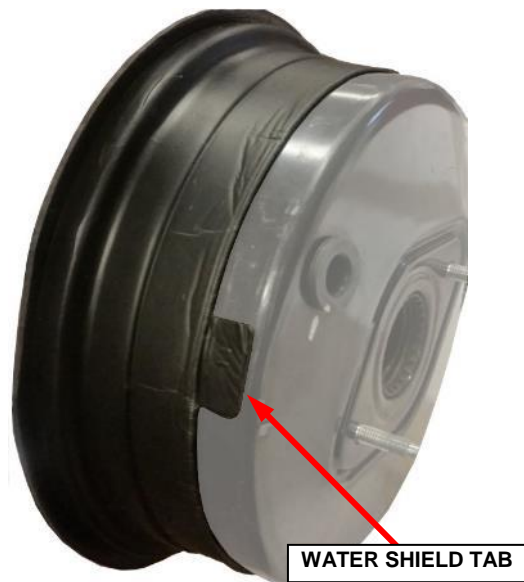
Figure 11 – Water Shield Tab Orientation

14. Inspect the brake booster water shield tabs orientation (Figures 11 and 12).

- Tabs **MUST** be oriented at three o'clock and nine o'clock positions as installed in the vehicle.
- Tabs must **NOT** be oriented at any position other than three o'clock and nine o'clock. A water shield that is not oriented properly may be deformed and potentially be less effective.
- Any tab orientation other than three o'clock and nine o'clock as installed in the vehicle indicates incorrect installation of the water shield.

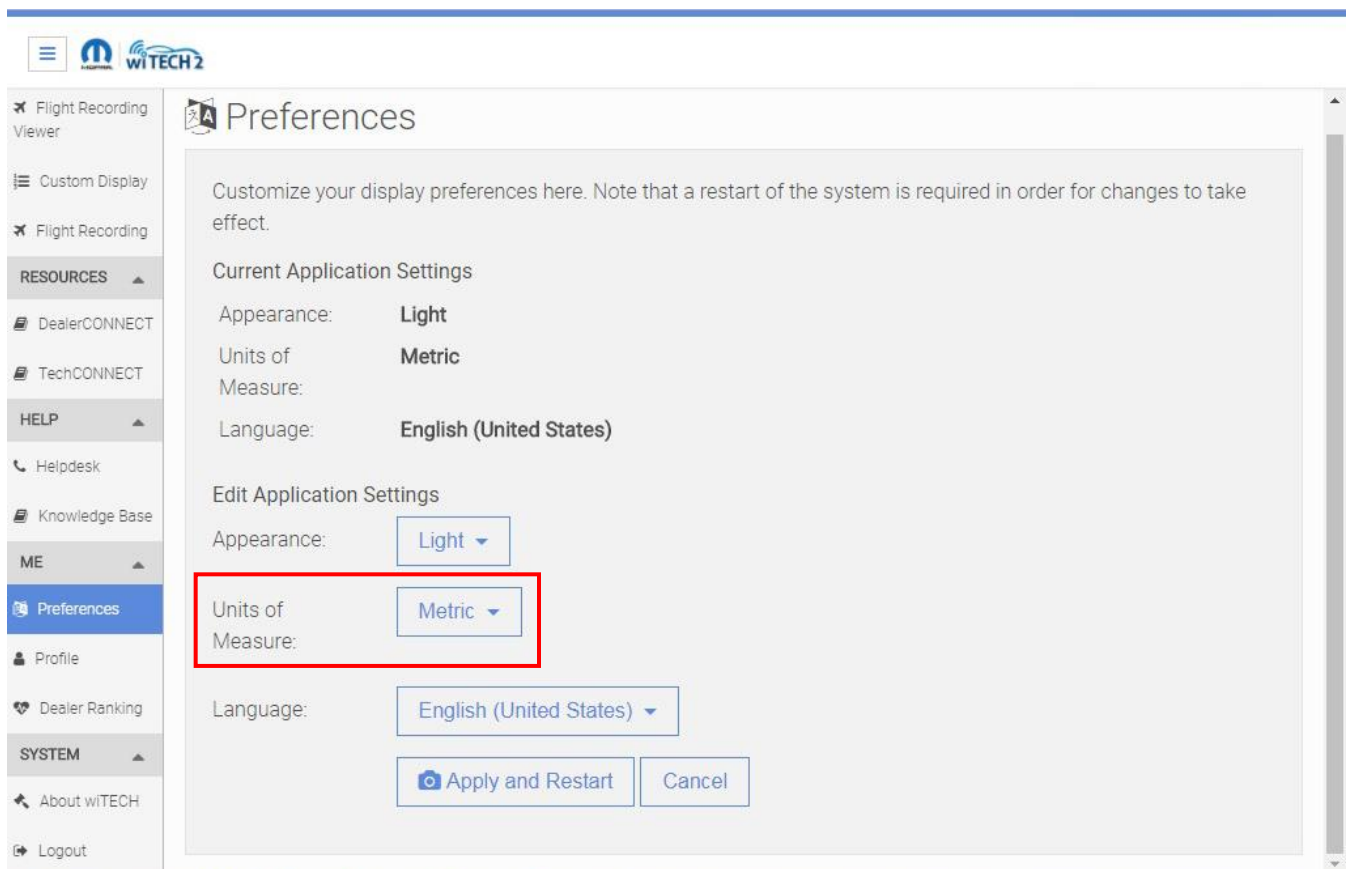
**Figure 14 – wiTECH II, Preferences, Units of Measure, Metric**

1. Connect the wiTECH micro pod II to the vehicle data link connector
2. Place the ignition in the “**RUN**” position.
3. Open the wiTECH 2.0 website.
4. Enter your “**User id**” your “**Password**” and your “**Dealer Code**”, then select “**Finish**” at the bottom of the screen.
5. On the “**Preferences**” screen, set the “**Units of Measure**” to “**Metric**” (Figure 14).

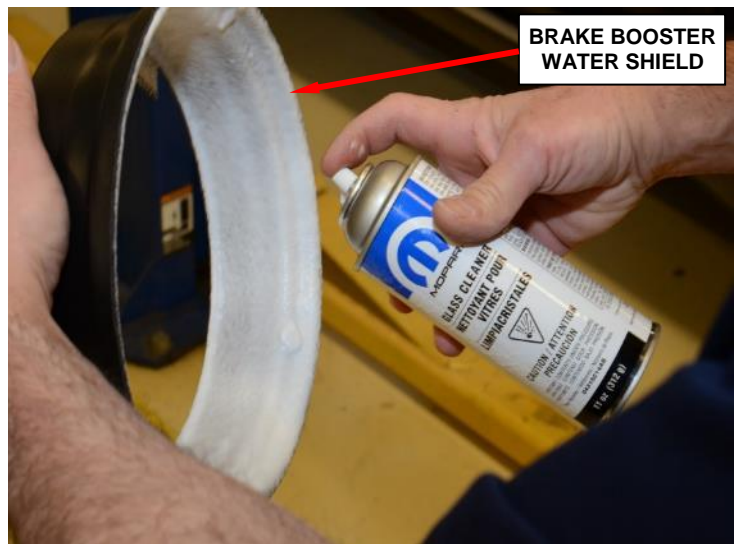
Figure 23 – Lubricate Brake Booster Water Shield

- 17. Using glass cleaner, lubricate the inside surface of the brake booster water shield (Figure 23).

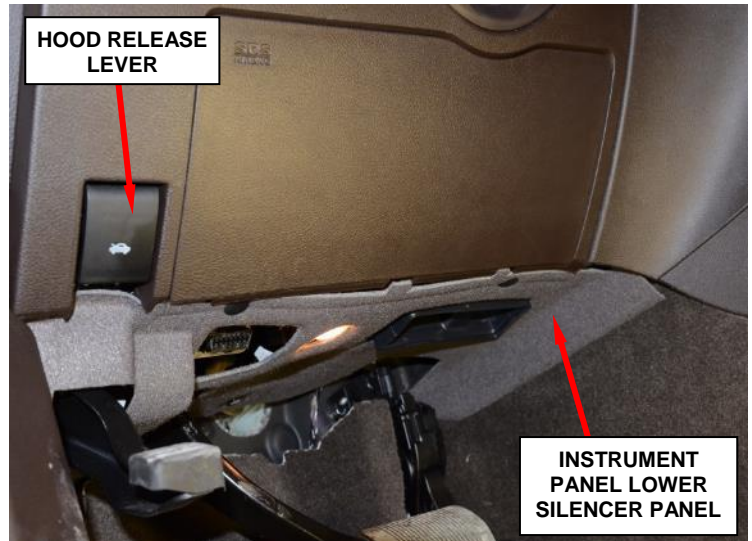
Figure 26 – Instrument Panel Lower Silencer

14. Remove and save the wiper motor and linkage as an assembly.
15. Remove and save the instrument panel lower silencer cover (Figure 26).
