Dealer Service Instructions for:

Safety Recall T59 / NHTSA 17V-572

Brake Booster Water Shield

2011 - 2014 (WD) Dodge Durango
(WK) Jeep® Grand Cherokee

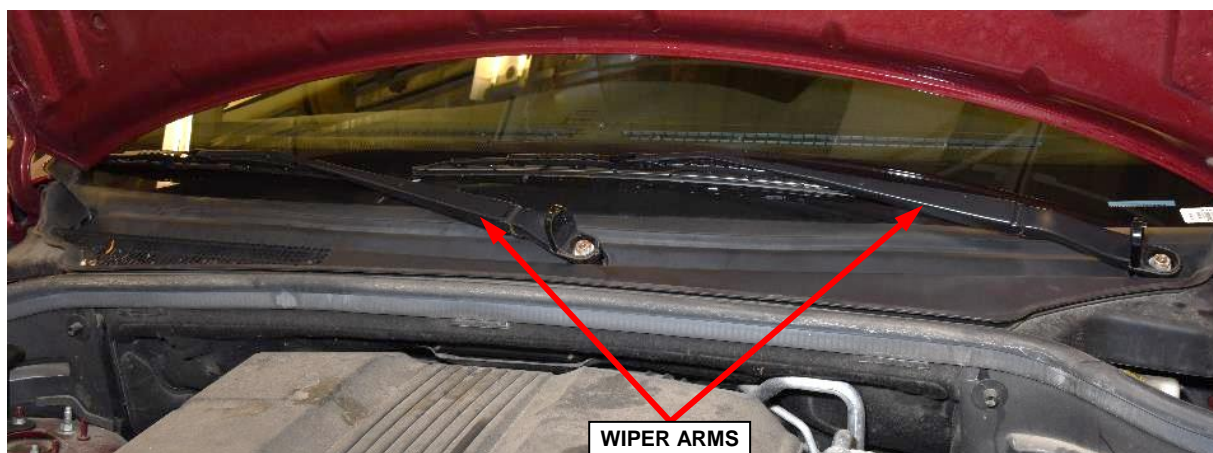
Figure 3 – Front Wiper Arms

4. Use a slight rocking action to disengage the front wiper arm from the pivot shaft then remove and save the wiper arm (Figure 3).

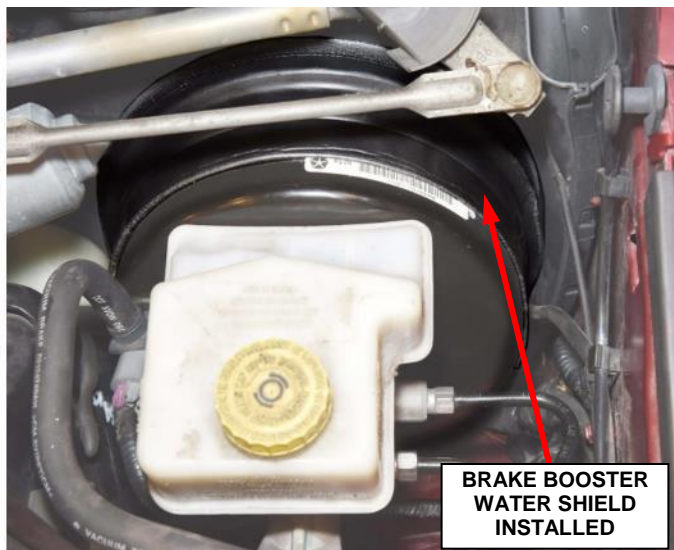
Figure 8 – Inspect Brake Booster for Water Shield

12. Inspect the brake booster for the presence of a water shield (Figure 8).

- **YES >>>** A water shield is installed on the brake booster. Continue with **Step 13** inspection of water shield for proper installation.
- **NO >>>** A water shield is **not** installed on the brake booster. Proceed to **Section B. Test Brake Booster.**

WATER SHIELD MISSING

WATER SHIELD INSTALLED

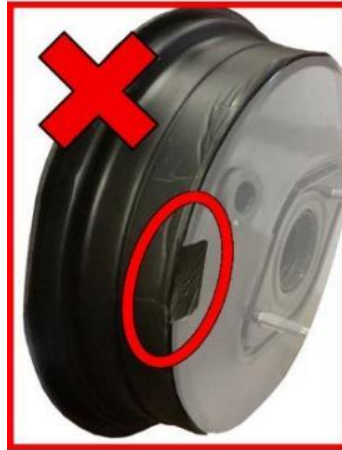
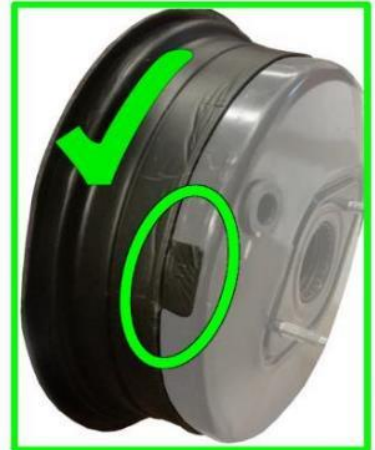
Figure 9 – Water Shield Tab Location

13. Inspect the water shield tabs location on the brake booster (Figures 9 and 10).

- Tab edges **MUST** be flush with brake booster front edge. Tabs **MUST** be securely adhered to outer circumference of the brake booster.
- Tabs must **NOT** extend beyond the brake booster front edge. Tabs must **NOT** wrap around to the front side of the booster.
- Tabs that extend beyond the front edge and/or wrap around to the front side of brake booster indicates incorrect installation of the water shield.

INCORRECT

CORRECT

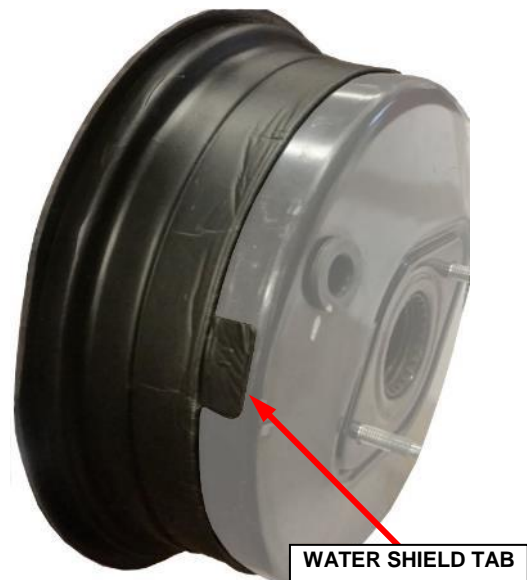
Figure 11 – Water Shield Tab Orientation

14. Inspect the brake booster water shield tabs orientation (Figures 11 and 12).

- Tabs **MUST** be oriented at three o'clock and nine o'clock positions as installed in the vehicle.
- Tabs must **NOT** be oriented at any position other than three o'clock and nine o'clock. A water shield that is not oriented properly may be deformed and potentially be less effective.
- Any tab orientation other than three o'clock and nine o'clock as installed in the vehicle indicates incorrect installation of the water shield.

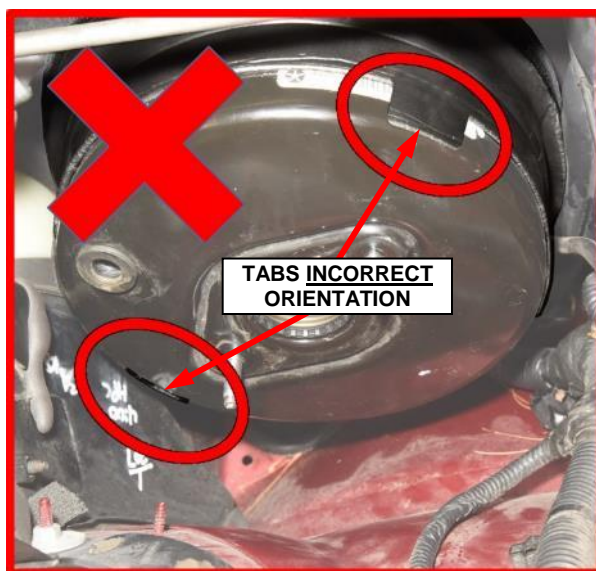
Figure 12 – Water Shield Tab Orientation In Vehicle

INCORRECT

CORRECT

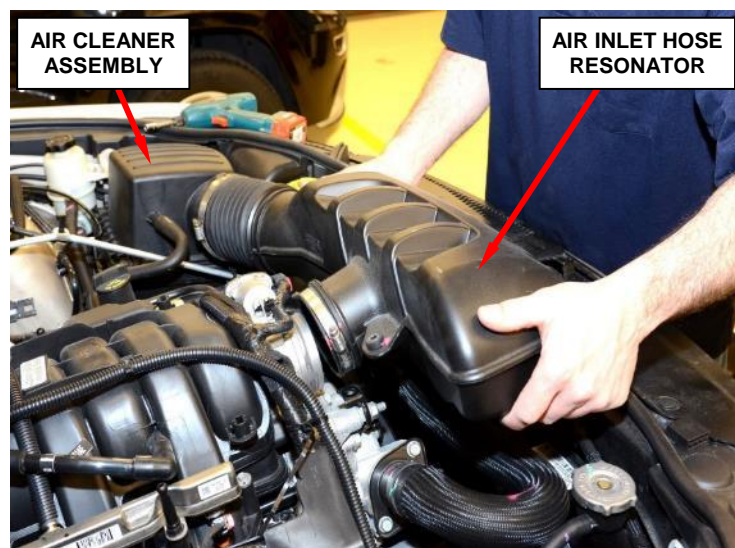
Figure 16 – Intake Air Resonator

4. **For vehicles with a 5.7L engine**, remove and save the air inlet hose resonator (Figure 16).

5. Remove and save the air cleaner assembly (Figure 16).

28. Install the air cleaner assembly.
29. **For vehicles with a 5.7L engine**, install the air inlet hose resonator (Figure 16).
30. **For vehicles with a 5.7L engine**, install the engine cover.

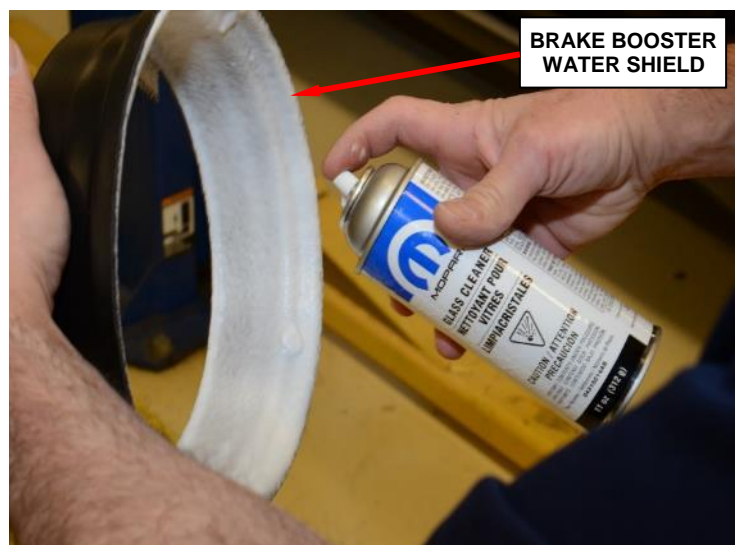
**Figure 23 – Lubricate Brake Booster Water Shield**

16. Using glass cleaner, clean the brake booster surface area where the water shield contacts the brake booster.
17. Using glass cleaner, lubricate the inside surface of the brake booster water shield (Figure 23).

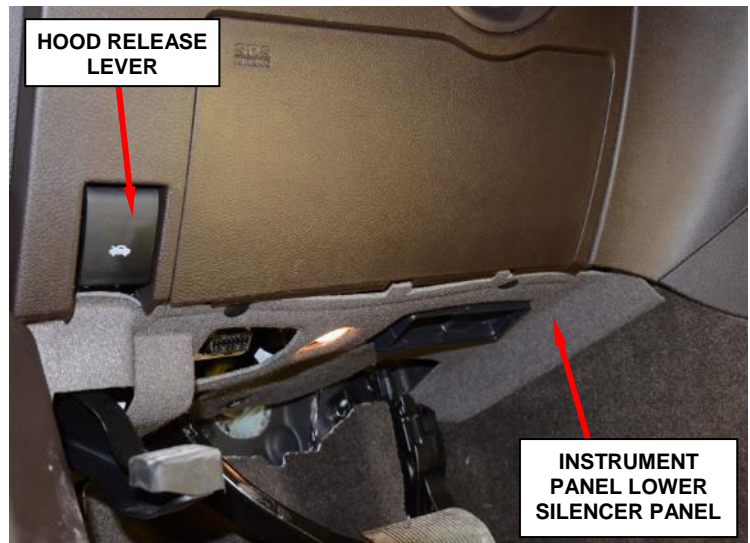
Figure 26 – Instrument Panel Lower Silencer

14. Remove and save the wiper motor and linkage as an assembly.
15. Remove and save the instrument panel lower silencer cover (Figure 26).
