Safety Recall

Code: 20Ai

Subject	Fuel Pump Flange
Release Date	March 09, 2018
Affected Vehicles	U.S.A. & CANADA: Certain 2004-2007 MY Touareg <i>Check Campaigns/Actions screen in Elsa on the day of repair to verify that a VIN qualifies for repair under this action. Elsa is the <u>only</u> valid campaign inquiry & verification source.</i> <ul style="list-style-type: none">✓ Campaign status must show "open."✓ If Elsa shows other open action(s), inform your customer so that the work can also be completed at the same time the vehicle is in the workshop for this campaign.
Problem Description	On certain vehicles, the fuel pump flange may develop fine cracks or fissures, which could result in a fuel leak. Leaking fuel, in the presence of an ignition source, could lead to a fire causing injury and/or damage to property.
Corrective Action	If cracks, leaks, and/or yellow discoloration are present, the fuel pump flange will be replaced and a protective film installed onto the fuel pump flange. If no cracks, leaks, and/or yellow discoloration are present, a protective film will be installed onto the fuel pump flange.

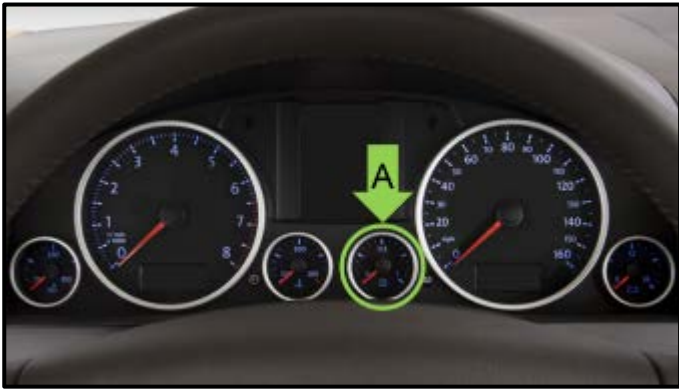
- Switch the ignition to the ON position and check the vehicle fuel level displayed on the instrument cluster <A>.
- Record the vehicle fuel level on the repair order.

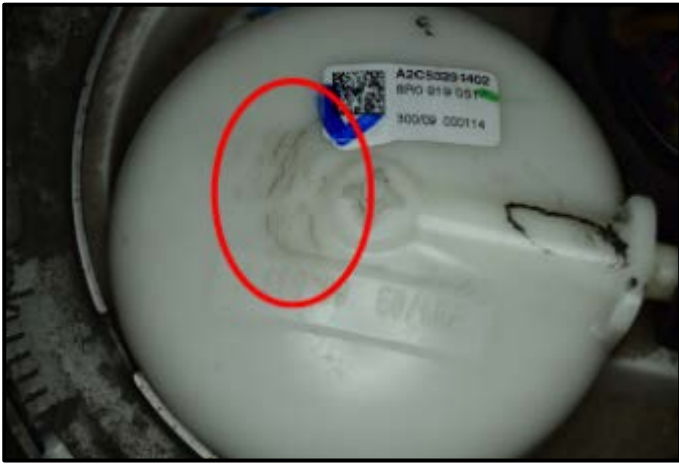
- If there is a visible presence of leaking fuel;
 - **Continue to Section D and Replace the Fuel Filter Flange and install the protective film.**
 - **All others continue to the next step.**

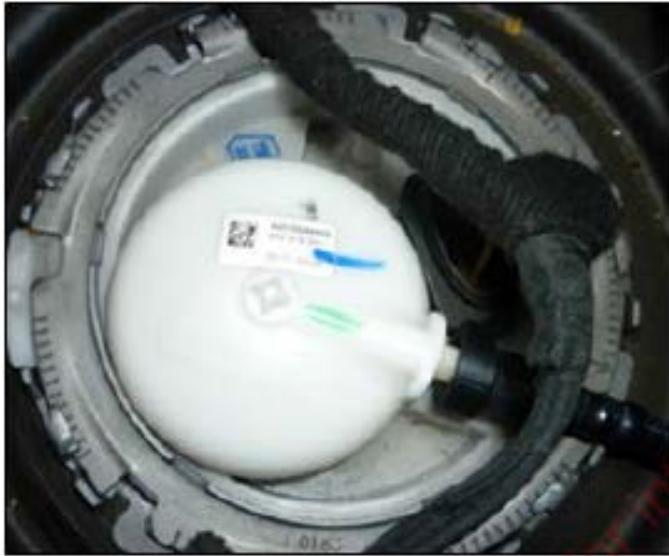
- If there are no signs of leaking present, but there **ARE** cracks <circle> and/or yellow discoloration present;
 - **Continue to Section D and Replace the Fuel Filter Flange and install the protective film.**
 - **All others continue to the next step.**

Shining a flashlight directly on the filter flange will allow for easier detection of cracks that may not be visible with the naked eye.

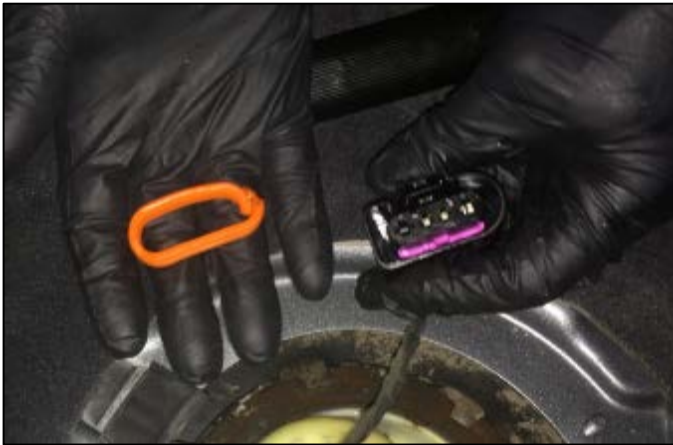
- Install flange cover and nuts <2>.
- Clean the threads in the body for bolts <1> before installing bolts.
- Install new bolts <1> and torque to 20 Nm.

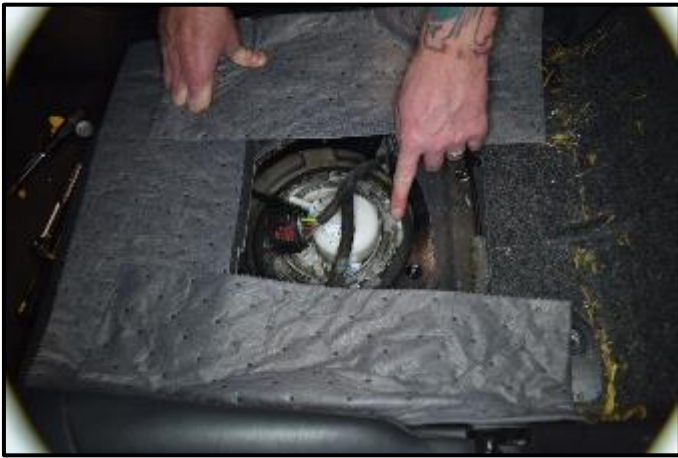
- Disconnect fuel supply line <1>, vent line <2> and electrical connector <3> from the fuel delivery unit on the right side of the vehicle.

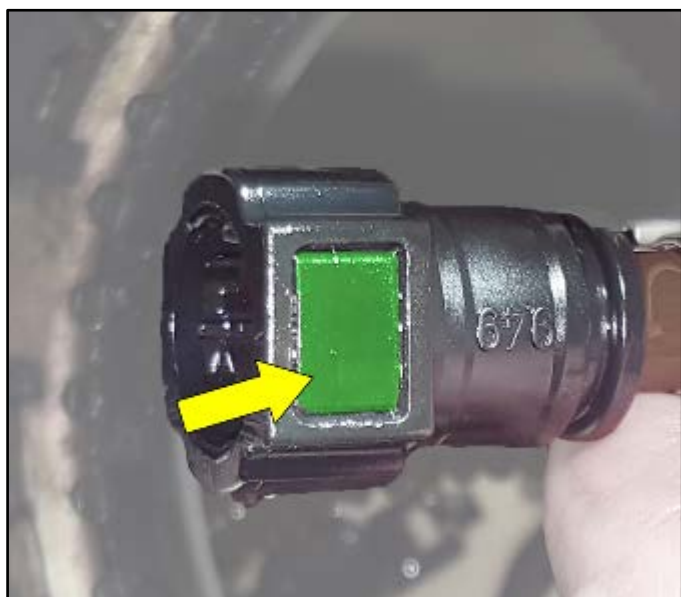
- Disconnect fuel lines from fuel filter flange by squeezing the release tabs between the finger

and thumb, pushing IN on the connector, then pulling OFF.

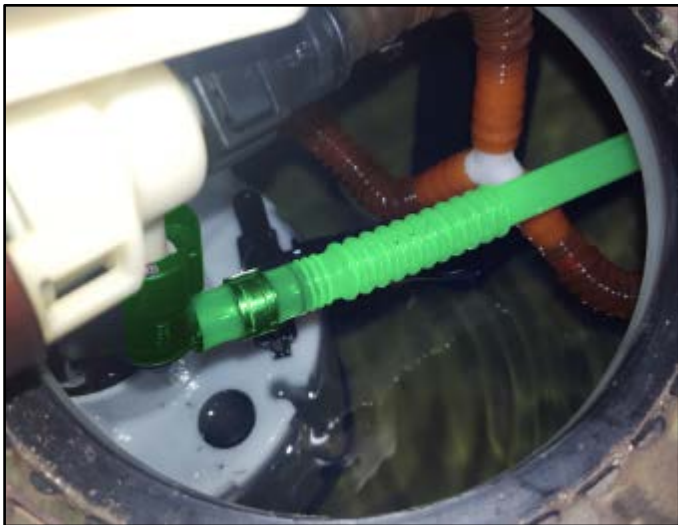
- Install the new seals for the fuel filter flange and fuel delivery unit flange into the fuel tank openings.
- Route fuel pressure regulator line through the fuel tank and attach to the fuel pressure regulator on the fuel delivery unit flange on the right side of the vehicle.
- Reconnect fuel lines and fuel level sensor connector.
- Install the new fuel filter flange into the fuel tank.

- Verify the locating tab <arrow> is in the correct position before reinstalling the locking ring.

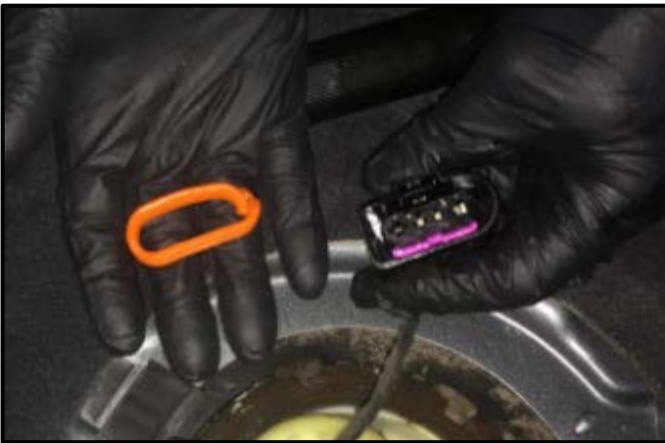
- Apply protective film as shown to the fuel filter flange. Start application from the center and work the protective film towards the outside edges of the fuel pump flange taking care to eliminate air gaps or bubbles under the film.

- Use care when applying protective film so that no dust or dirt comes in contact with the adhesion side of the film.
