Safety Recall Code: 80C5

Subject	Auxiliary Heater		
Release Date	December 18, 2017		
Revision Summary	Claiming instructions updated to include labor operation for adapting HVAC door end stops.		
Affected Vehicles	U.S.A. & CANADA: Certain 2013-2016 MY Audi A4 Sedan, allroad, Audi Q5, A5 Coupe and A5 Cabriolet		
	Check Campaigns/Actions screen in Elsa on the day of repair to verify that a VIN qualifies for repair under this action. Elsa is the <u>only</u> valid campaign inquiry & verification source.		
	 ✓ Campaign status must show "open." ✓ If Elsa shows other open action(s), inform your customer so that the work can also be completed at the same time the vehicle is in the workshop for this campaign. 		
Problem Description	The electrical connector of the auxiliary heater is susceptible to contact corrosion, which may cause the auxiliary heater to fail and/or cause the wires to overheat and melt. Melting wires may lead to an open circuit, but can also lead to overheating which can result in a fire.

Subject: Safety Recall 80C5 – Auxiliary Heater Certain 2013-2016 Model Year Audi A4 sedan, allroad, Audi Q5, A5 Coupe and A5 Cabriolet

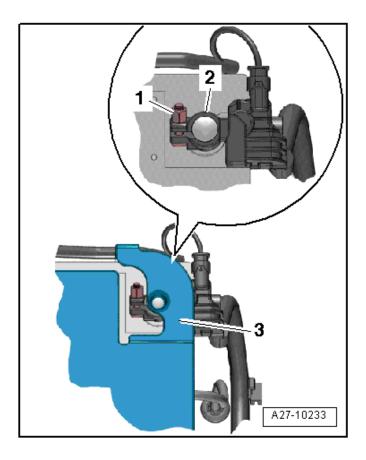
- Move the front passenger seat as far back as possible.
- Turn off the ignition.

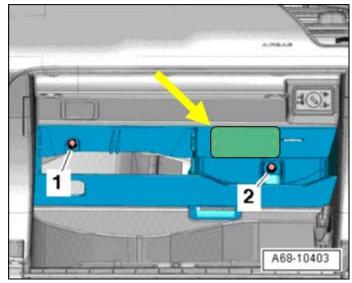
- Vehicles with a storage compartment inside • the glove compartment:
 - Release the tabs on the left and right 0 sides with a screwdriver in direction of <arrow> and then remove the storage compartment from the glove compartment.

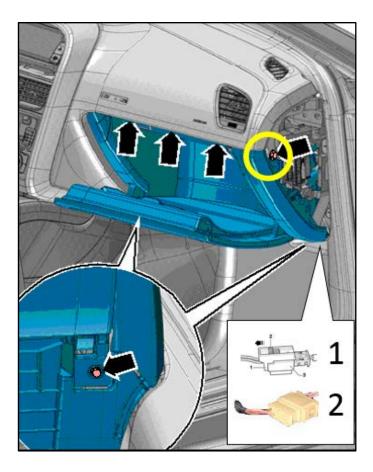
- If equipped, remove storage compartment in • area of <arrow>.
 - o Slide the storage compartment out toward the rear of the vehicle.
- Remove bolts <1 and 2>.

- Support the glove compartment when removing the bolts.
- The glove compartment could drop unexpectedly if not supported, resulting in damage to glove compartment components.
- Remove the bolts <arrows> and remove the glove compartment just far enough so the electrical connector <2> can be disconnected.
- Remove bolt <circle> located behind the instrument panel side cover last.

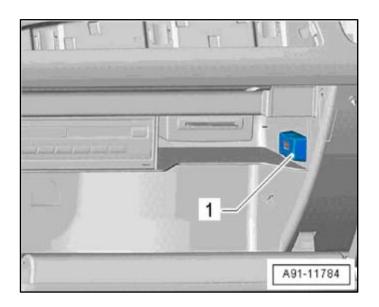
- Models equipped with a knee airbag.
 - Disconnect yellow knee airbag connector <1>.

- Bolt location and quantity may vary based on model.
- Models equipped with a knee airbag will have an additional two bolts installed in the bottom of the glove compartment.

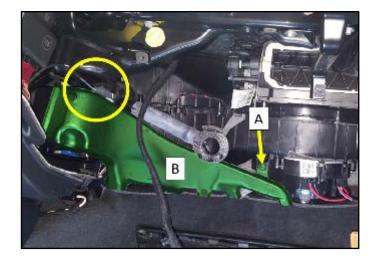
• Remove the screw clips <A> and remove the insulation mat .

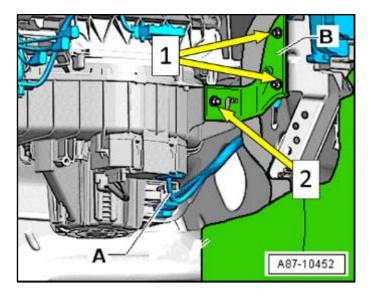
• Remove bolts <arrows> and remove glove compartment mounts <1 and 2>.

- Remove bolts <1>.
- Remove the air guide channel <A>.

The air guide channels are in two pieces <A and B>. Removing the bolt for the section attached to the dash vent will allow air guide channel <A> to be removed easier. However, the air guide channel section does not have to be removed.

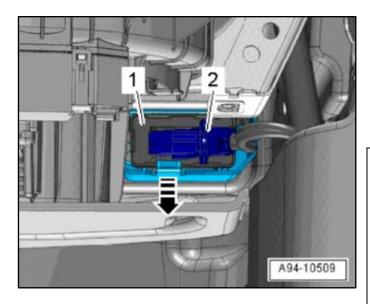
- Disconnect wiring harness from bracket using -80-200- (if necessary).
- Remove bolts <1 and 2> and remove bracket .
- Disconnect connector <A> from the Fresh Air Blower Control Module -J126-.

Remove bolts <1> and remove bracket <A> (if equipped).

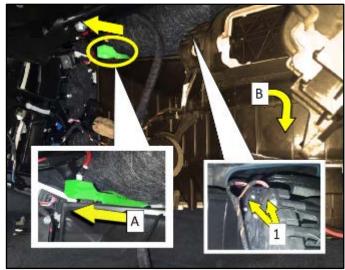
- Remove bolt <C> (if equipped).
- Release the locking mechanism <A> and turn the Fresh Air Blower -V2- housing in the direction of the <arrow>.

Do not grasp fan wheel of Fresh Air Blower -V2-, press against the fan wheel or move the balancing weights fastened to fan wheel. Doing so may cause fan imbalance during operation.

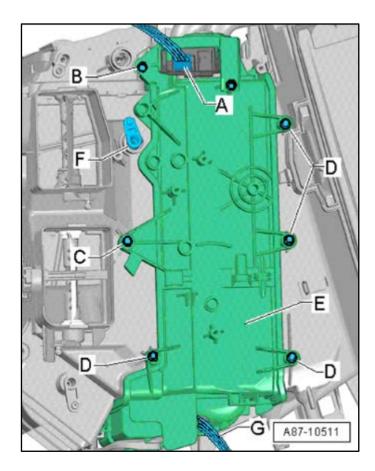
- Carefully loosen connecting rods, <A> to <D>, from each door lever at their connections <circles>.
- Remove bolts <E>.

- Do not remove the left and right heater core • housing at the same time.
- Both heater core housings are support components of the A/C unit and must not be removed at the same time or the A/C unit will become unstable.

Pull the right heater core housing <A> • (together with the retaining plate, actuators and levers, curved washers and connecting rods) in the direction of the <arrow> from the A/C unit.

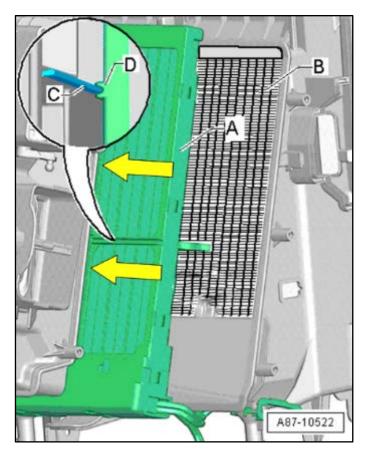
Remove the Auxiliary Heater Heating Element -Z35- <A> from the A/C unit in direction of <arrows>.

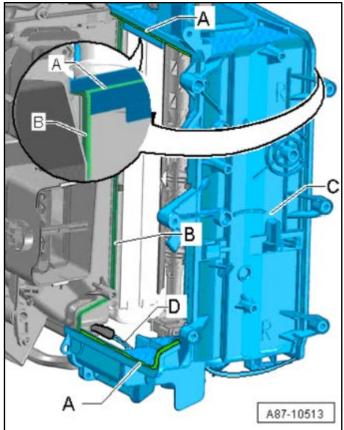
- Install foam seals <A> and as shown onto the new Auxiliary Heater Heating Element -Z35-.
- Install seal <A> first.

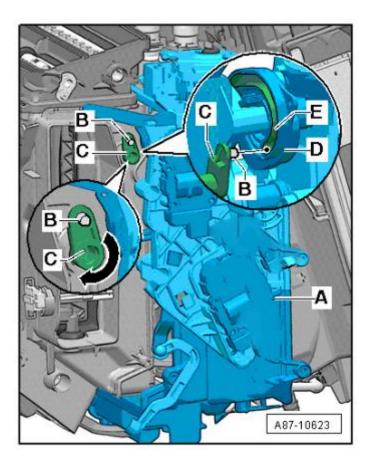
Install new Auxiliary Heater Heating Element -Z35- <A>.

• Ensure the groove <D> on the Auxiliary Heater Heating Element -Z35- <A> lines up with the guide <C> on the A/C unit.

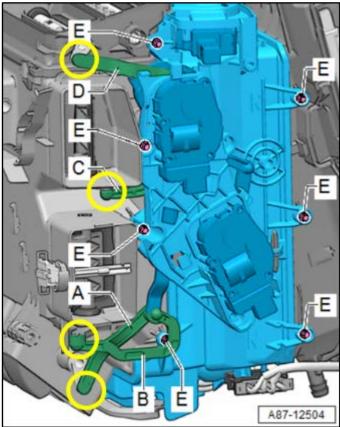
Insert the grooves <A> on the right heater core housing into the guides on the A/C unit and push the right heater core housing <C> just a little into the A/C unit.

If the groove <A> on the right heater core housing <C> or the grove on the A/C unit are damaged, seal these with, for example, Silicone Adhesive D 176 001 A3 (shop supply).

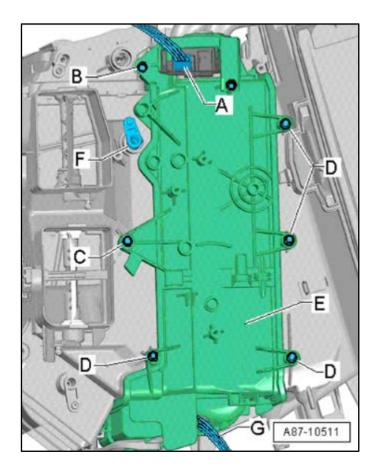
Since the airflow direction was set to "DEF" (to the windshield) on the Climatronic Control Module -J255display and control head before removing the radiator housing, the curved washer <D> is now positioned so that the pin fits into the groove in the curved washer <E> when the radiator housing is installed.

- Turn the lever on the door for the instrument • panel vent <C> all the way up in the direction of <arrow>.
- Line up the door connecting rods so they do • not get caught when the radiator housing is completely installed.
- Carefully push the heater core housing <A> all • the way into the A/C unit.
- Check the position of the pin inside the • groove in the curved washer <E> using an illuminated mirror or borescope.
- Install bolts <E> and torque to 1 Nm.
- Carefully connect the connecting arms <A> to <D> to the lever of each door.

- Do not over-tighten bolts <E>.
- Do not press the arms on with too much force.
- If the arms are difficult to install onto the door levers, use pliers to press the arm onto the lever.

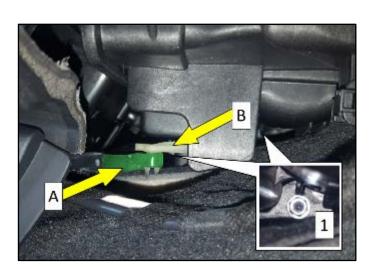
- Install bolts <B, C and D> and torque to 1 Nm.
- Connect connector <A> (for the Right Temperature Door Motor -V159-).

Do not over-tighten bolts <B, C and D>.

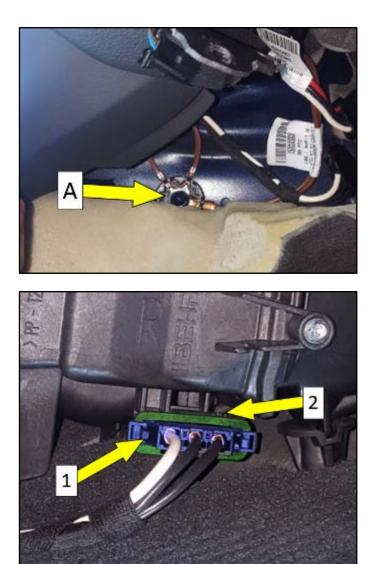
- Reconnect the connector rod <A> to the lever on the right temperature door .
- Install the two bolts <1>, located at the bottom of the heater core housing and torque to 1 Nm.

Do not over-tighten bolts <1>.

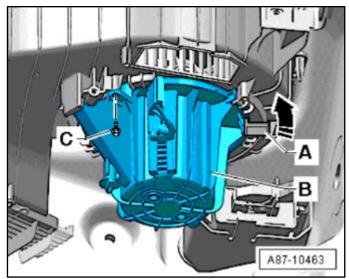
Position air intake housing <A> onto the mounts <arrows>

- Rotate air intake housing up in direction of <arrow>.
- Once in place, slide locking mechanism <circle> in direction of <arrow>.
- Connect connectors <1> and install the harness into the mounting points.

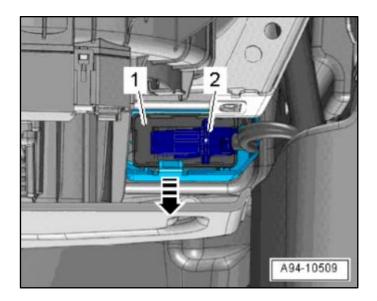
- Install Fresh Air Blower <V2> into air intake housing and rotate clockwise until locking mechanism engages.
- Install bolt <C> (if equipped).

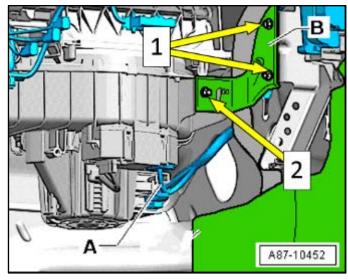
• If equipped, install the Headlamp Range Control Module <1> and connect connector <2>.

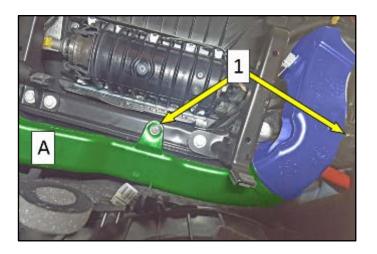
- Install bracket .
- Install bolts <1> and torque to 9 Nm.
- Install bolt <2> and torque to 3.6 Nm.
- Connect connector <A>.
- Reattach wiring harness to bracket (if necessary).

• Install bracket <A> (if equipped) and torque bolts <1> to 9 Nm.

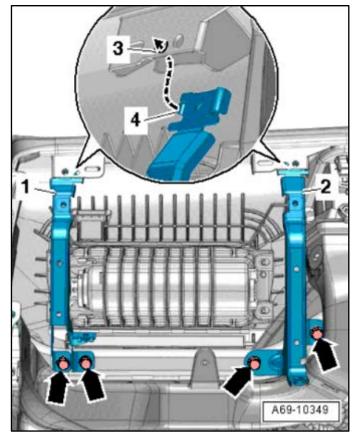
Install air guide channel <A> and torque bolts
 <1> to 3 Nm.

- Position both glove compartment brackets so that tab <4> engages in hole <3> in the instrument panel.
- Install bolts <arrows> and torque to 9 Nm.

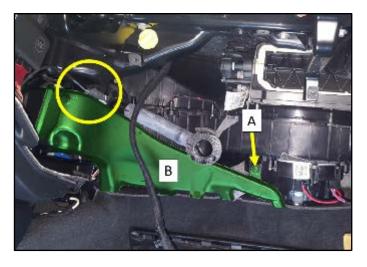
- Install footwell vent and torque bolt <A> to 3 Nm.
- Reconnect temperature sensor <circle>.

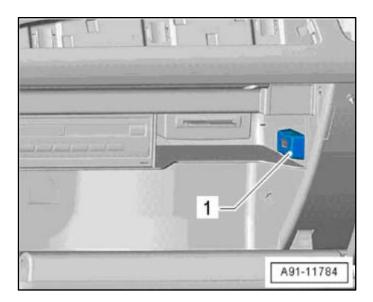
- Vehicles with External Audio Source Connection -R199-.
 - Install -R199- into the glove compartment and install cover <1>.
 - Reattach -R199- harness to the glove compartment.

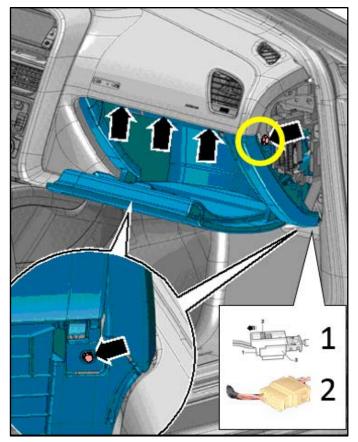
- Support the glove compartment when installing the bolts.
- The glove compartment could drop unexpectedly if not supported, resulting in damage to glove compartment components.
- Reconnect connector <2>.

- Models equipped with a knee airbag: Connect yellow knee airbag connector <1>.
- Install bolts <arrows> and torque to 3 Nm.
