# Safety Recall

## Code: 80C6

<b>Subject</b>	<b>Auxiliary Heater &amp; Software</b>
<b>Release Date</b>	December 21, 2017
<b>Revision Summary</b>	<b>Criteria 01 added to the claim entry instructions.</b>
<b>Affected Vehicles</b>	<b>U.S.A. &amp; CANADA: Certain 2013-2016 MY Audi A5 Cabriolet, A4 Sedan, A4 allroad, Q5 and A5 Coupe</b>  <i>Check Campaigns/Actions screen in Elsa on the day of repair to verify that a VIN qualifies for repair under this action. Elsa is the <u>only</u> valid campaign inquiry &amp; verification source.</i> <ul style="list-style-type: none"><li>✓ Campaign status must show "open."</li><li>✓ If Elsa shows other open action(s), inform your customer so that the work can also be completed at the same time the vehicle is in the workshop for this campaign.</li></ul>
<b>Problem Description</b>	The electrical connector of the auxiliary heater is susceptible to contact corrosion, which may cause the auxiliary heater to fail and/or cause the wires to overheat and melt. Melting wires may lead to an open circuit, but can also lead to overheating which can result in a fire.

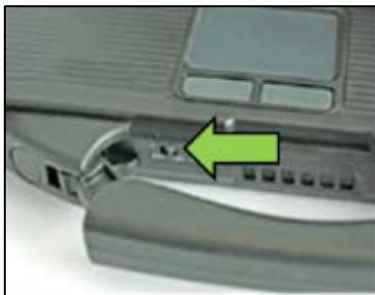
**VAS 6150 & VAS 6150A**  
(Front panel behind handle)

- ✓ **The Bluetooth function of the scan tool is physically switched off <see pictures below>.**

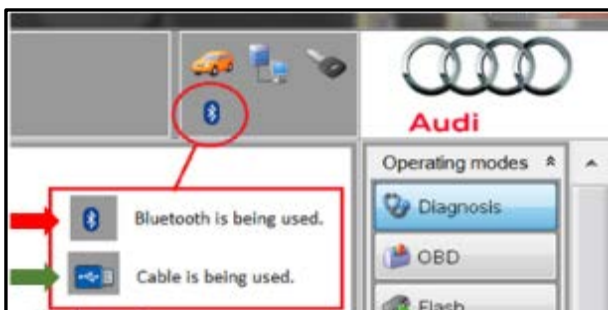
- Connect the VAS6150D Diagnostic Tester (or equivalent) to the vehicle.
- Start the ODIS program.
- Confirm that scan tool is communicating with the diagnostic head by USB <Green Arrow>.
  - If the Bluetooth symbol is shown <Red Arrow> then disconnect the diagnostic head from the vehicle and reconnect the USB cable to the diagnostic head and then reattach to the vehicle.

- From the home screen of the scan tool select Flash
- Follow the on-screen prompts.
- Select “SVM code input.”
- Enter SVM code **80C6A144**.
- Follow the on-screen prompts.
- Send GFF protocol online.
- Switch off the hazard warning lights.
- **Proceed to Section D.**
