Safety Recall

Code: 80C5

Subject	Auxiliary Heater
Release Date	December 15, 2017
Affected Vehicles	<p>U.S.A. & CANADA: Certain 2013-2016 MY Audi A4 Sedan, allroad, Audi Q5, A5 Coupe and A5 Cabriolet</p> <p><i>Check Campaigns/Actions screen in Elsa on the day of repair to verify that a VIN qualifies for repair under this action. Elsa is the <u>only</u> valid campaign inquiry & verification source.</i></p> <ul style="list-style-type: none"> ✓ Campaign status must show "open." ✓ If Elsa shows other open action(s), inform your customer so that the work can also be completed at the same time the vehicle is in the workshop for this campaign.
Problem Description	The electrical connector of the auxiliary heater is susceptible to contact corrosion, which may cause the auxiliary heater to fail and/or cause the wires to overheat and melt. Melting wires may lead to an open circuit, but can also lead to overheating which can result in a fire.

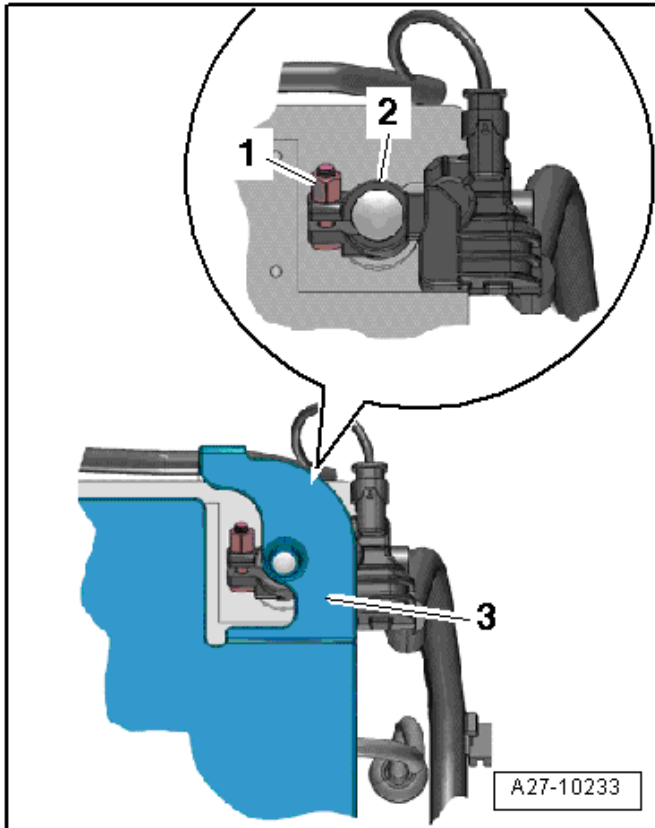
- Turn the ignition **ON**.
- Access the battery.
- If equipped, reposition or remove the vehicle tool kit.
- Open the cover <3> over the battery negative terminal.
- Loosen the nut <1>.
- Remove and isolate the battery ground cable terminal from the battery pole.

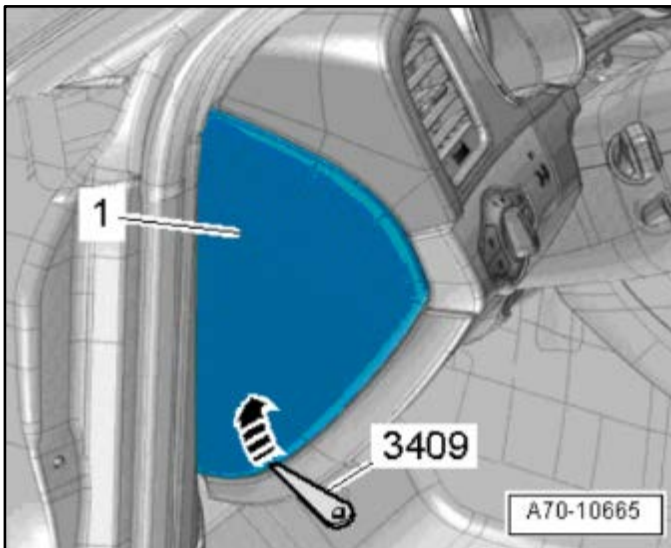
- Remove the instrument panel side cover <1> using Trim Removal Wedge -3409-.

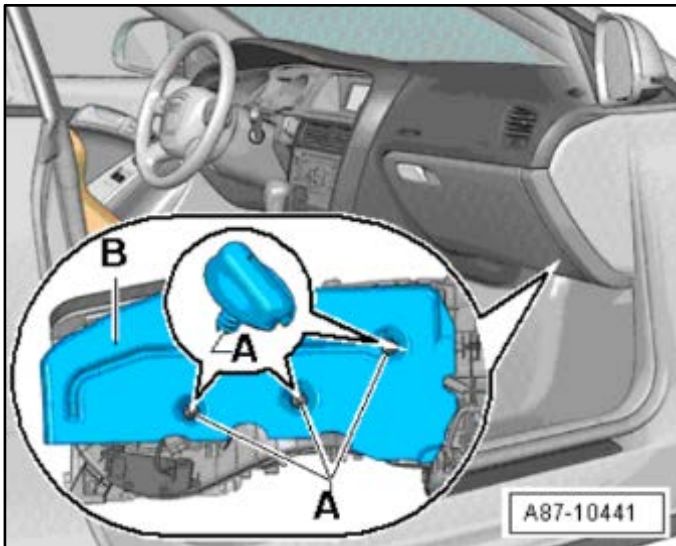
- Remove the screw clips <A> and remove the insulation mat .

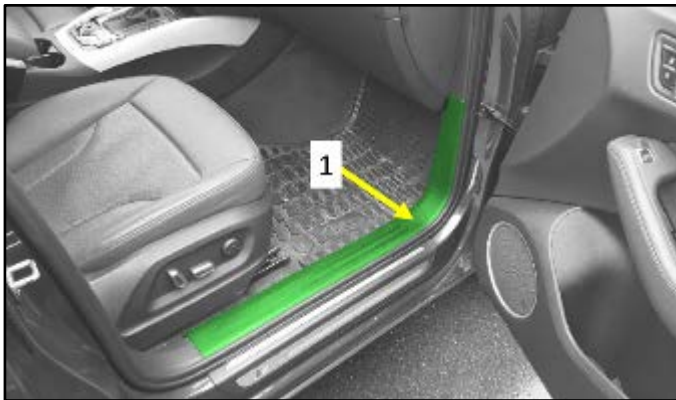
- Unclip the front sill panel strip <1> from the sill panel beginning at the front using the Trim Removal Wedge -3409-.
- A5 and A5 Cabriolet models:
 - Just the lower A-pillar trim requires removal and not the sill panel trim.

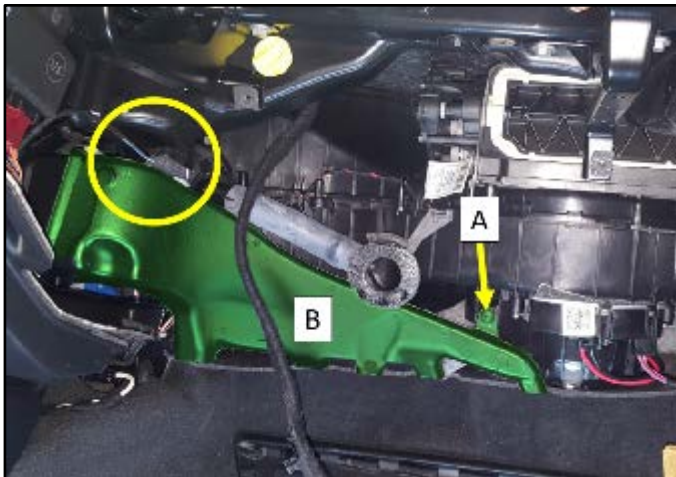
- Disconnect temperature sensor <circle> (if equipped).
- Remove bolt <A> and remove footwell vent .

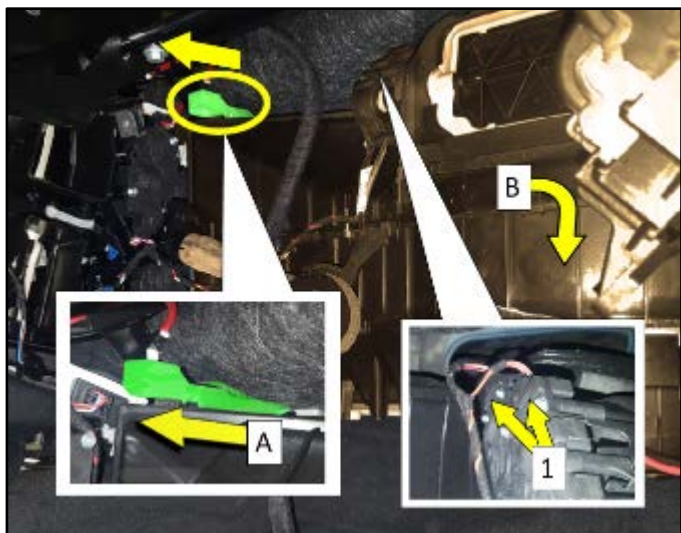
- Disconnect connectors <1> and carefully remove harness from air intake housing.
- Lift up slightly on locking mechanism <circle> and pull out in direction of <arrow A> to disengage the air intake housing.
- Rotate air intake housing down in direction of <arrow B>.

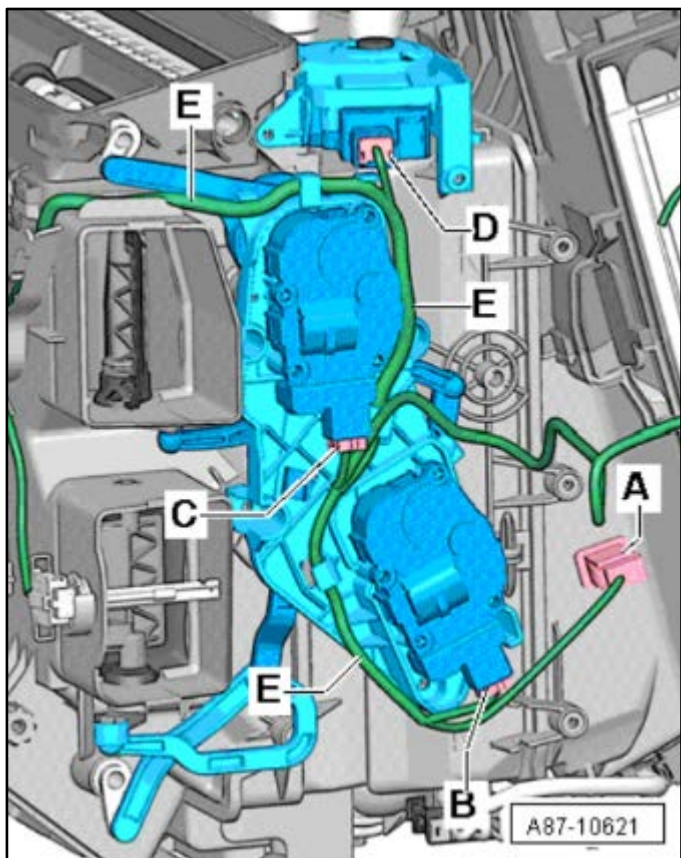
- Disconnect the connector <A> from the Evaporator Vent Temperature Sensor -G263-.
- Mark the connectors (for the Right Footwell Door Motor -V109-), <C> (for the Right Center Vent Motor -V111-) and <D> (for the Right Temperature Door Motor -V159-).

- Disconnect the connectors <B, C and D> from the actuators.
- Loosen the wiring harness <E> from the mounting points on the retaining plate.

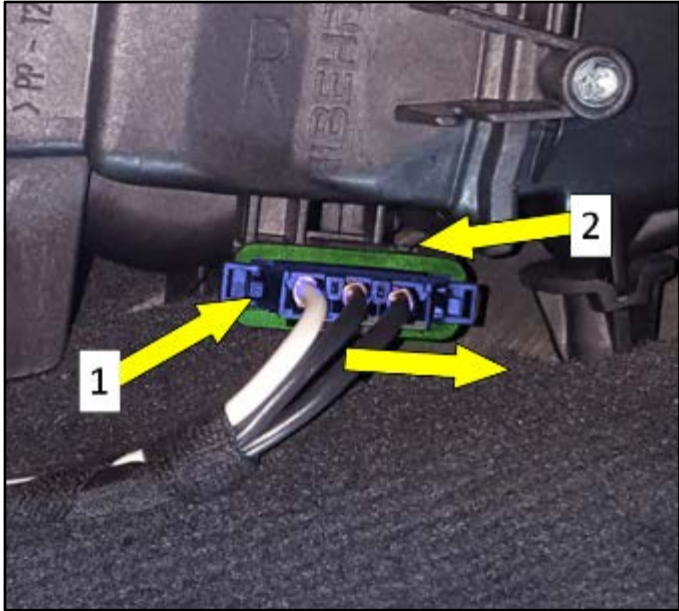
- Disconnect connector <1> from the Auxiliary Heater Heating Element -Z35-.
- Pry locking tab <2> up slightly and remove auxiliary heater connector from air intake housing in direction of <arrow>.

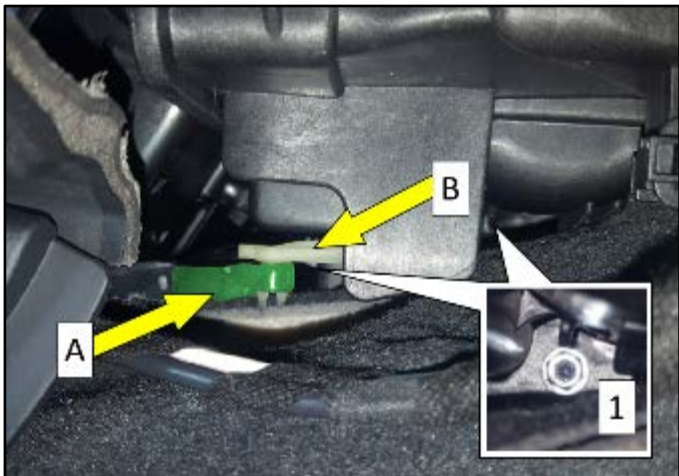
- Carefully disconnect the connector rod <A> (so the lever does not get damaged) from the lever on the right temperature door .
- Remove the two bolts <1>, located at the bottom of the heater core housing.

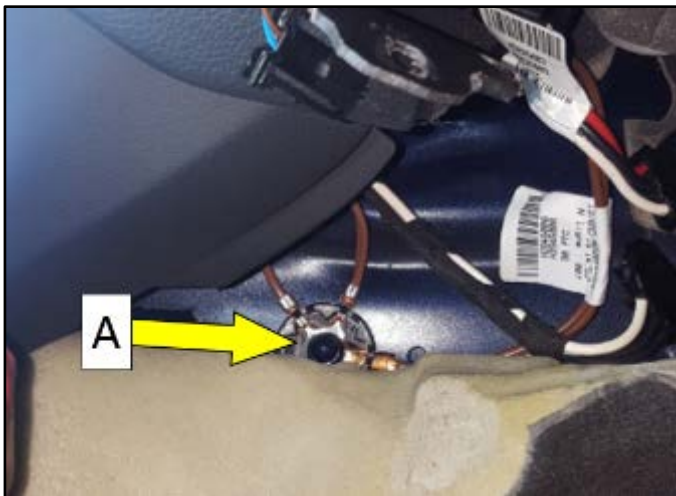
- Carefully fold the carpet back near the center console and loosen the ground connection to the Auxiliary Heater Heating Element -Z35- from the ground point <A> on the right side of the center tunnel.

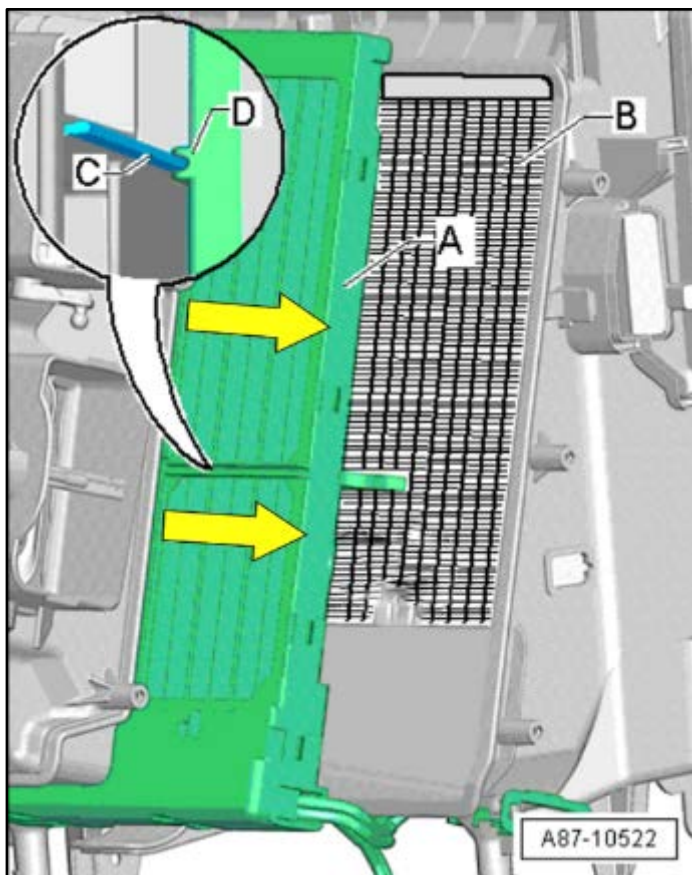
- Remove the Auxiliary Heater Heating Element -Z35- <A> from the A/C unit in direction of <arrows>.

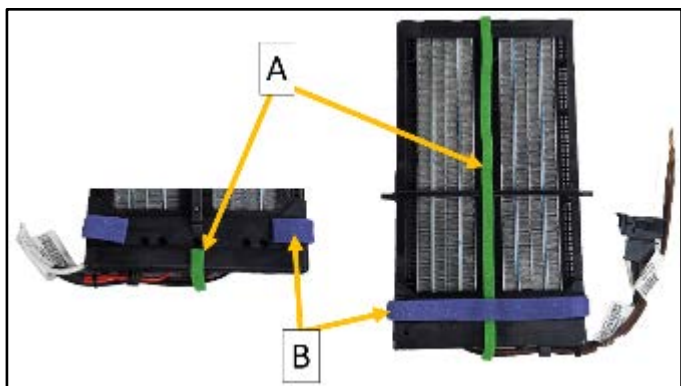
- Install foam seals <A> and as shown onto the new Auxiliary Heater Heating Element -Z35-.
- Install seal <A> first.

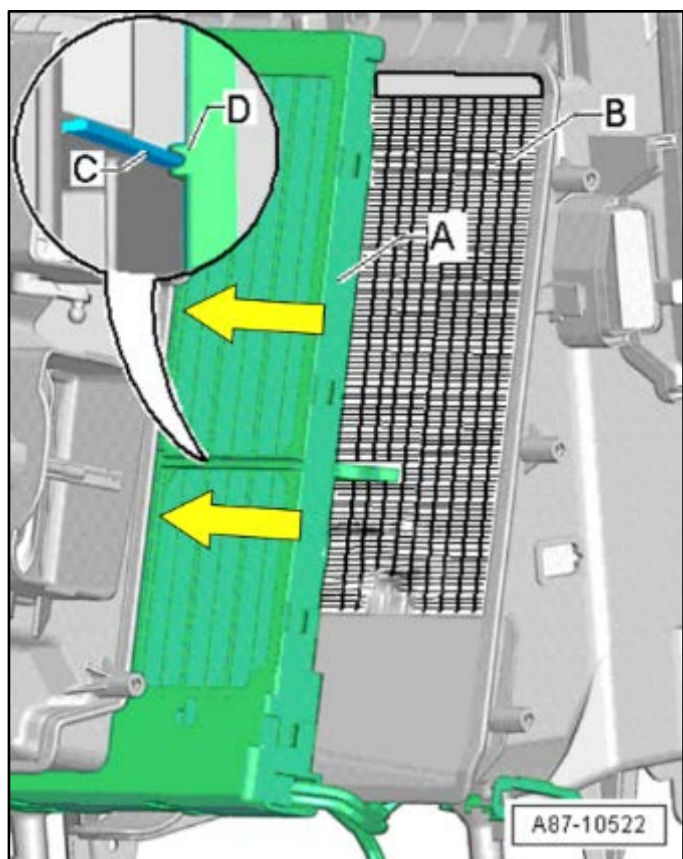
- Install new Auxiliary Heater Heating Element -Z35- <A>.

Repackage the removed Auxiliary Heater and return to your parts department for a core return.

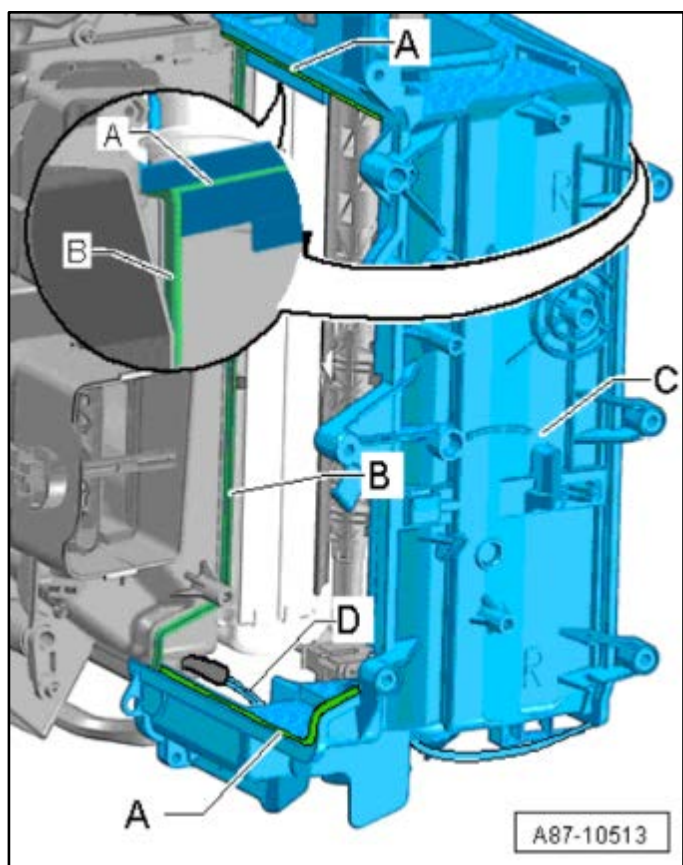
- Insert the grooves <A> on the right heater core housing into the guides on the A/C unit and push the right heater core housing <C> just a little into the A/C unit.

If the groove <A> on the right heater core housing <C> or the groove on the A/C unit are damaged, seal these with, for example, Silicone Adhesive D 176 001 A3 (shop supply).

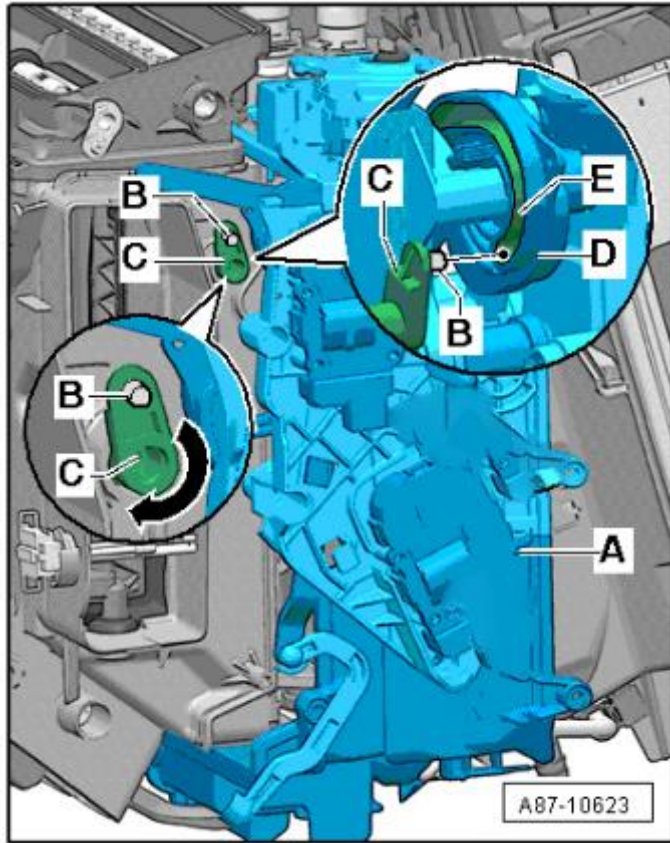
- Install bolts <E> and torque to 1 Nm.
- Carefully connect the connecting arms <A> to <D> to the lever of each door.

- Do not over-tighten bolts <E>.
- Do not press the arms on with too much force.
- If the arms are difficult to install onto the door levers, use pliers to press the arm onto the lever.

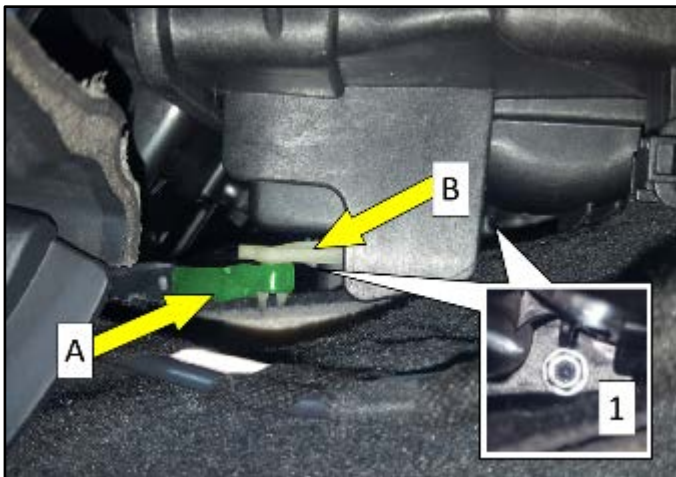
- Reconnect the connector rod <A> to the lever on the right temperature door .
- Install the two bolts <1>, located at the bottom of the heater core housing and torque to 1 Nm.

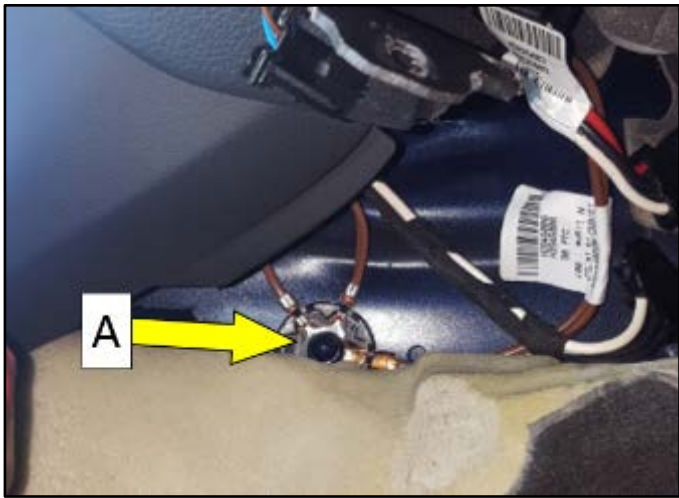
- Install ground cable onto ground point <A> and torque nut to 9 Nm.
- Fold carpet back to its original position.

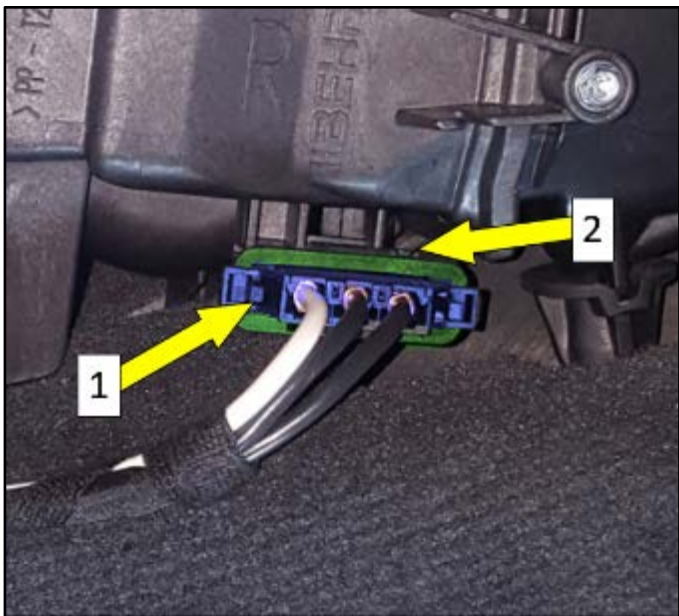
- Install Auxiliary Heater Heating Element -Z35- connector to the heater core housing so that locking tab <2> engages.
- Connect connector <1> to the Auxiliary Heater Heating Element -Z35-.

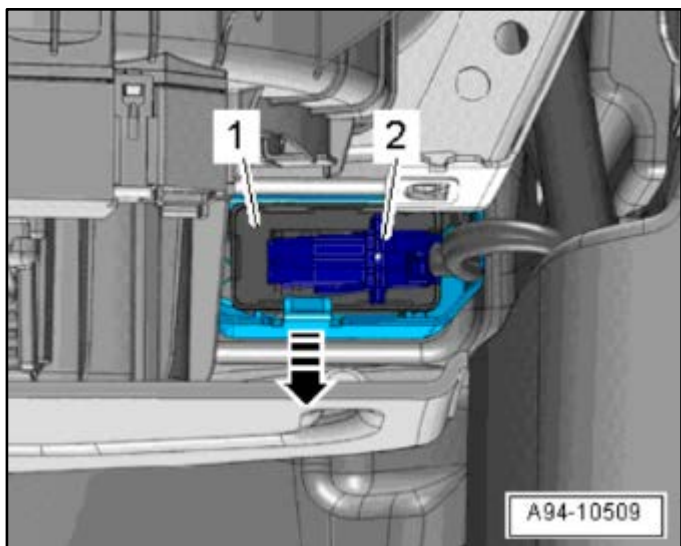
- If equipped, install the Headlamp Range Control Module <1> and connect connector <2>.

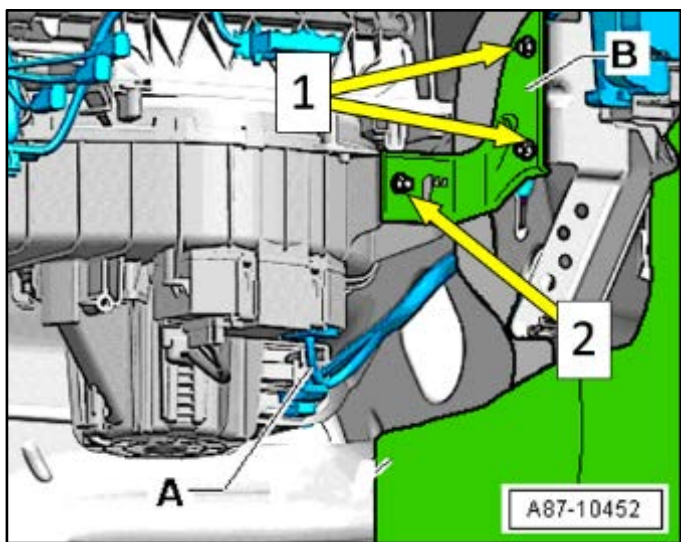
- Install bracket .
- Install bolts <1> and torque to 9 Nm.
- Install bolt <2> and torque to 3.6 Nm.
- Connect connector <A>.
- Reattach wiring harness to bracket (if necessary).

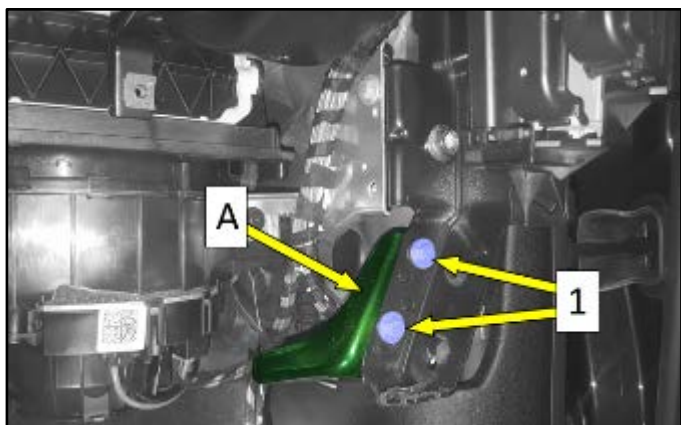
- Install bracket <A> (if equipped) and torque bolts <1> to 9 Nm.

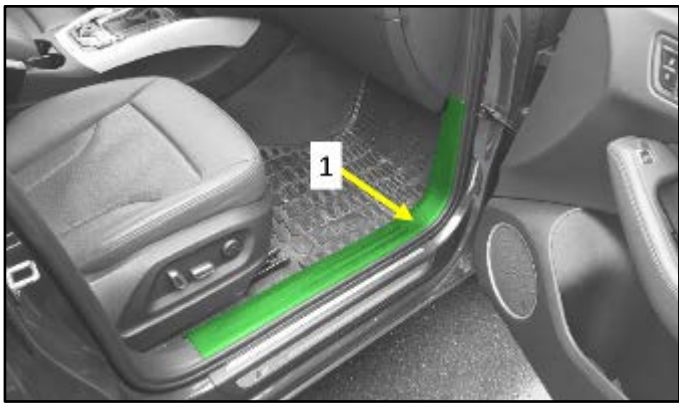
- Remove any clips still installed in the body using Omega Clip Tool -T40280- and reinstall into the trim.
- Slide the front sill panel trim guide into the carpet.
- Install sill panel trim <1>.
- A5 and A5 Cabriolet models:
 - Install lower A-pillar trim.
