# TECHNICAL SERVICE BULLETIN

Bulletin Number: V-17-02  
Model Years: 2010-17

**SUBJECT: 2010-17 Victory Cross Country / Cross Country Tour / Cross Roads /  
Magnum / Hard Ball brake line routing**

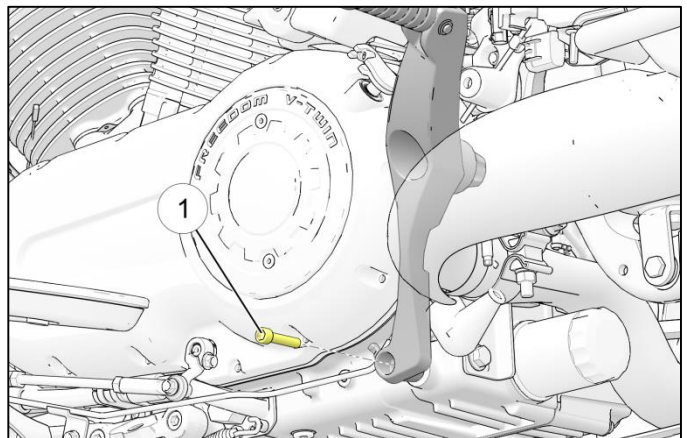
3. Using a 6 mm allen wrench, remove lower passenger footrest bolt ①.

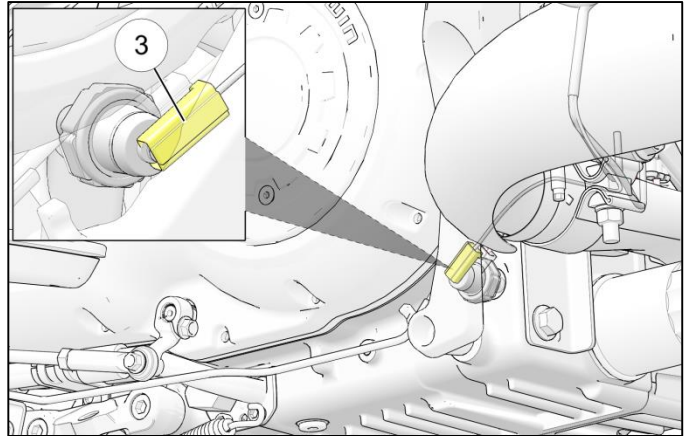
5. Disconnect oil pressure switch connector ③.

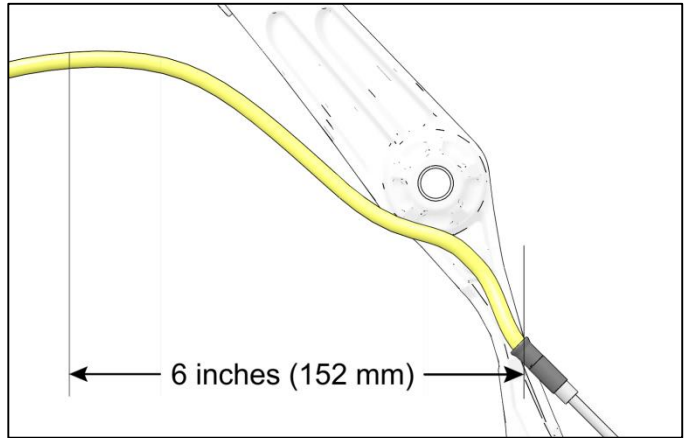
Measure 6 inches rearward from the Brake Line crimp location. Inspect brake line, oil pressure switch and sidestand switch wire (INTL models) for thermal damage.

Measure brake line rearward from Brake crimp location:  
**6 inches (152 mm)**

Replace if necessary.

If the brake line is damaged, refer to the online service manual for BRAKE LINE REPLACEMENT.

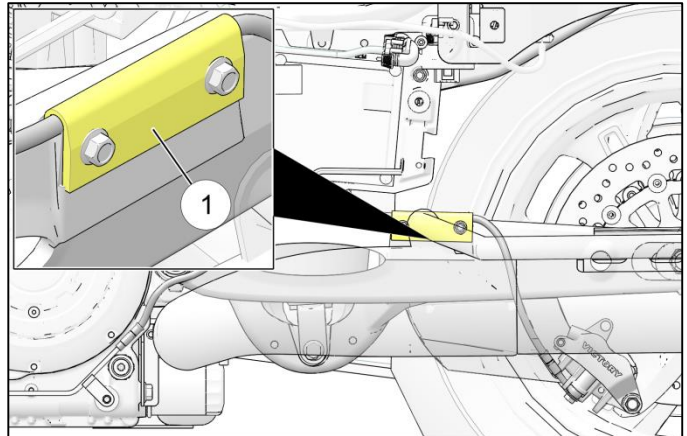
1. **NON-ABS MODELS ONLY:**  
Remove brake line retainer ① on swingarm.

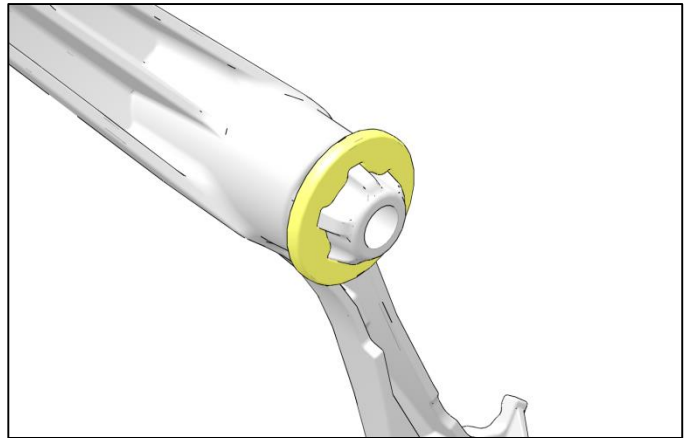
2. **ALL MODELS:**  
Install the swingarm guard over the footrest bracket until fully seated.

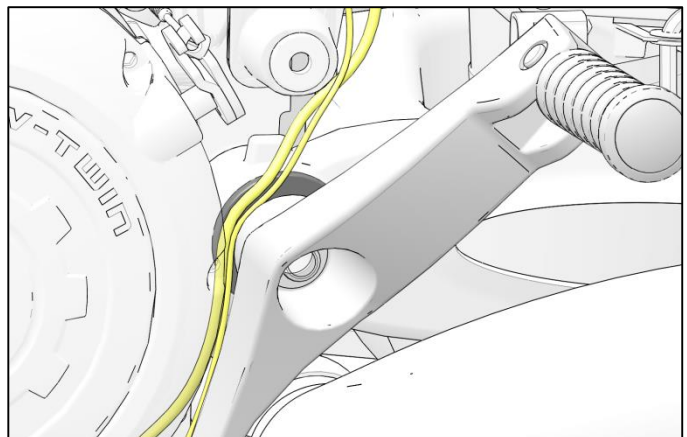
3. **ALL MODELS:**  
**IMPROVED LINE ROUTING**  
Route the brake line and oil pressure switch lines over the footrest as shown. Assemble the footrest over the swingarm pivot until fully seated.  
*\*ABS model routing shown for illustration.*

Verify the brake line and oil pressure switch lines are not pinched between the footrest and swingarm pivot.

Sidestand Switch Wire will also route over the footrest.

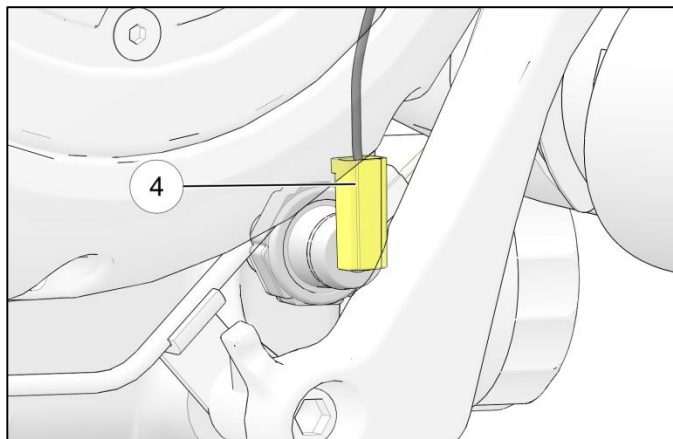
7. **ALL MODELS:**  
Connect oil pressure switch connector ④ in a vertical orientation as shown.

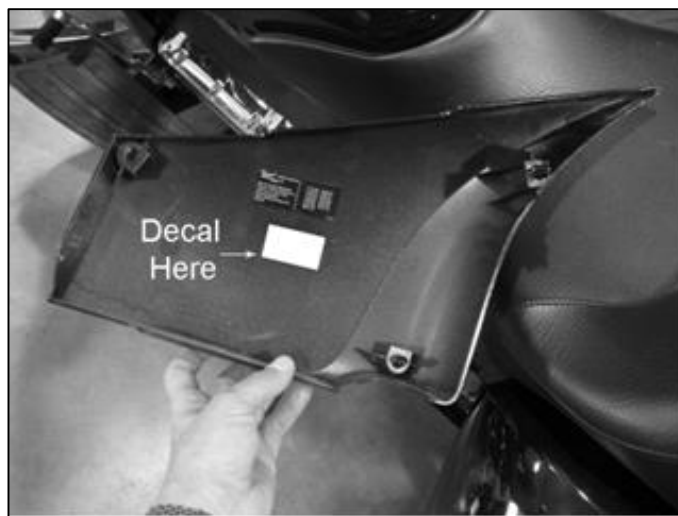
9. **ALL MODELS:**  
Install a completed Service Bulletin Completion Decal (7170107) on the inside of the side cover.
