Keystone RV Company

SAFETY ADVISORY # 17-303

Flame King Exterior Cook Top

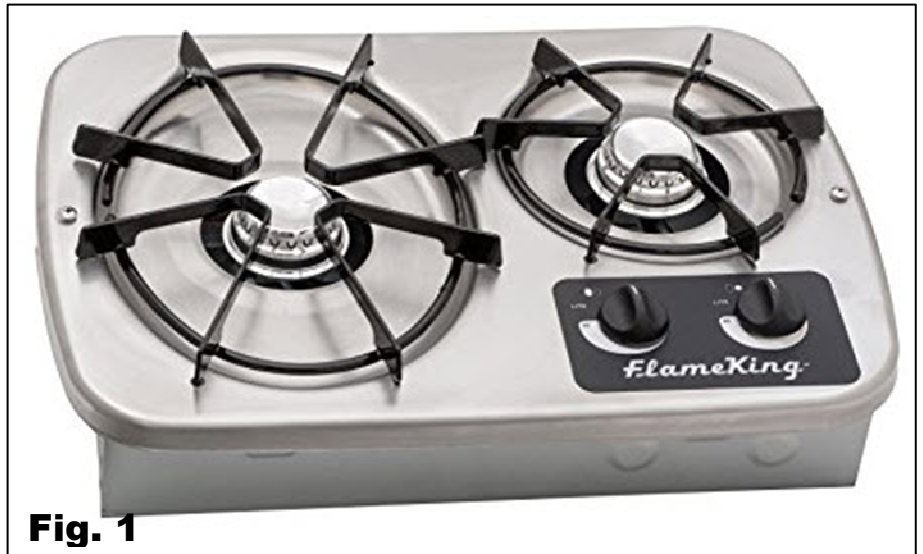
Fig. 1

Locate the exterior kitchen to inspect cook top to verify the appliance is a Flame King, Figure 1. If it is a different brand name, proceed to Warranty Reimbursement below. If it is a Flame King, proceed with inspection.

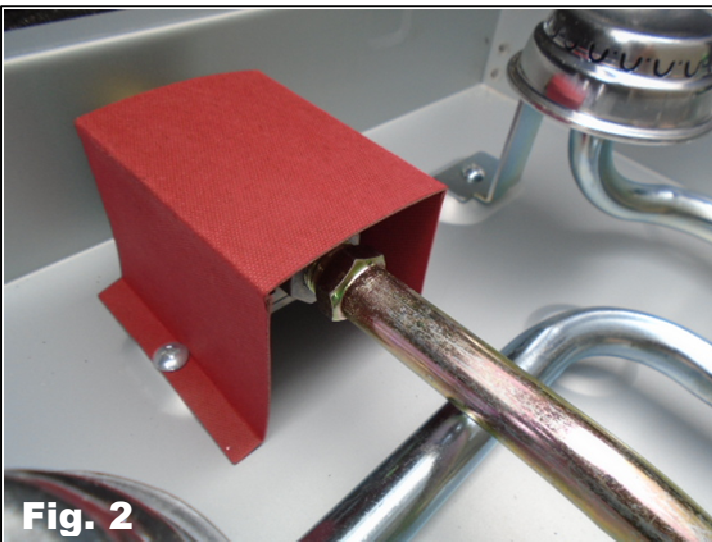
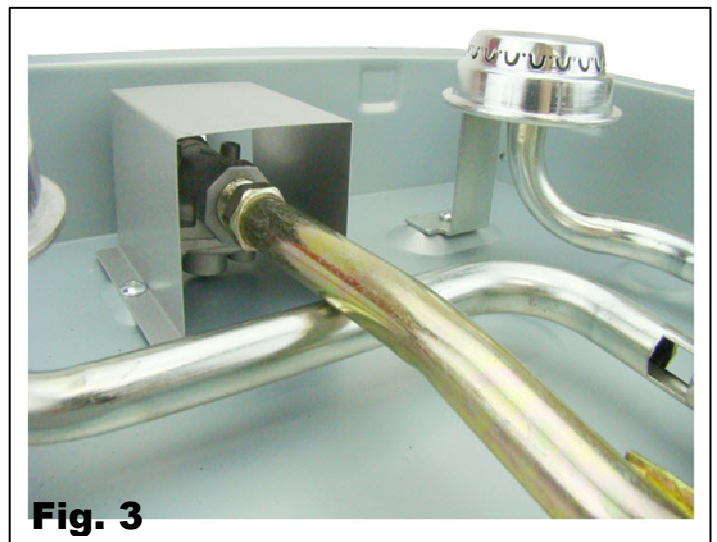
Fig. 2

Remove burner cover and inspect regulator cover, Figures 2 and 3.

If no damage is found to the corrugated fiber board protector, replace the protector using KRV part number 586977. Remove 2 screws holding down the corrugated fiber board protector and reuse the screws when installing the metal protector.

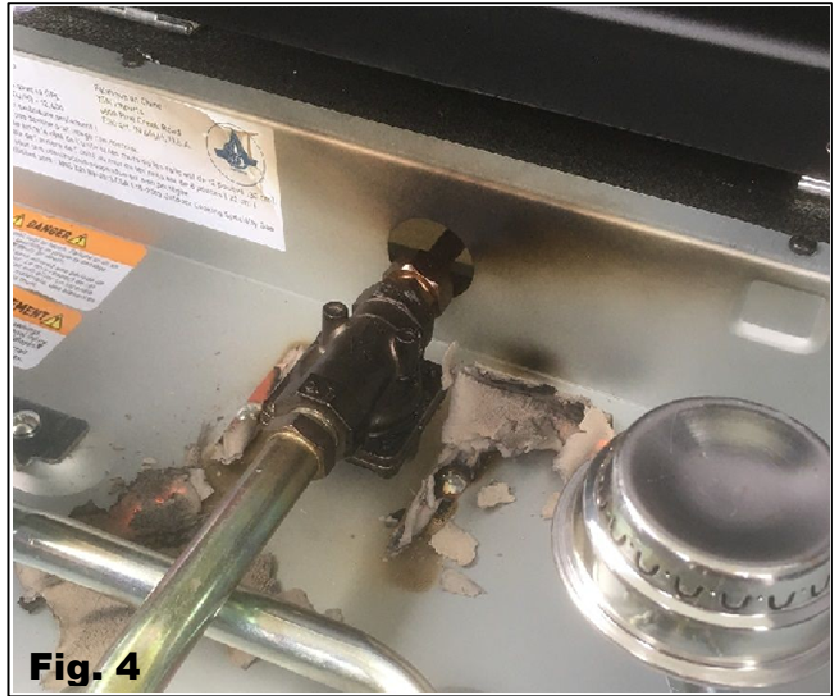
If the corrugated fiber board protector is found to be damaged from an inverted flame, Figure 4, replace cook top by removing the gas line, using industry standards, and the four screws holding the cook top in place. Replace the cook top with a new cook top using KRV part #534089.

Using a soapy solution check connections for leaks and proceed to warranty reimbursement instructions below.
