# Safety Recall

## Code: 70G6

<b>Subject</b>	Door Speaker Trim
<b>Release Date</b>	March 02, 2018
<b>Revision Summary</b>	<b>Work procedure and claiming instructions updated to include installation of new speaker trim.</b>
<b>Affected Vehicles</b>	<b>U.S.A. &amp; CANADA: Certain 2017-2018 MY Audi A4 &amp; allroad Certain 2018 MY Audi A5 Sportback</b>  <i>Check Campaigns/Actions screen in Elsa on the day of repair to verify that a VIN qualifies for repair under this action. Elsa is the <u>only</u> valid campaign inquiry &amp; verification source.</i> <ul style="list-style-type: none"><li>✓ Campaign status must show "open."</li><li>✓ If Elsa shows other open action(s), inform your customer so that the work can also be completed at the same time the vehicle is in the workshop for this campaign.</li></ul>
<b>Problem Description</b>	The aluminum trim on the front and rear door speaker covers can come loose. Loosened trim may bend away from the speaker cover and could expose sharp edges. Injury (such as a cut or puncture) could occur if someone came into contact with one of these sharp edges.

## Section B – Speaker Trim Removal (from all four doors) Criteria 01 and 02

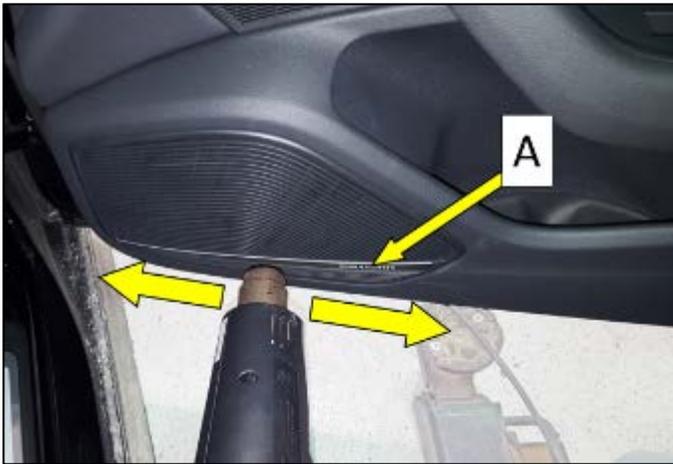
- The speaker trim being removed is extremely sharp and will be hot after being heated.
  - Use extreme caution when removing the trim as the trim has very sharp edges.
  - To avoid injuries, use leather gloves when removing and handling the trim.
- 
- Set the Hot Air Blower -VAS1978/14A- fan speed to high and the heat setting at 4 (or medium-high heat).
  - Using Hot Air Blower -VAS1978/14A- (or equivalent), heat the length of the speaker trim <A> for approximately 90 seconds.

- Do not aim the blower at one spot on the speaker, but keep the blower moving.
- The temperature of the hot air blower must not exceed 100° C.
- Damage to the speaker grills will not be covered under this action.

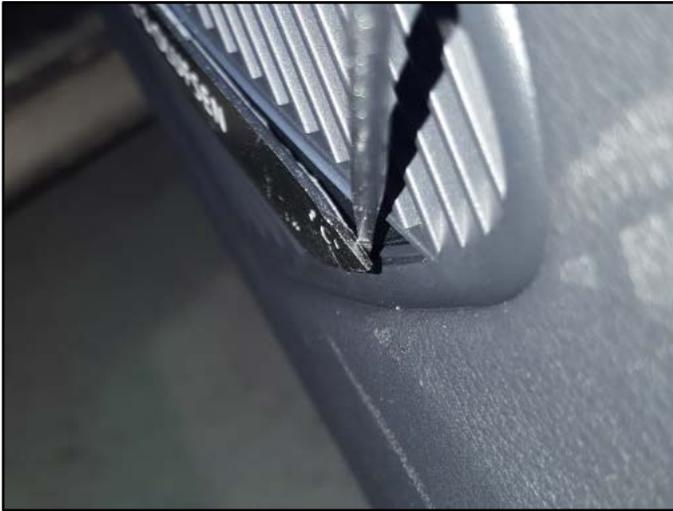
- Using a pocket screwdriver, pry the end of the speaker trim away from the speaker cover slightly, just enough to grab the trim with needle nose pliers.

Use care when removing the speaker trim so no damage to the speaker cover occurs.

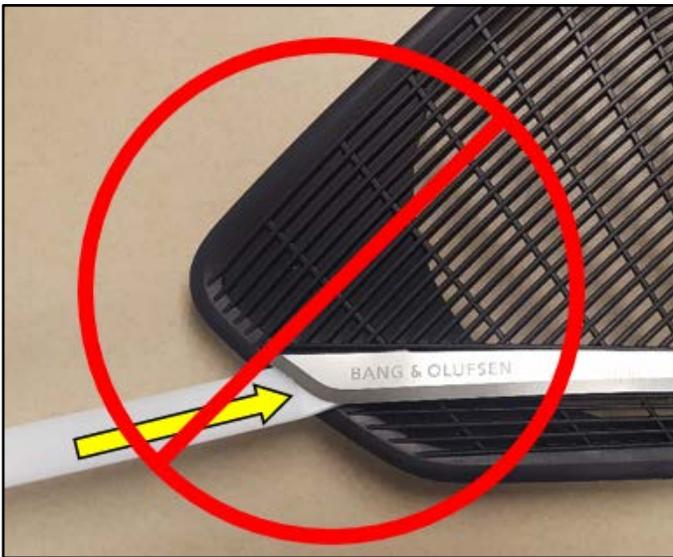
Do not push any tools in direction of <arrow> when removing the speaker trim. If the tool were to slip, severe injury could occur.

Speaker cover shown removed for clarity. The speaker covers do not require removal.

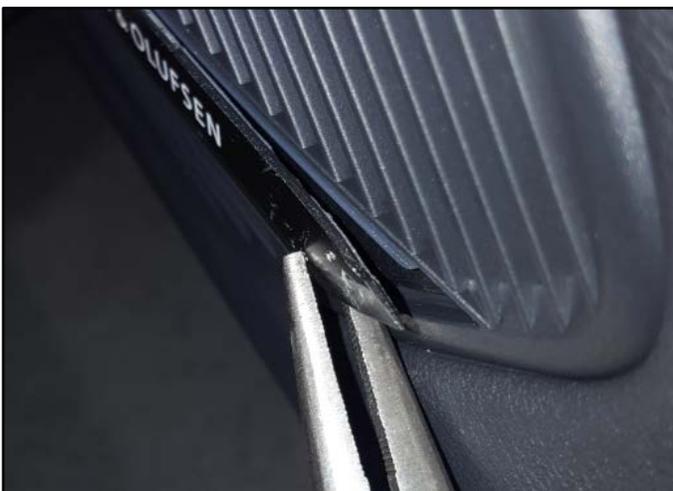
- When removing speaker cover trim, be sure to pull the trim away from your body.
- The speaker trim being removed is extremely sharp and will be hot after being heated.
- Use extreme caution when removing the trim as the trim has very sharp edges.
- To avoid injuries, use leather gloves when removing and handling the trim.

- While holding the speaker grill in place, slowly and carefully pull the speaker grill trim off the speaker grill using locking needle nose pliers.
- Once the speaker grill trim is removed, clean off any residual adhesive from the speaker grill using Cleaning Solution D 009 401 04 (shop supply).

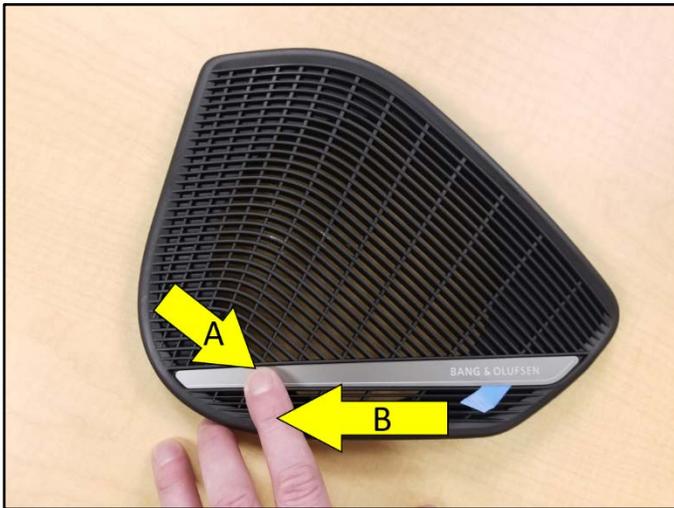
- Allow cleaning solution to completely dry.
- Center the speaker grill trim in the recess for the trim.

- Remove adhesive backing and install new speaker grill trim to all four speaker grill covers.
  - Once the trim is centered, start peeling off the adhesive backing in direction of arrow <B>.
  - Then hold the trim at point <A> and completely remove the adhesive backing in direction of arrow <B>.
  - When the trim is in place, firmly press the trim onto the speaker grill.

**NOTE**  
 Speaker cover shown removed for clarity. The speaker covers do not require removal to install the new speaker grill trim.
