# Safety Recall

## Code: 70G6

<b>Subject</b>	<b>Door Speaker Trim</b>
<b>Release Date</b>	November 29, 2017
<b>Revision Summary</b>	Work instructions updated to include using needle nose pliers for trim removal. Warnings and Cautions updated.
<b>Affected Vehicles</b>	<b>U.S.A. &amp; CANADA: Certain 2017-2018 MY Audi A4 &amp; allroad and certain 2018 MY Audi A5 Sportback</b>  <i>Check Campaigns/Actions screen in Elsa on the day of repair to verify that a VIN qualifies for repair under this action. Elsa is the <u>only</u> valid campaign inquiry &amp; verification source.</i> <ul style="list-style-type: none"><li>✓ Campaign status must show "open."</li><li>✓ If Elsa shows other open action(s), inform your customer so that the work can also be completed at the same time the vehicle is in the workshop for this campaign.</li></ul>
<b>Problem Description</b>	The aluminum trim on the front and rear door speaker covers can come loose. Loosened trim may bend away from the speaker cover and could expose sharp edges. Injury (such as a cut or puncture) could occur if someone came into contact with one of these sharp edges.

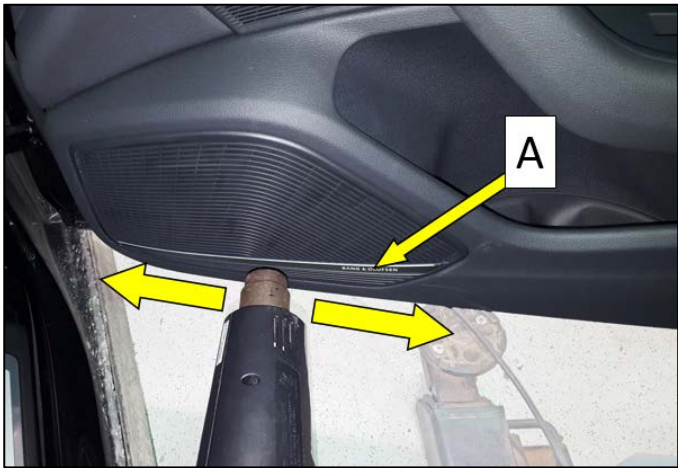
- The speaker trim being removed is extremely sharp and will be hot after being heated.
- Use extreme caution when removing the trim as the trim has very sharp edges.
- To avoid injuries, use leather gloves when removing and handling the trim.
- Set the Hot Air Blower -VAS1978/14A- fan speed to high and the heat setting at 4 (or medium-high heat).
- Using Hot Air Blower -VAS1978/14A- (or equivalent), heat the length of the speaker trim <A> for approximately 90 seconds.

- Do not aim the blower at one spot on the speaker, but keep the blower moving.
- The temperature of the hot air blower must not exceed 100° C.
- Damage to the speaker grills will not be covered under this action.

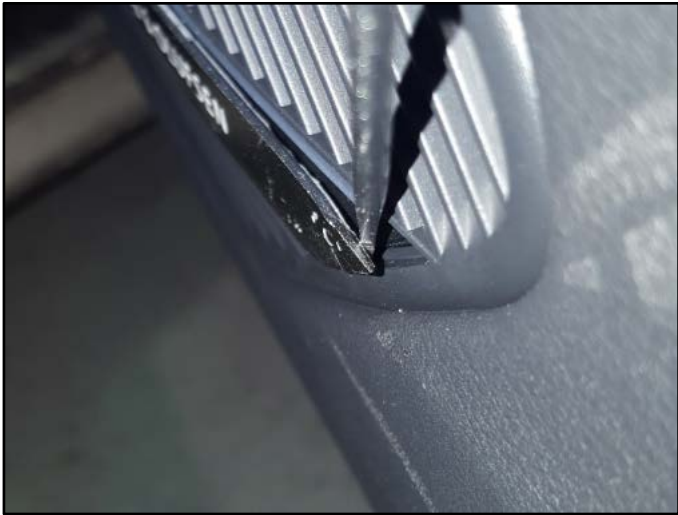
- Using a pocket screwdriver, pry the end of the speaker trim away from the speaker cover slightly, just enough to grab the trim with needle nose pliers.

Use care when removing the speaker trim so no damage to the speaker cover occurs.

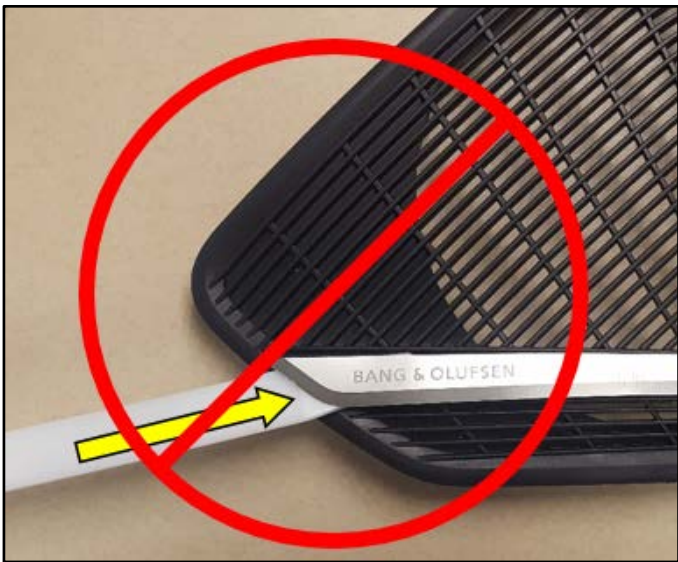
Do not push any tools in direction of <arrow> when removing the speaker trim. If the tool were to slip, severe injury could occur.

Speaker cover shown removed for clarity. The speaker covers do not require removal.

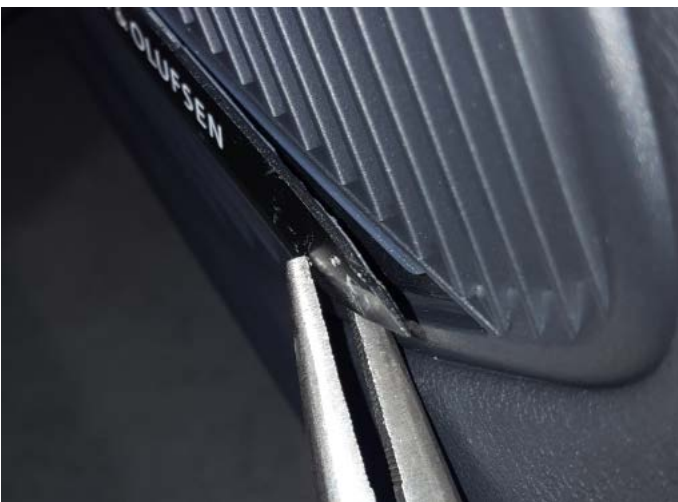
- When removing speaker cover trim, be sure to pull the trim away from your body.
- The speaker trim being removed is extremely sharp and will be hot after being heated.
- Use extreme caution when removing the trim as the trim has very sharp edges.
- To avoid injuries, use leather gloves when removing and handling the trim.

- While holding the speaker grill in place, slowly and carefully pull the speaker grill trim off the speaker grill using locking needle nose pliers.
- Once the speaker grill trim is removed, clean off any residual adhesive from the speaker grill using Cleaning Solution D 009 401 04 (shop supply).
