Safety Recall

Code: 70G6

Subject	Door Speaker Trim
Release Date	November 10, 2017
Affected Vehicles	U.S.A. & CANADA: Certain 2017-2018 MY Audi A4 & allroad and certain 2018 MY Audi A5 Sportback <i>Check Campaigns/Actions screen in Elsa on the day of repair to verify that a VIN qualifies for repair under this action. Elsa is the <u>only</u> valid campaign inquiry & verification source.</i> <ul style="list-style-type: none">✓ Campaign status must show “open.”✓ If Elsa shows other open action(s), inform your customer so that the work can also be completed at the same time the vehicle is in the workshop for this campaign.
Problem Description	The aluminum trim on the front and rear door speaker covers can come loose. Loosened trim may bend away from the speaker cover and could expose sharp edges. Injury (such as a cut or puncture) could occur if someone came into contact with one of these sharp edges.
Corrective Action	Remove existing trim from affected speaker covers. When replacement aluminum trim becomes available, new aluminum trim will be installed under a new Service Action free of charge.

Section B – Speaker Trim Removal (from all four doors) Criteria 01 and 02

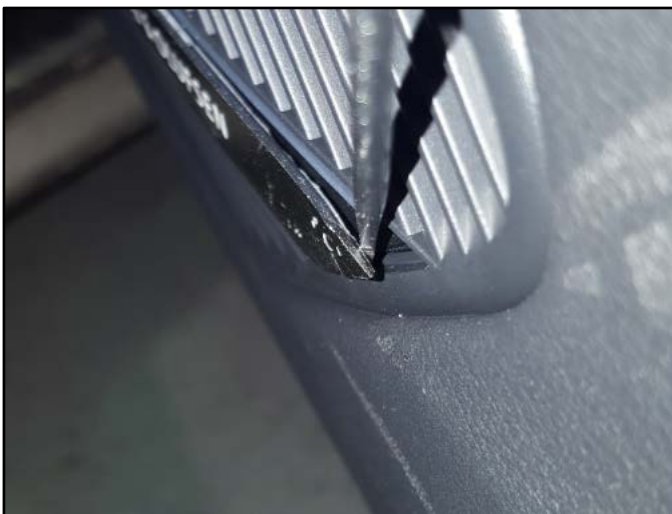
NOTE

Use care when removing the speaker trim so no damage to the speaker cover occurs.

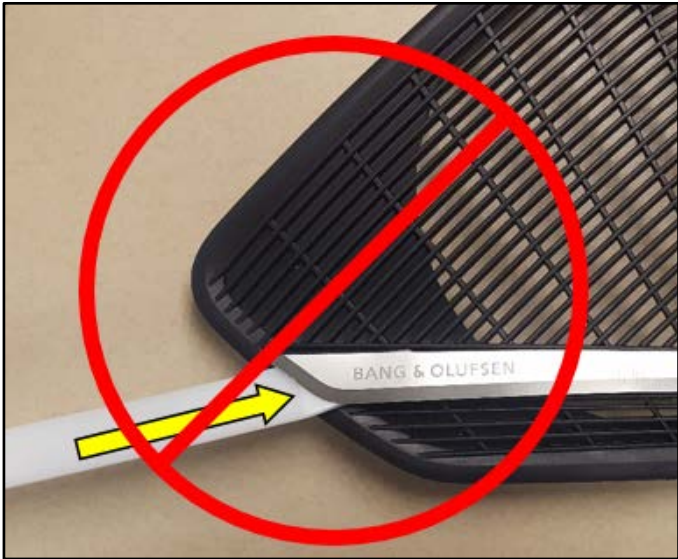
⚠ WARNING

Do not push any tools in direction of <arrow> when removing the speaker trim. If the tool were to slip, severe injury could occur.

ⓘ NOTE

Speaker cover shown removed for clarity. The speaker covers do not require removal.

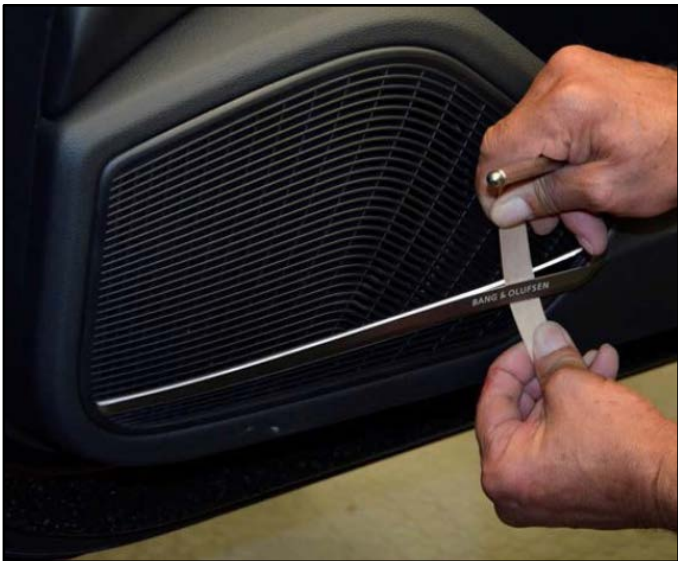
⚠ WARNING

Use extreme caution when removing the speaker trim.

- Carefully pull the trim off the speaker cover using Trim Removal Wedge -3409- (or equivalent).
- Once the speaker trim is removed, clean off any residual adhesive from the speaker cover using Cleaning Solution D 009 401 04 (shop supply).
