SI B11 16 17  
Engine

September 2018  
Technical Service

## RECALL 17V-683: POSITIVE CRANKCASE VENTILATION (PCV) VALVE HEATER

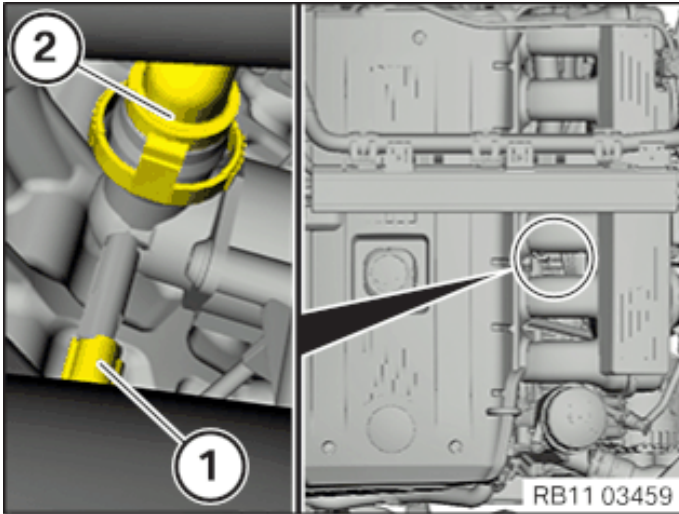
4. **E70 (X5) vehicles only:** UPDATE!  
A coolant pipe will be blocking the access to one of crankcase ventilation heater screws.  
Remove the M10 x 18 screw to allow the coolant pipe to be moved away from the crankcase ventilation heater screws.  
See the red arrow in the illustration.
