SI B11 16 17
Engine

RECALL 17V-683: POSITIVE CRANKCASE VENTILATION (PCV) VALVE HEATER

Recall 17V-683: Positive Crankcase Ventilation (PCV) System Heater

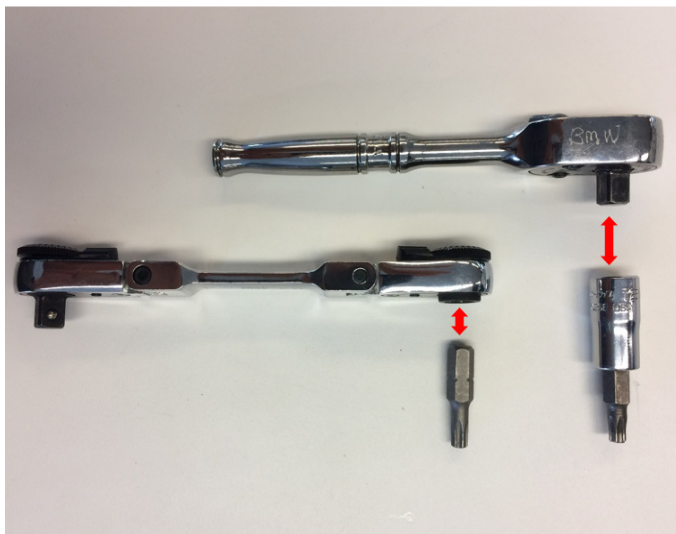
6. Use a suitable tool with T25 Torx bit to release the screws.

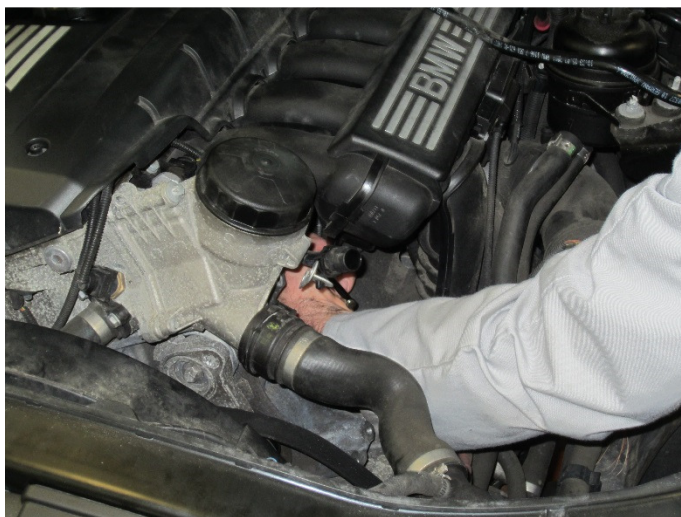
7. Reach under the intake with your left hand/arm to access the crankcase ventilation heater.

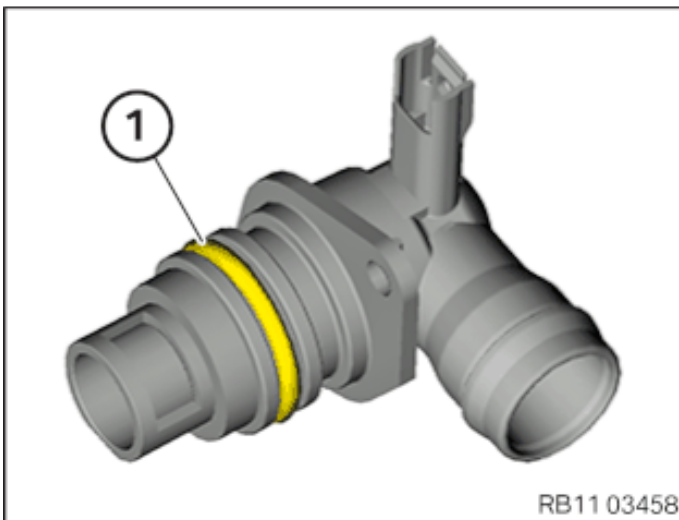
Important! Installation risk of damage.

9. Use only distilled water for lubrication when installing the new crankcase ventilation heater.

No grease or lubricating oils should be used.
