ITB18-001

## **VOLUNTARY SAFETY RECALL CAMPAIGN 2017-2018 QX30 STEERING COLUMN BUSHING**

**CAMPAIGN ID #:** PG7BS  
**NHTSA #:** 17V-691  
**APPLIED VEHICLES:** 2017-2018 QX30 (H15)

Infiniti is conducting this voluntary safety recall campaign on certain specific model year 2017-2018 QX30 vehicles to install a steering column bushing. This service will be performed at no charge to the customer for parts or labor.

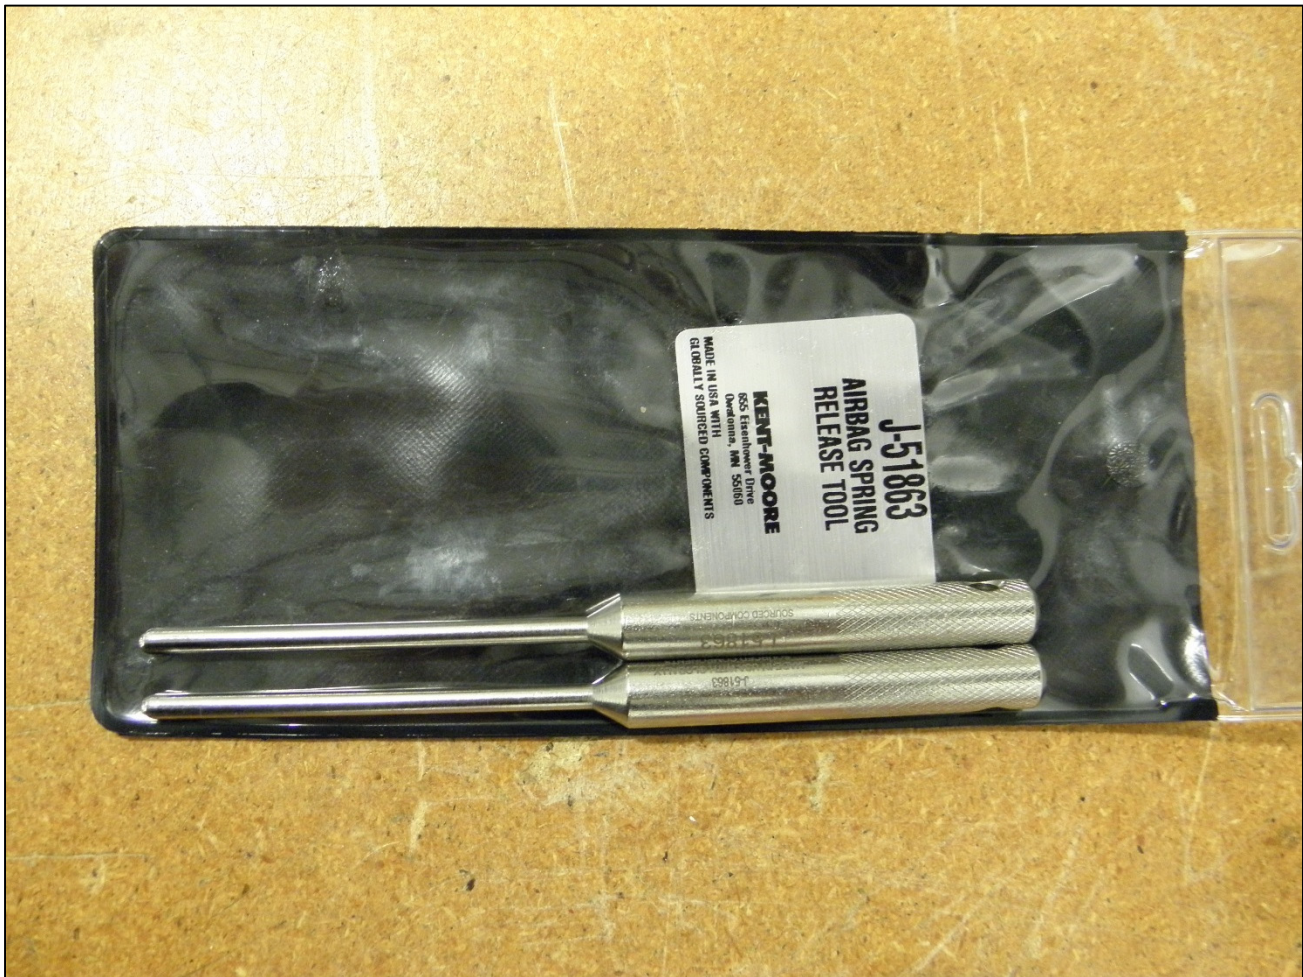
Figure A

- Airbag Spring Release Tool #J-51863

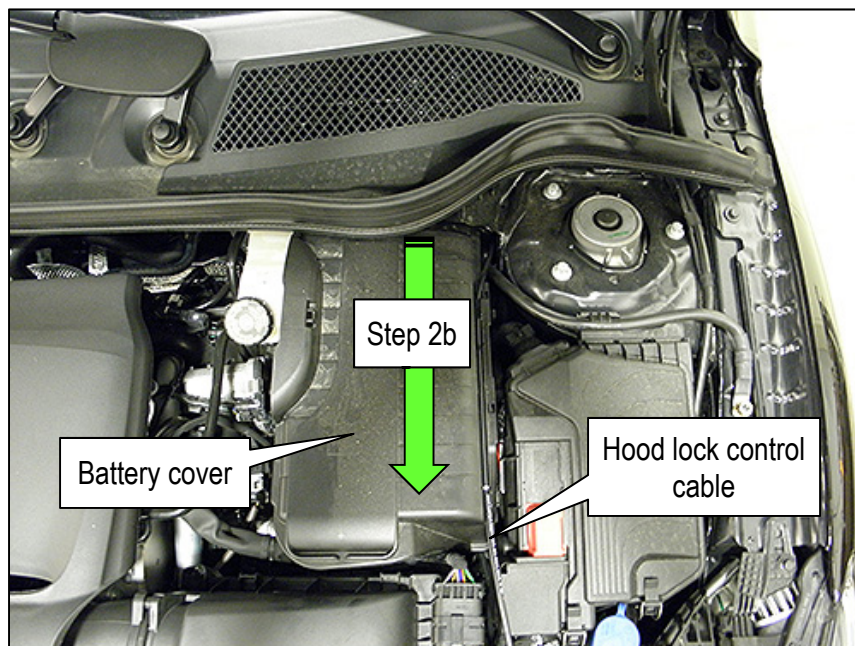
Figure 1

1. Turn the vehicle OFF.
2. Remove the battery cover shown in Figure 1.
  - a. Disconnect the hood lock control cable from the top of the battery cover.
  - b. Slide the battery cover forward to release, and then remove the battery cover.

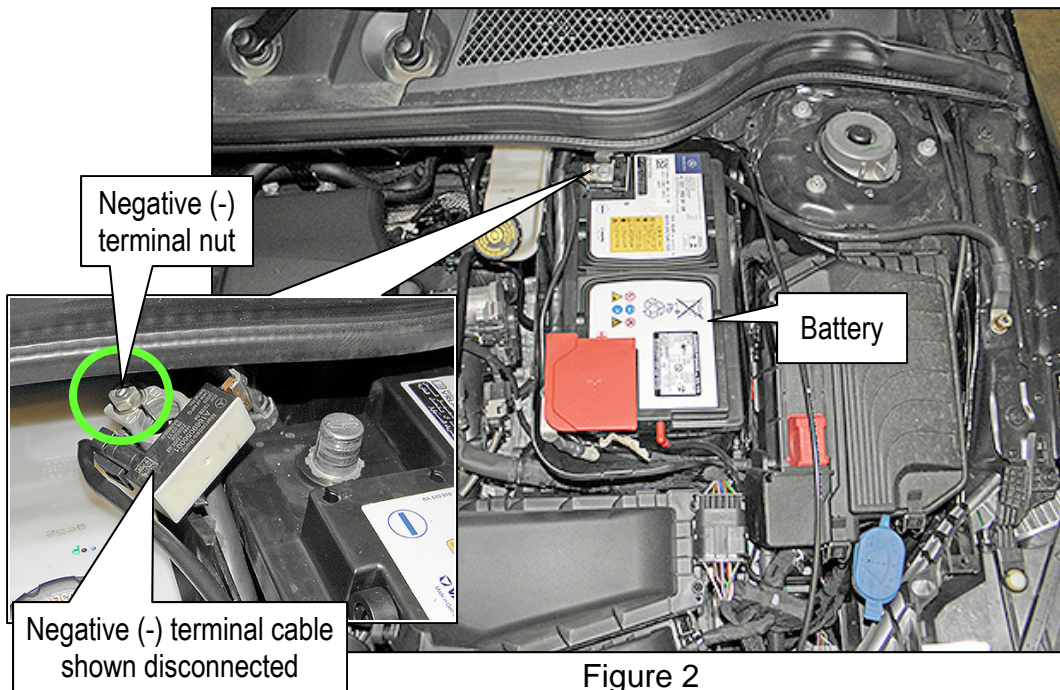
3. Loosen the nut for the negative (-) terminal cable of the battery (Figure 2) and then disconnect the negative (-) terminal cable from the battery.
  - Apply tape to the negative (-) terminal to ensure no contact.
  - Wait 3 minutes before proceeding to next step.

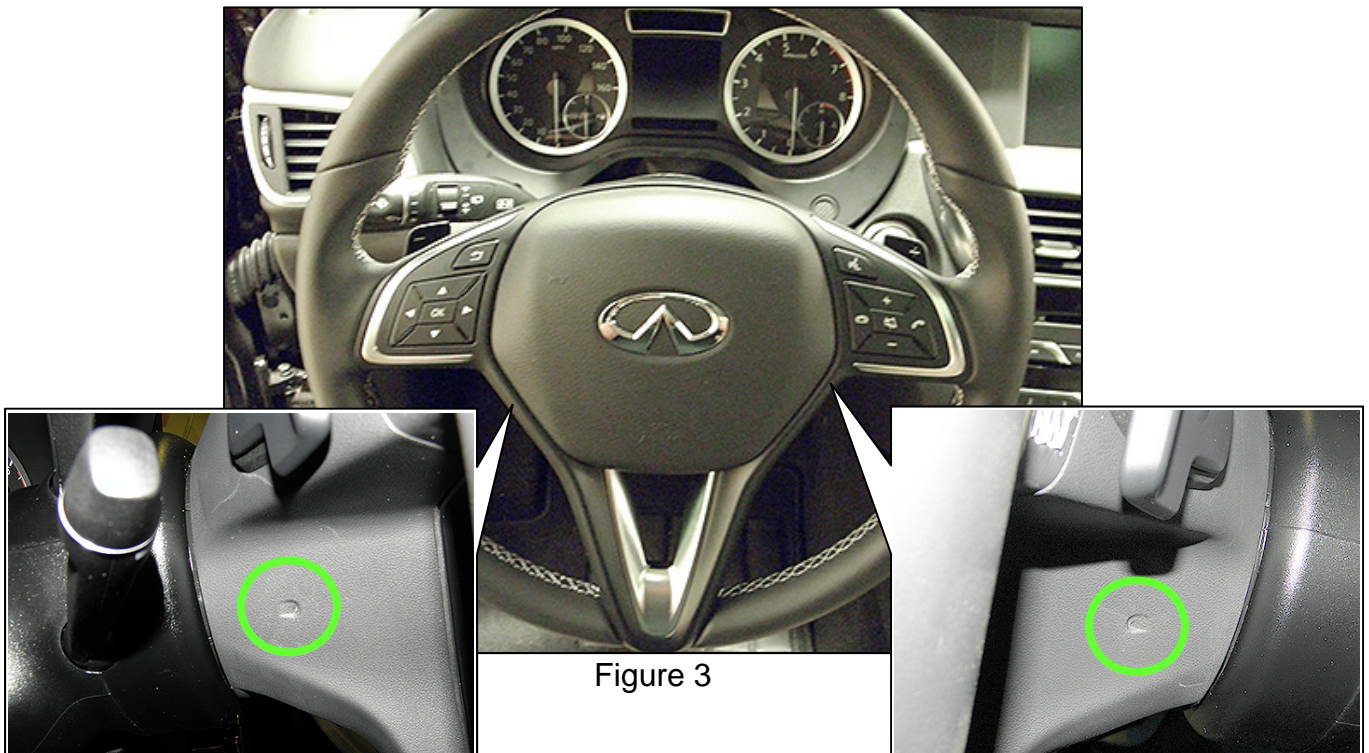
4. Locate the two (2) tool access holes on the backside of the steering wheel (see Figure 3).

NOTE: The areas are each marked by a recess.

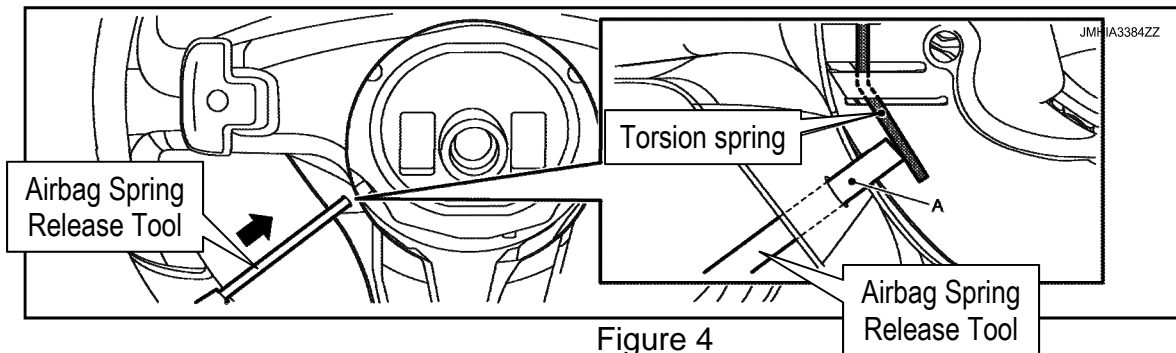
Figure 4

5. Gently pierce the center of each recessed access hole using the Airbag Spring Release Tool (#J-51863).
6. Insert the Airbag Spring Release Tool (A) into hole on the left side or the right side of the steering wheel, and then place the end of the Airbag Spring Release Tool on the torsion spring (Figure 4).

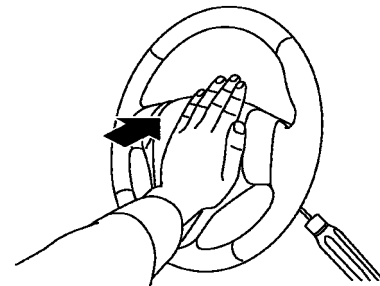
Figure 5

7. Press and hold the driver air bag module on the side where the Airbag Spring Release Tool is inserted.

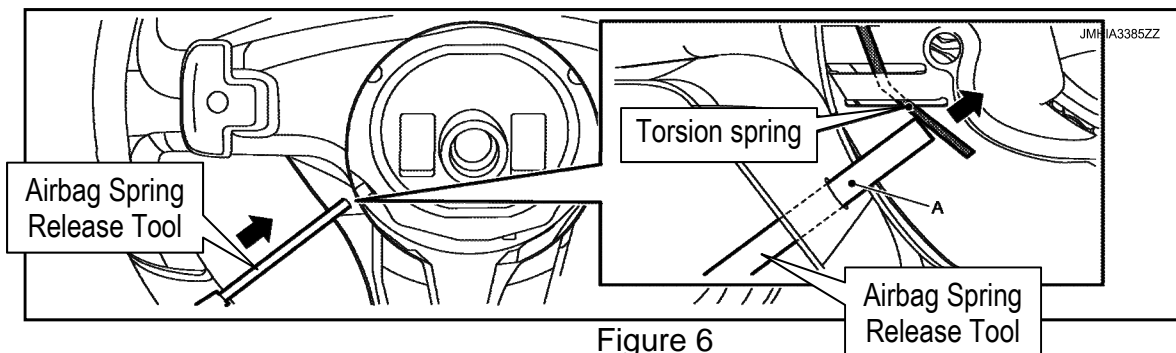
Figure 6

8. Press and disengage the torsion spring by using the inserted Airbag Spring Release Tool (A) (Figure 6).

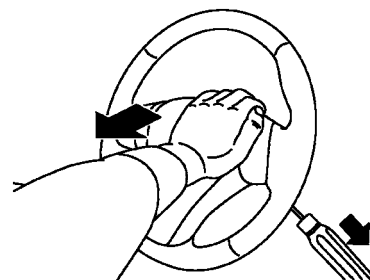
Figure 7

9. Pull the driver air bag module side, previously pressed and held, and then pull out the Airbag Spring Release Tool from the steering wheel.

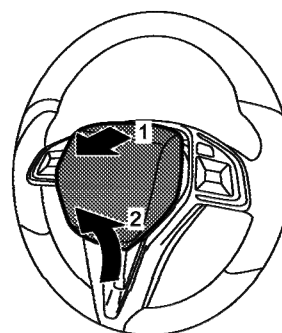
Figure 8

11. Lift the driver air bag module bottom up and away while pulling the top, according to the numerical order 1→2 as shown in the Figure 8, and then remove the driver air bag module from steering wheel.

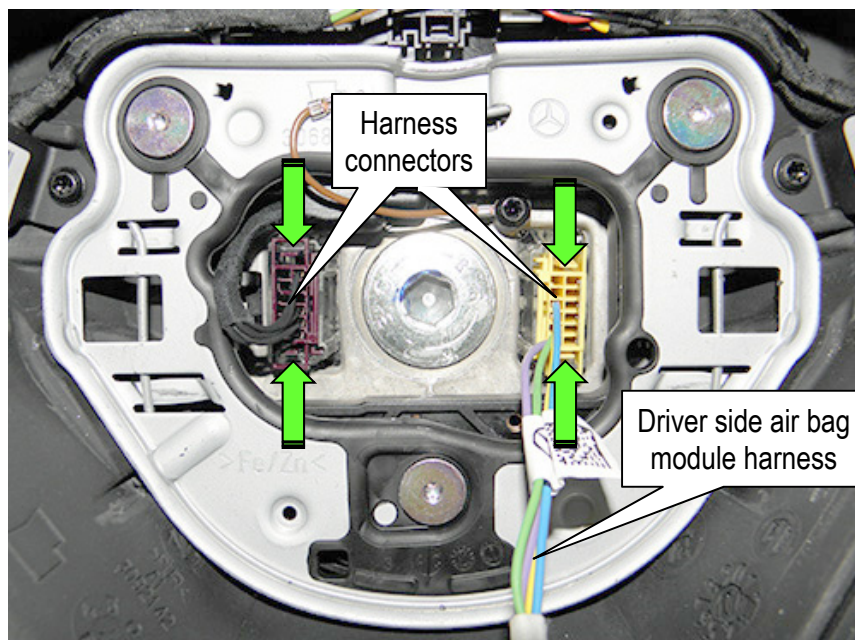
Figure 9

12. Disconnect the two (2) harness connectors from the steering wheel (Figure 9).

- Squeeze harness connector tabs inward to release (see green arrows in Figure 9).

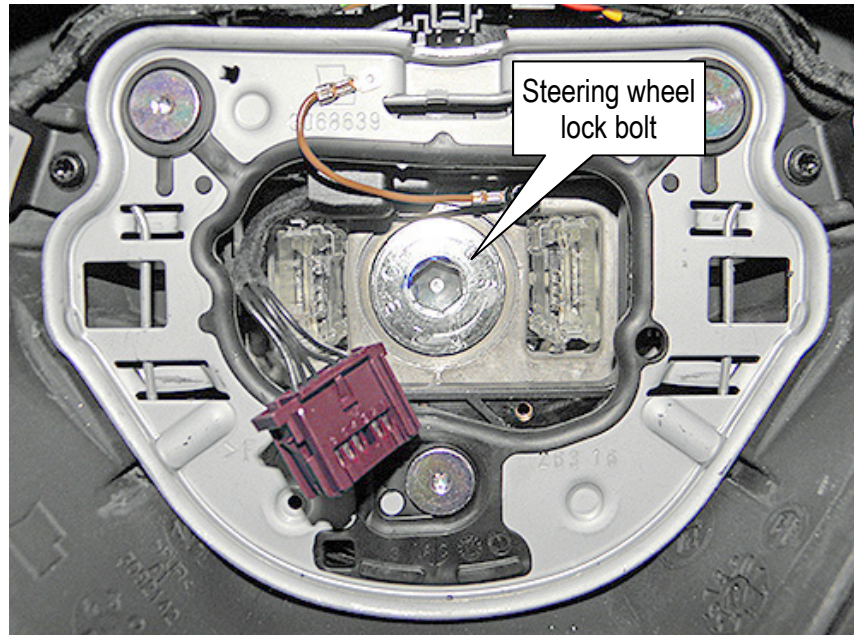
Figure 11

14. Remove the steering wheel lock bolt.

- The steering wheel lock bolt will be replaced during reassembly.

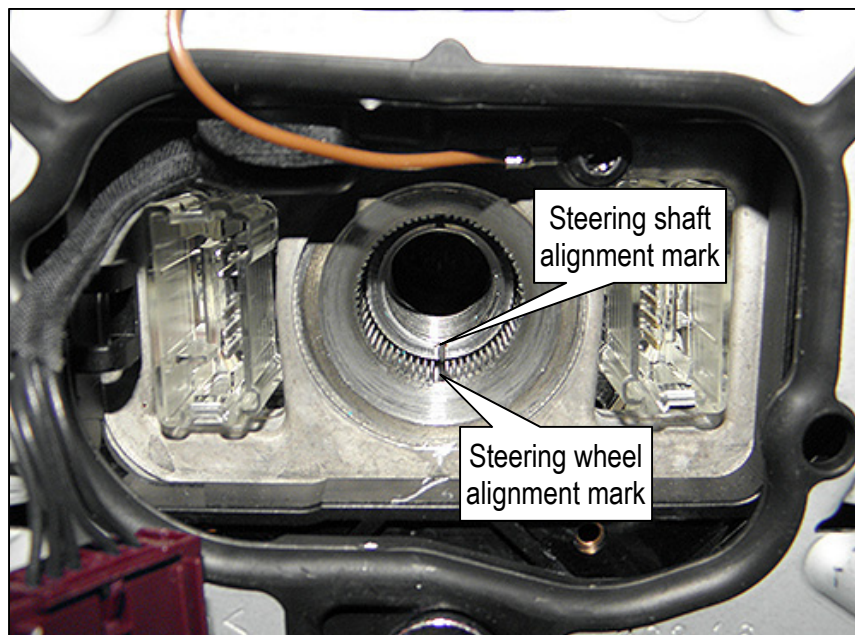
Figure 12

**IMPORTANT:** Before removing the steering wheel, note the location of the steering wheel and steering shaft alignment marks. The correct alignment is shown in Figure 12.

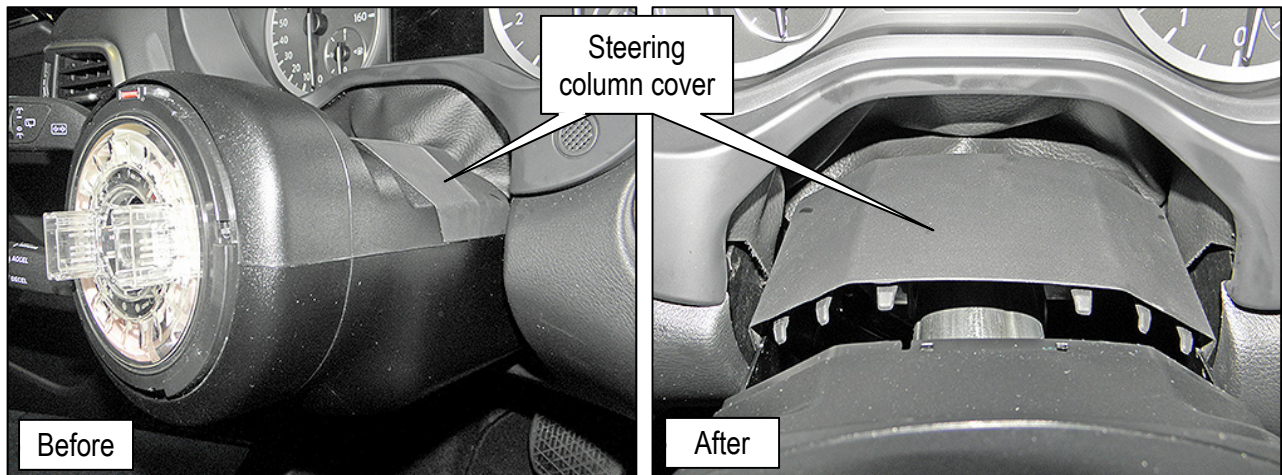
Figure 13

16. Disconnect the steering column cover from the steering column control module and leave it in place.

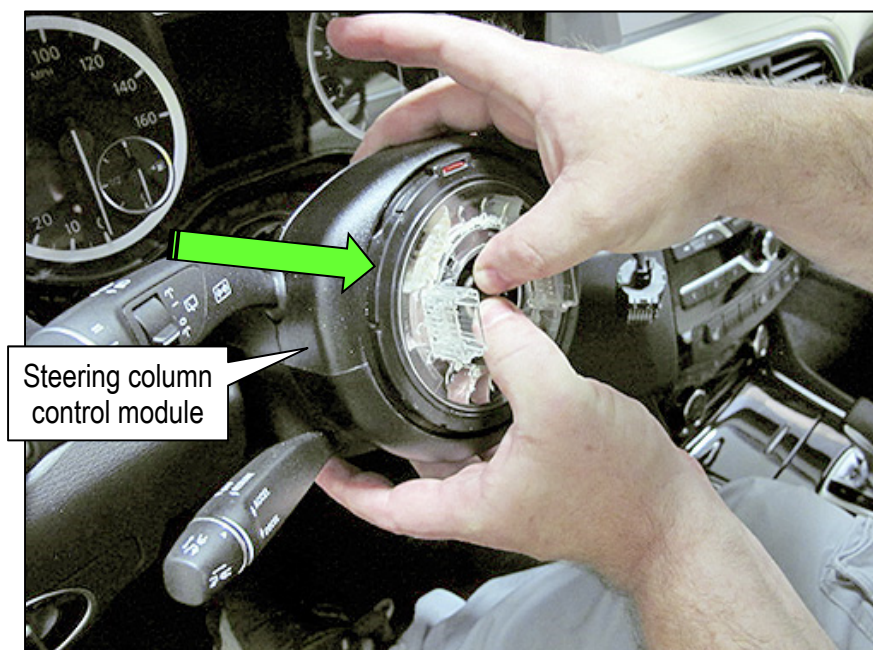
Figure 14

17. Remove the steering column control module from the steering column housing.

- Slide steering column control module straight back and off of the steering column.

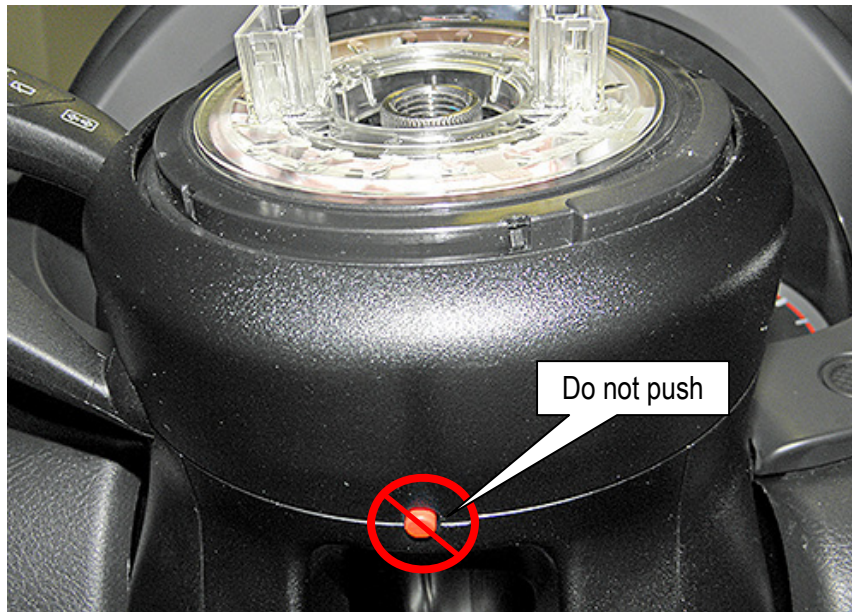
Figure 15

**CAUTION:** Do NOT push the red button on the bottom of the steering column control module at any time while it is being removed or installed. Damage to the steering column control module can occur.

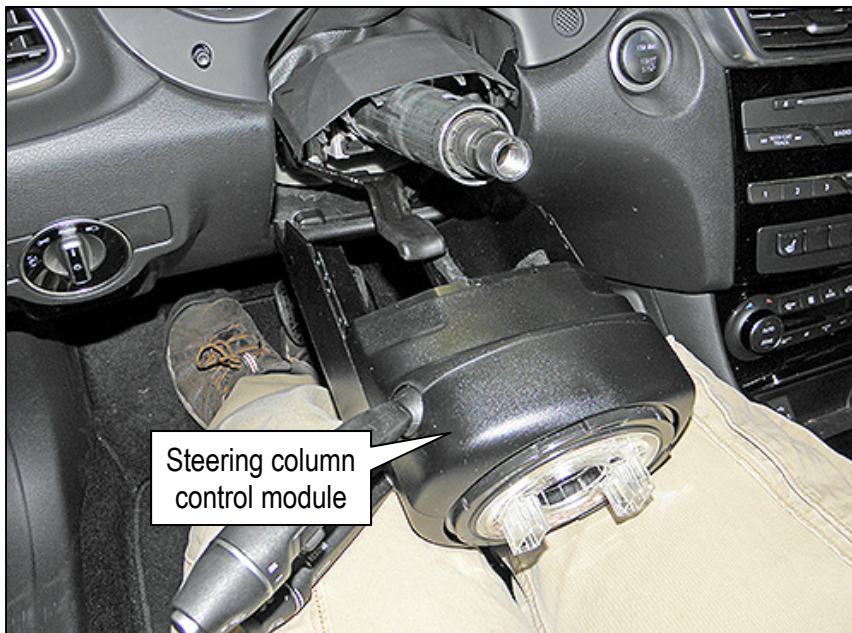
Figure 16

18. Support the steering column control module as shown in Figure 16; allow it to rest on technician's lap while next steps are performed.

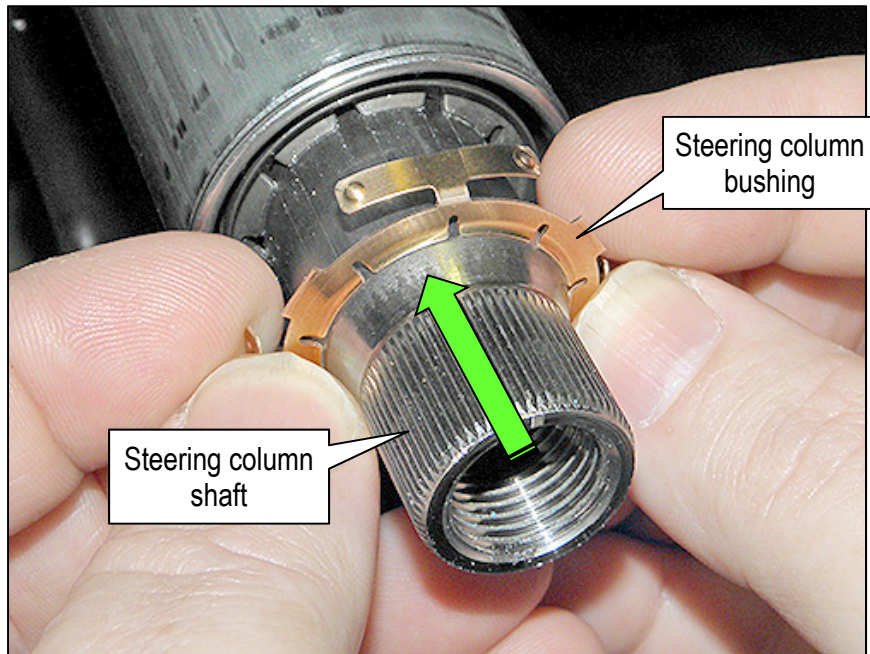
Figure 17

19. Slide the "BEARING ASSY-ST" (steering column bushing) onto the steering column shaft as shown in Figure 17.

- BEARING ASSY-ST is listed in the Parts Information section of this bulletin.

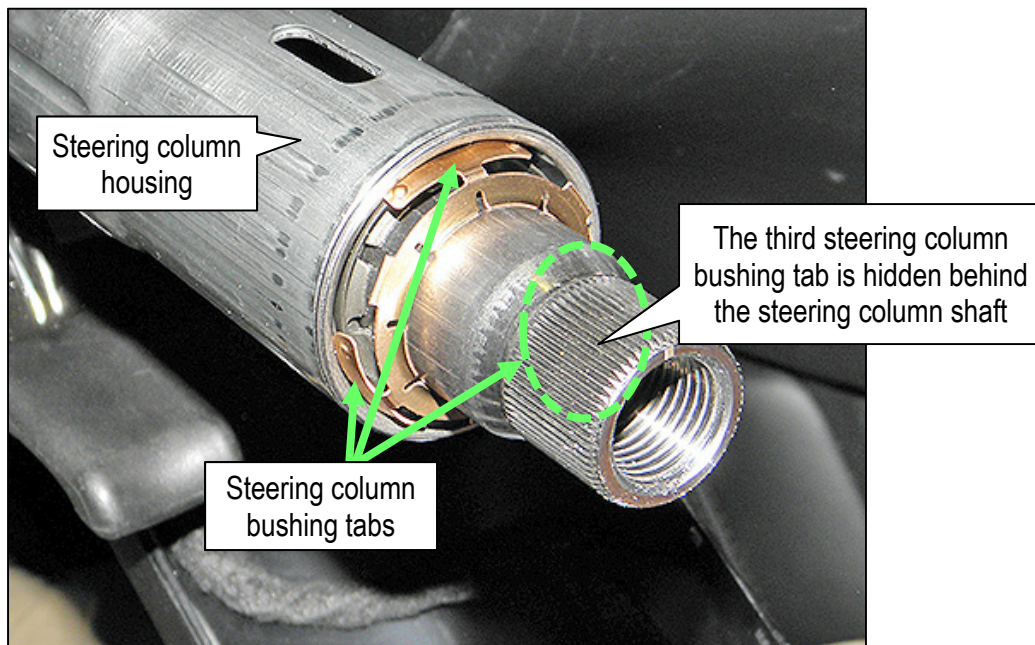
Figure 18

20. Continue to slide the steering column bushing down until the three (3) steering column bushing tabs are next to the steering column housing.

NOTE: Only two of the three (3) steering column bushing tabs are shown in Figure 18. The third steering column bushing tab is hidden behind the steering column shaft.

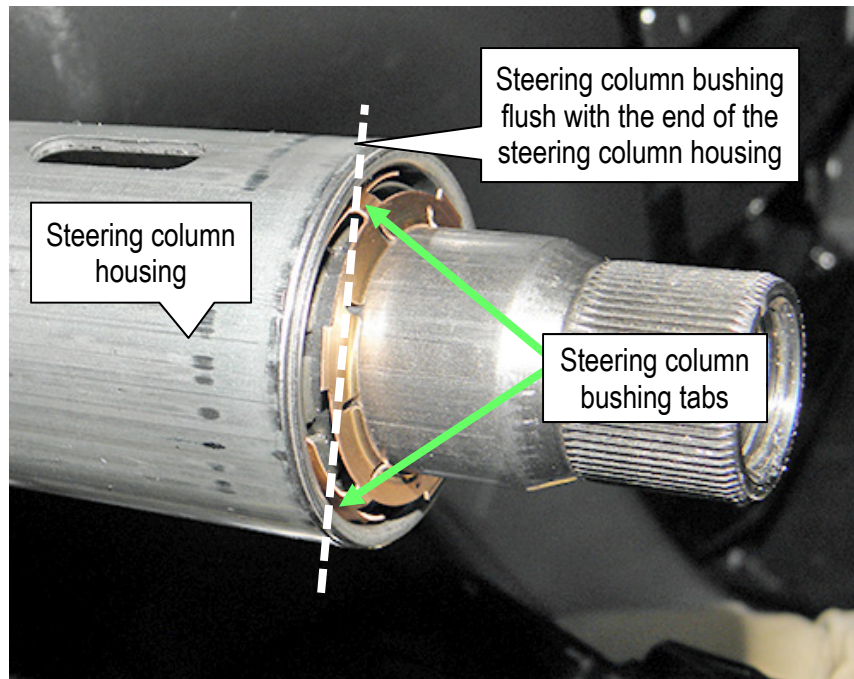
Figure 19

21. Tuck the three (3) steering column bushing tabs into the steering column housing, and then push the steering column bushing into the steering column housing until it is flush with the end, as shown in Figure 19.

**NOTE:** Only two of the three (3) steering column bushing tabs are shown in Figure 19. The third steering column bushing tab is hidden behind the steering column shaft.

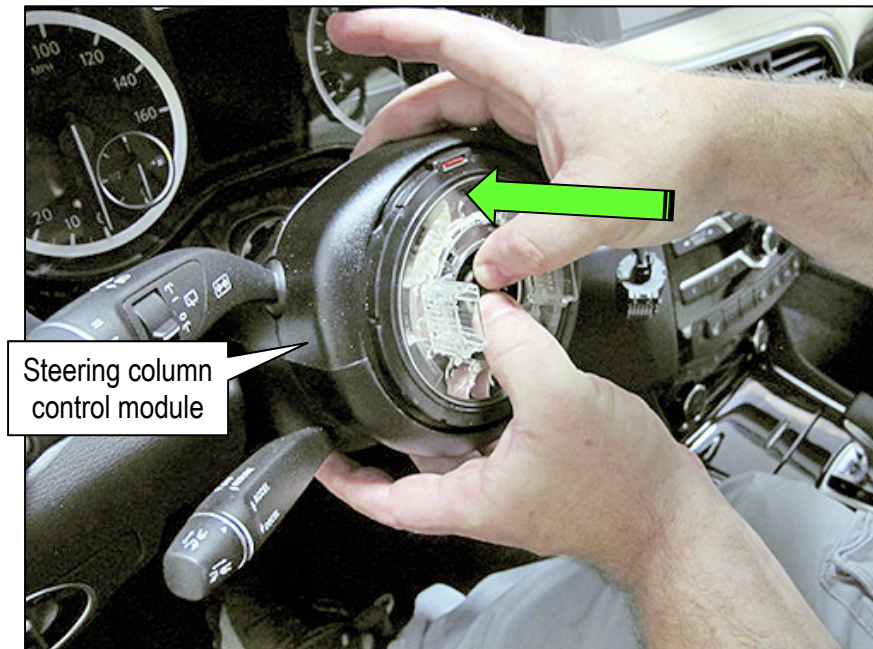
Figure 20

22. Reinstall the steering column control module onto the steering column housing.

- Gently push onto the steering column housing until the detent is engaged; click sound should be heard when fully seated.

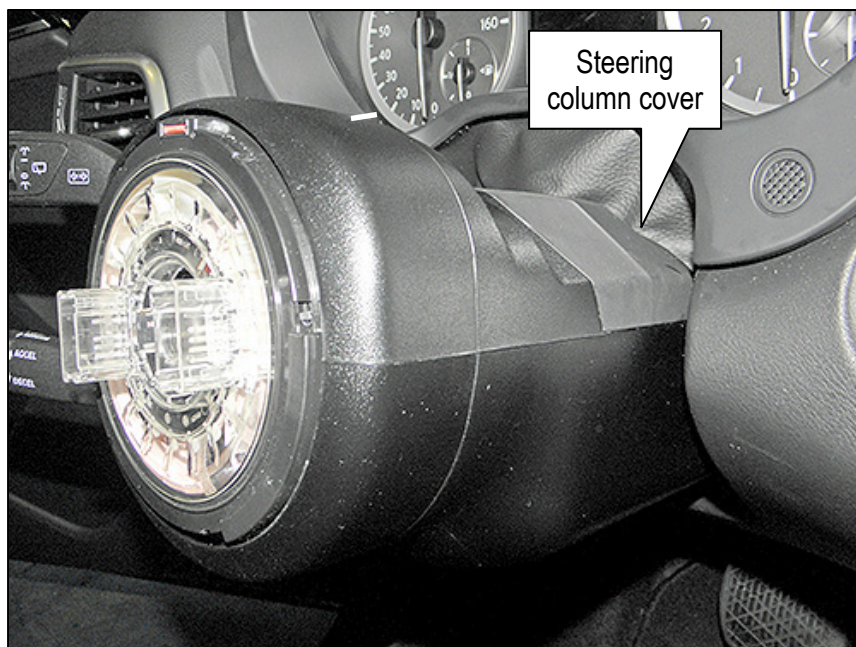
Figure 21

23. Reattach the steering column cover.

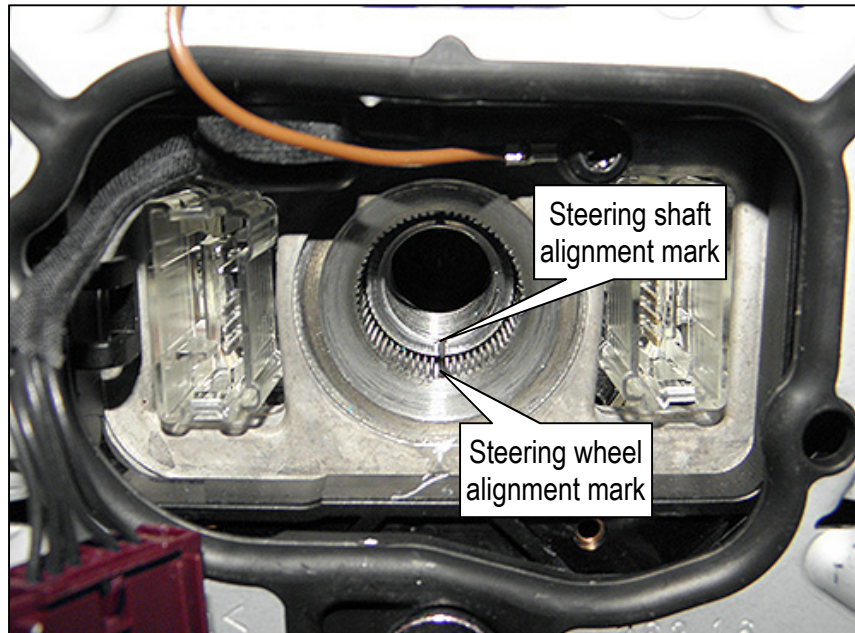
Figure 22

24. Reinstall the steering wheel.

**IMPORTANT:** Confirm that the steering wheel alignment marks are as shown in Figure 22.

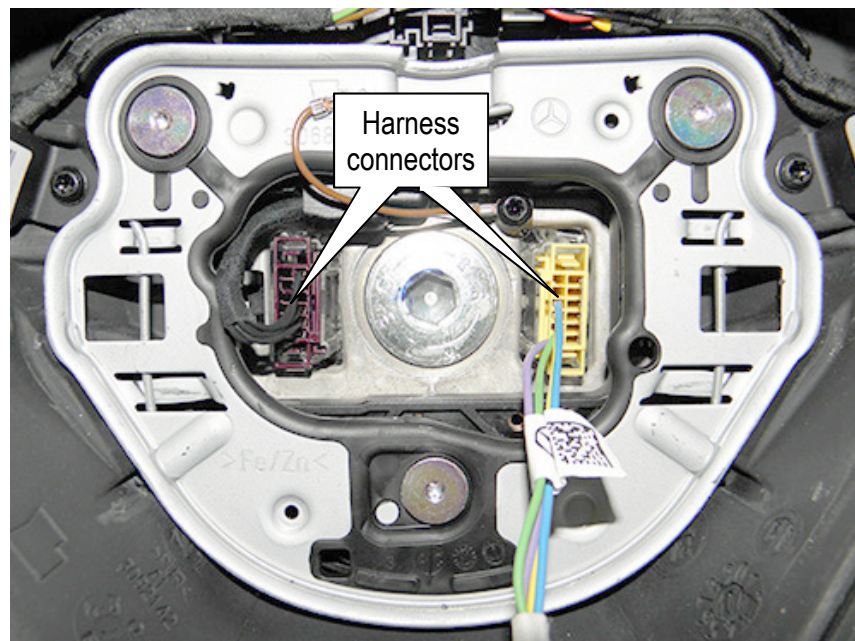
Figure 23

26. Connect the steering wheel harness connectors that were disconnected in step 12.
