Recall Campaign

May 2018
FL753
NHTSA#17V-729

Subject: TBB IMMI Seat Belt Buckle Rods

Models Affected: Specific Thomas Built Buses Saf-T-Liner C2, HDX, and EFX buses and Minotour DRW and SRW school buses manufactured November 23, 2015, through June 15, 2016.

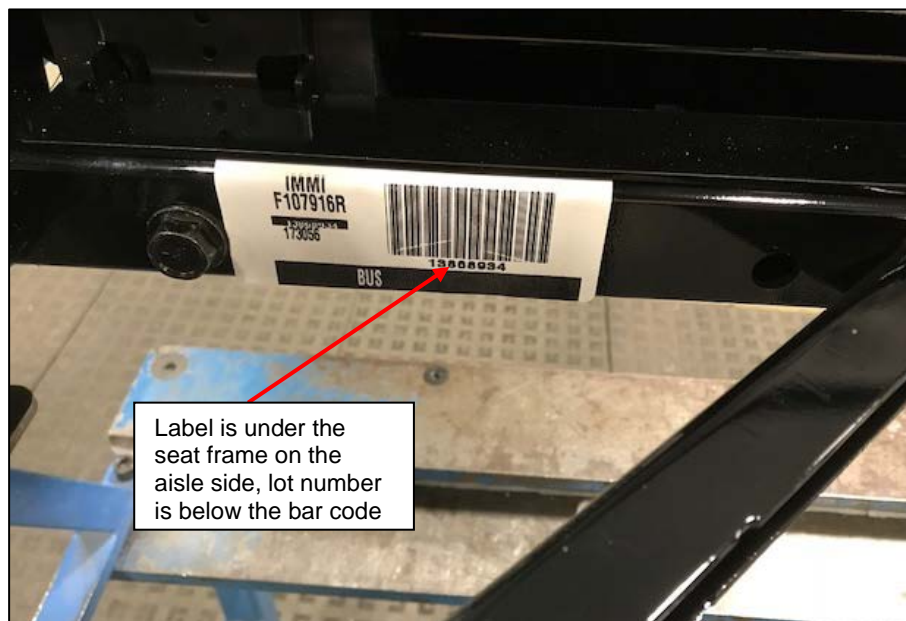
Figure 3: Label on the Seat Frame Rail with the Lot Number

- Screw the nuts on either end of the mounting rod.
- Write seat lot number, found on the label underneath the seat frame, on the mounting rod.
- Write the VIN on the mounting rod.
- Using a paint pen, mark the mounting rod with a red dot.

7. After removing the mounting rod, prepare it for shipping to IMMI. See **Figures 3 and 4**.
