Southeast Toyota Distributors, LLC

TECHNICAL INSTRUCTIONS
FOR
VOLUNTARY SAFETY RECALL CAMPAIGN SET17C
4RUNNER BILLET GRILLE OVERLAY
CERTAIN 2015, 2016, 2017, AND 2018 MODEL YEAR 4RUNNER VEHICLES

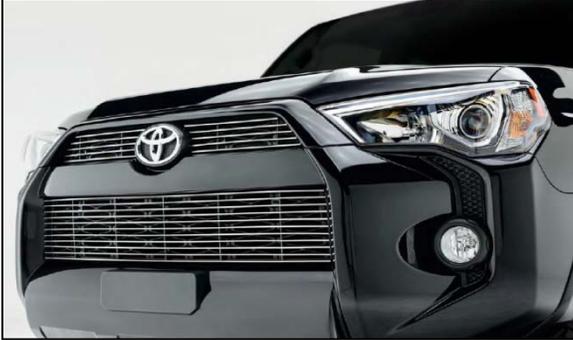
BG2000 Billet Grille Overlay

SET has either installed or sold to dealers to install an accessory Billet Grille Overlay since October, 2014. SET began receiving Billet Grille Overlay kits with a revised U-nut as of July 19, 2017. The revised U-nut may fracture when installed or in the field. If the U-nut fractures, the Billet Grill Overlay may detach from the grille and cause a hazard to following traffic.

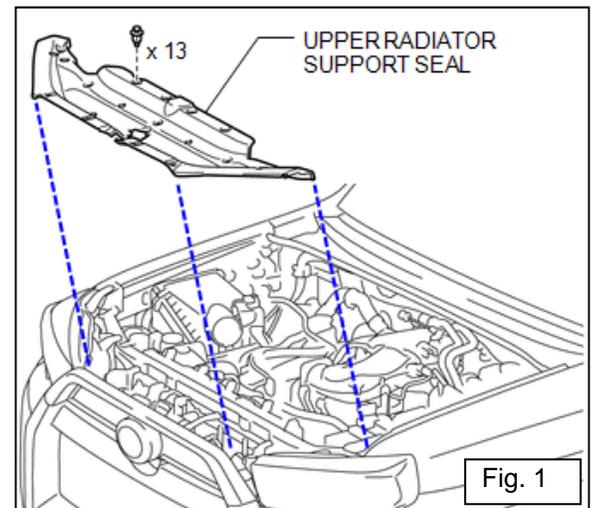
1. Remove the 13 push pins retaining the upper radiator support seal and remove the cover. (Fig. 1)

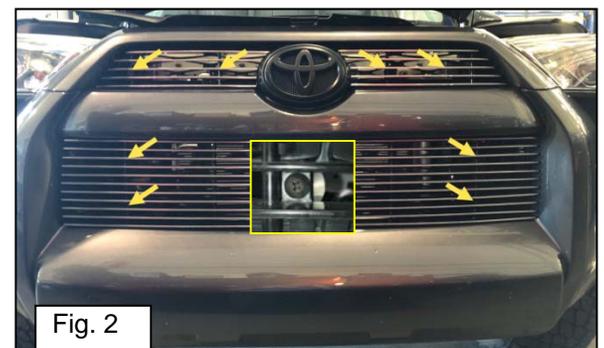
2. Locate the 8 phillips head screws to be replaced in the area shown. (Fig. 2)

HINT: Replace the screw and hardware assemblies one at a time to simplify this procedure.

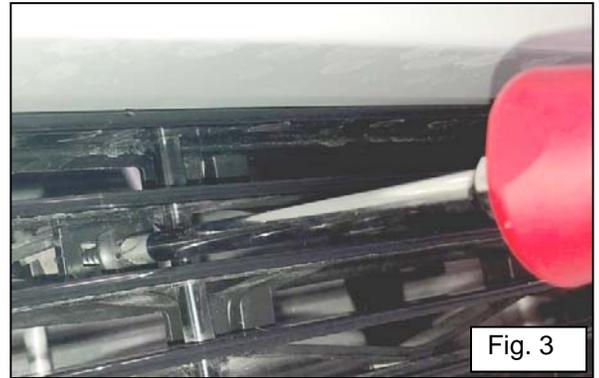
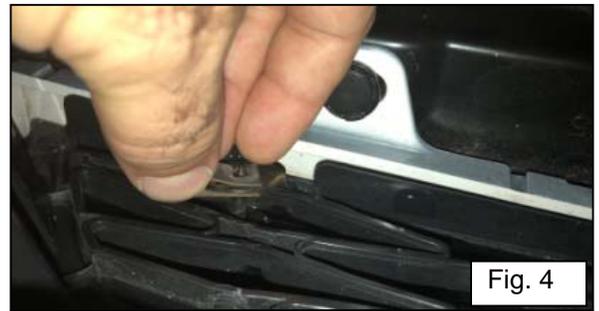
- Using a phillips screw driver, remove screw (Fig. 3) while holding the U-nut (Fig. 4)

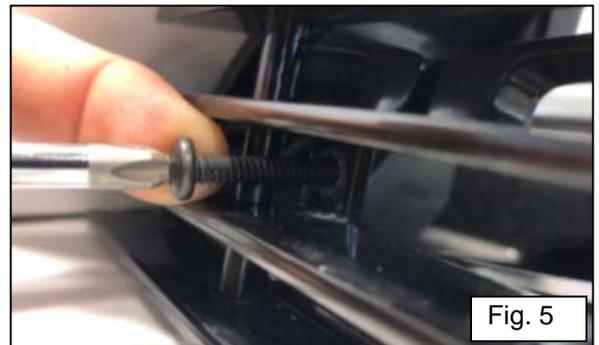
- Insert new machine screw into front of grill into hole which screw was removed. (Fig. 5)

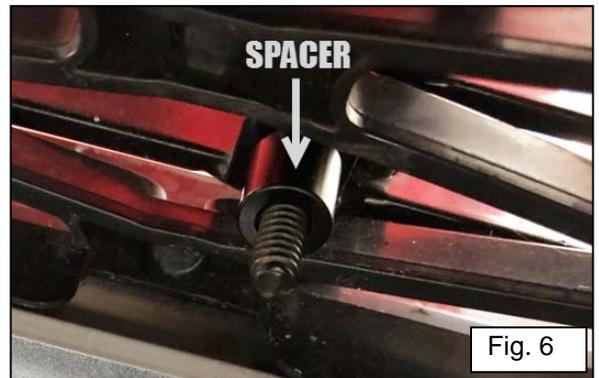
- Insert spacer onto screw from the back of grille. (Fig. 6)

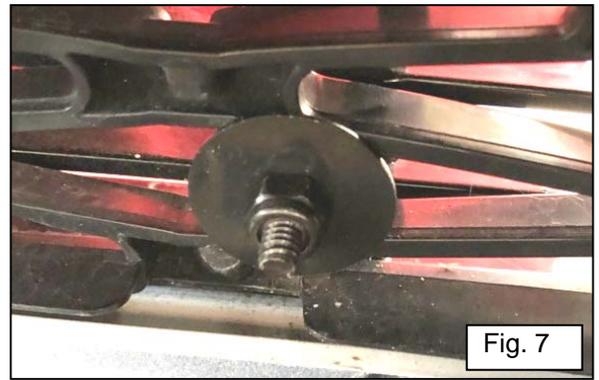
- Place washer and nylock nut on the machine screw. Tighten until nut makes light contact to washer.

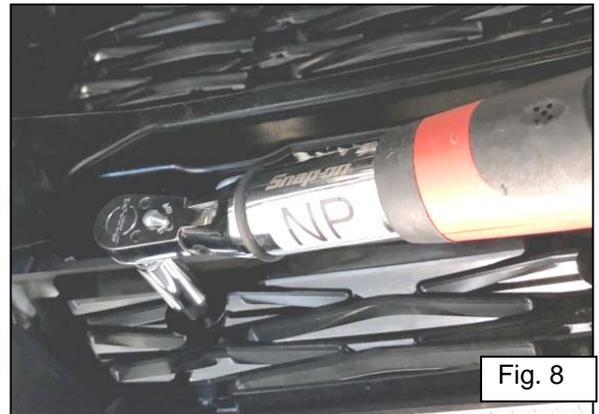
- While holding screw with screw driver tighten nylock nut to 21 in/lbs with torque wrench.(Fig. 8)

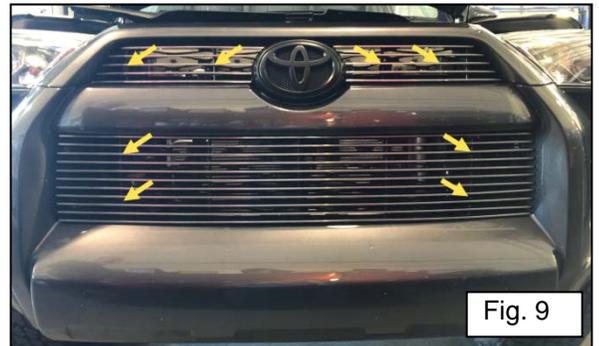
- Repeat steps 3-7 for all eight screws attaching the grille to vehicle. (Fig. 9)

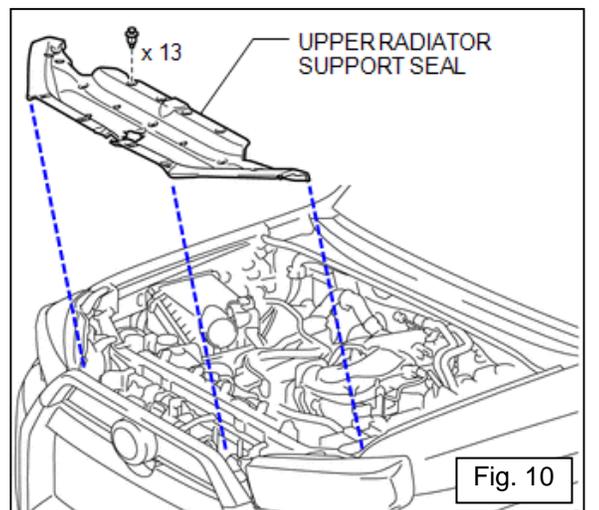
- Install upper radiator support seal and Install the 13 push pins retaining the cover. (Fig. 10)
