GROUP Safety Recall Campaign	MODEL 2012-2013MY Forte & Forte Koup (TD) 2014MY Forte & Forte Koup (YD)
	NUMBER SC158	DATE January 2018
SAFETY RECALL CAMPAIGN		
SUBJECT: BRAKE PEDAL STOPPER PAD REPLACEMENT (SC158)

This bulletin provides the procedure to replace the brake pedal stopper pad with an improved one on some 2012-2014MY Forte & Forte Koup (TD/YD) produced from May 2, 2012 through February 28, 2014. The material of the brake pedal stopper pad may deteriorate over time allowing the stop lamp switch plunger to remain extended when the brake pedal is released. A deteriorated pad can result in:

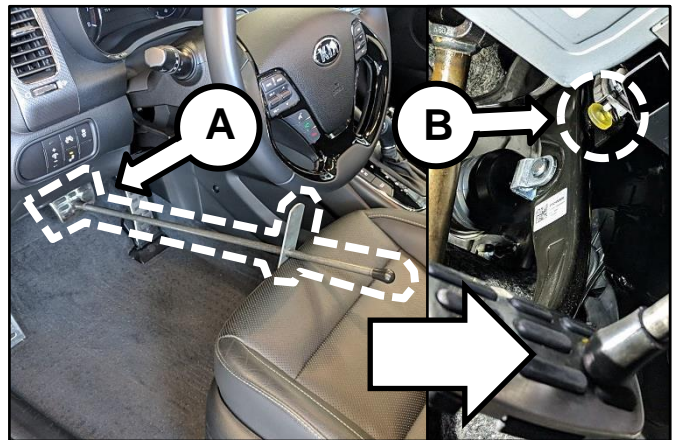
3. The brake pedal stopper (B) is mounted on the brake pedal retainer arm (C), in-line with the brake stop lamp switch (D).

All pictures of the brake stopper are for reference use only. The old stopper requiring removal may have a different color or appearance.

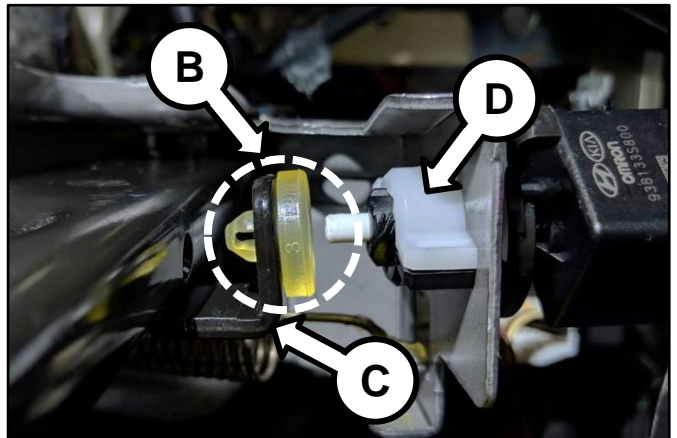
4. Insert a clip/trim tool (E) in between the brake pedal stopper pad and the brake pedal retainer arm as shown to remove the brake pedal stopper pad.

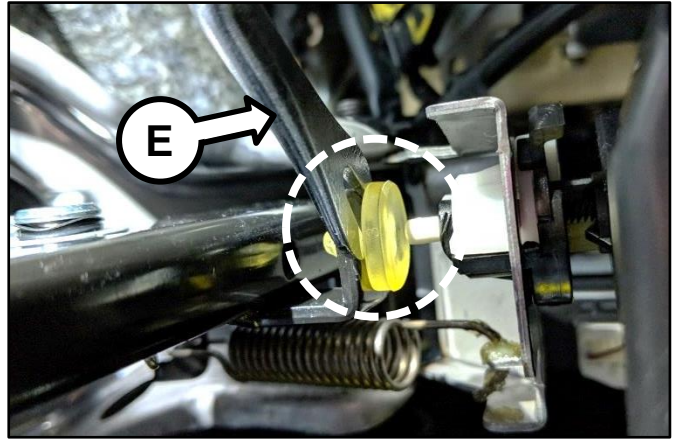
5. Cut the nub off of the removed brake stopper pad (B) where shown and discard the old brake stopper pad.

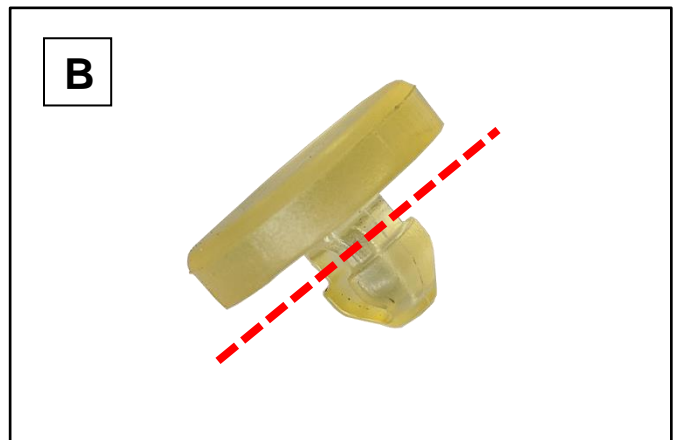
6. Install the new brake stopper (B) by pressing the nub through the pedal arm (C) mounting hole shown.

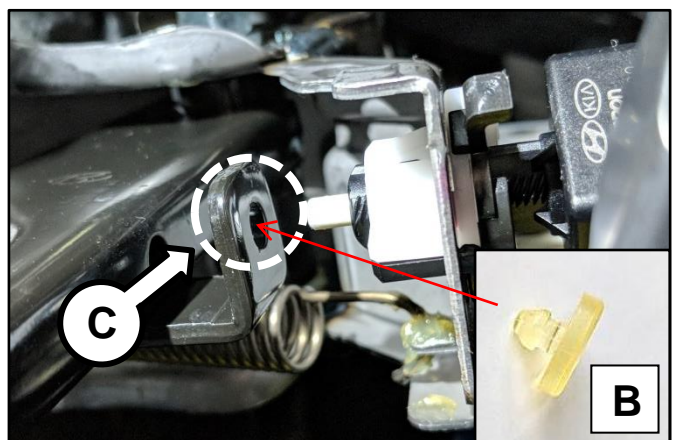
7. Remove the brake depressor tool. Without pressing the brake pedal adjust the gap between the end of the metal threaded housing of the stop lamp switch (D) and the brake pedal stopper pad (B).

Gap Specification:

1.0 - 2.0 mm (0.04 - 0.08. in)

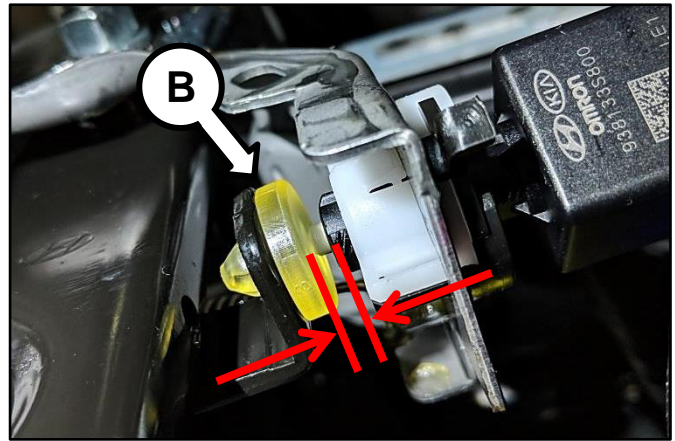
8. Check the proper function of the rear brake lamps. When applying the brake pedal, the brake lamps should illuminate on. After releasing the pedal, the brake lamps should shut off.
