<b>HYUNDAI</b> <b>Technical Service Bulletin</b>	GROUP <b>RECALL</b>	NUMBER <b>17-01-074</b>
	DATE <b>DECEMBER, 2017</b>	MODEL(S) <b>SANTA FE SPORT (AN)</b>

**SUBJECT:** 2018 SANTA FE SPORT (AN) CURTAIN AIRBAG REPLACEMENT  
(RECALL CAMPAIGN 171)

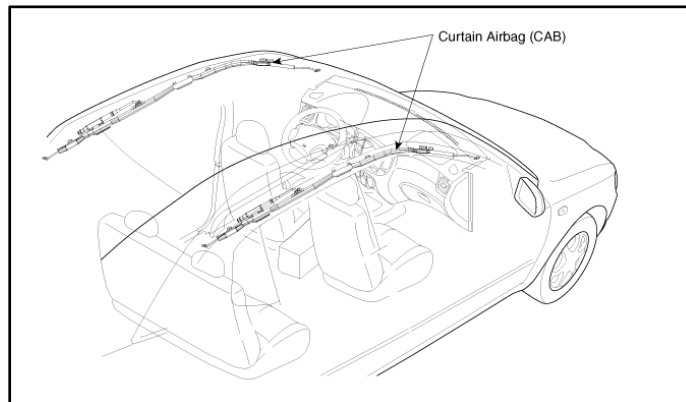
**Description:** Certain 2018MY Santa Fe Sport (AN) vehicles may contain curtain airbag modules with an inflator that could potentially not meet specification. If the curtain airbag inflator does not meet specification, the airbag may not inflate as designed in a collision. A failure of the curtain airbags to properly inflate could increase the risk of injury to the driver and the passengers in a side impact/rollover collision. This bulletin describes the procedure to replace the driver’s side and passenger’s side curtain airbags.

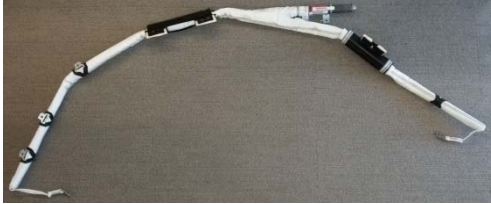
Curtain Air Bag Module, RH	85020-4Z000QQH	1

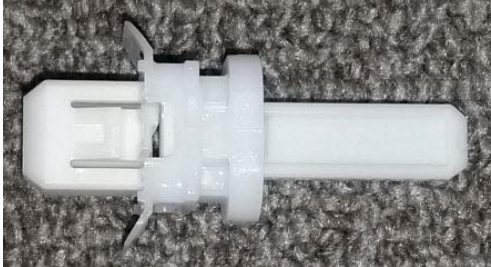
Clip-Trim Mtg (A-pillar tether clip)	85815-C1000QQH	2

15. Remove the screw (R) on the A-pillar trim (S) and slide the locking tab (T) out in order to replace the A pillar tether clip (U).

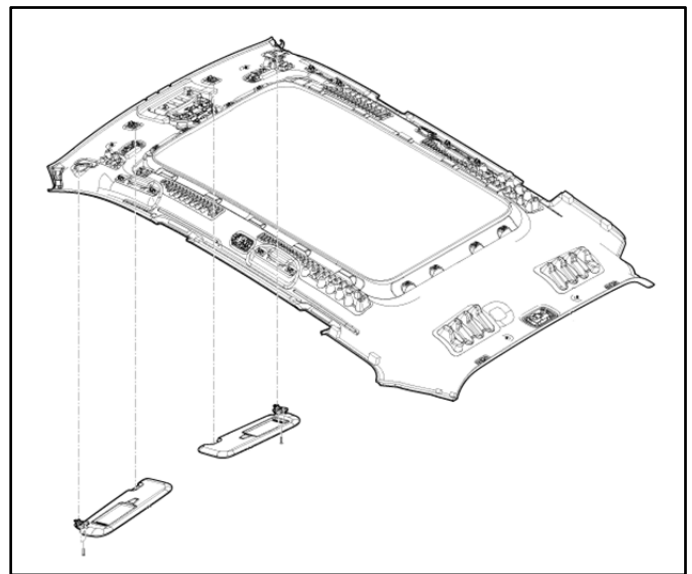
10. Place a protective cover over the dash to avoid permanent markings/scuffing on the dash panel from the corner of the headliner edges.  
Lower the headliner (N).

Use caution not to lean or crease the headliner while replacing the curtain airbag modules.

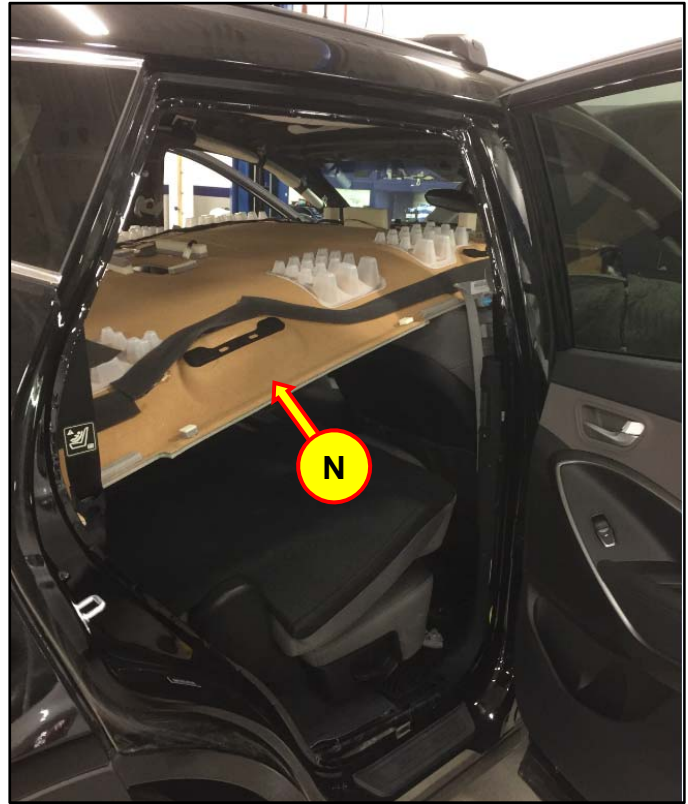
11. Carefully disconnect the driver curtain airbag harness connector by lifting up the locking tab (O) first, then separating the squib connector (P). Repeat for the passenger curtain airbag.

Be **EXTREMELY** careful when removing the locking tab. If the locking tab breaks, the entire airbag harness will need to be replaced.

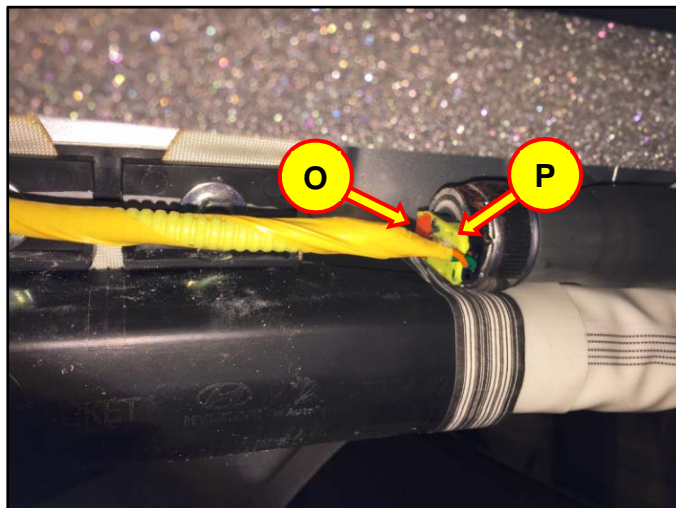
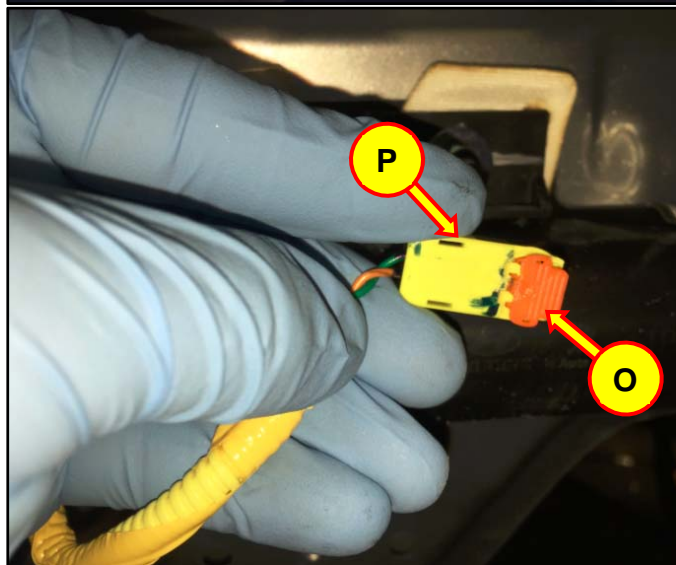
12. Remove all mounting bolts and nuts from the passenger and driver side curtain airbag assemblies and remove the curtain airbag assemblies from the vehicle.

**Bolt : 7.8 ~ 11.8 N.m (0.8 ~ 1.2 kgf.m, 5.8 ~ 8.7 lb-ft)**

**Nut : 3.9 ~ 5.9 N.m (0.4 ~ 0.6 kgf.m, 2.9 ~ 4.3 lb-ft)**

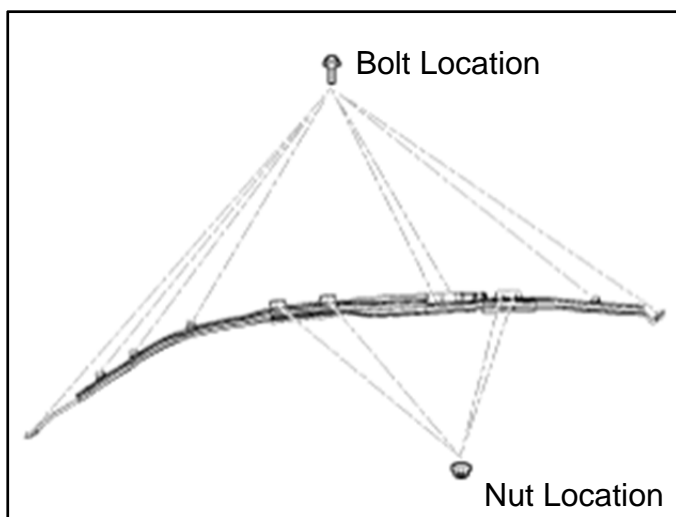
13. Cut the fabric of the front 4 attachment points (Q) on the original passenger and driver side curtain airbag assemblies that have been removed from the vehicle.

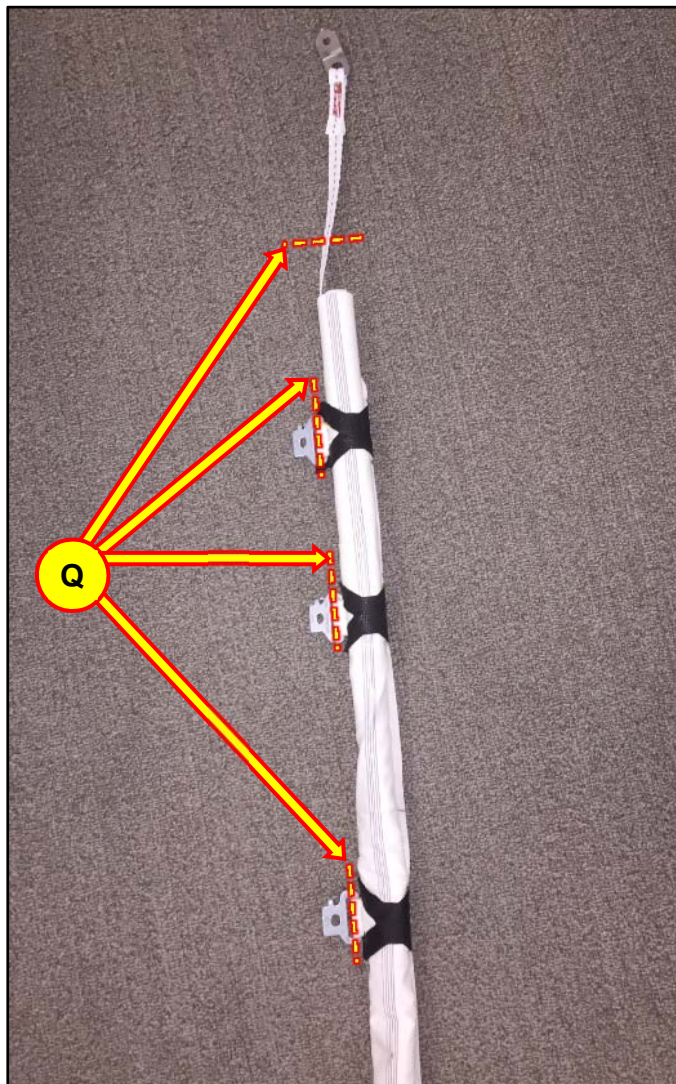
14. Install the new passenger and driver curtain airbag assemblies in the vehicle following the procedures detailed in the 2013-2018 Santa Fe Sport Service Manual (Restraint) section. Torque each nut and bolt to the spec shown below.

**Bolt : 7.8 ~ 11.8 N.m (0.8 ~ 1.2 kgf.m, 5.8 ~ 8.7 lb-ft)**

**Nut : 3.9 ~ 5.9 N.m (0.4 ~ 0.6 kgf.m, 2.9 ~ 4.3 lb-ft)**

**Never twist the curtain airbag assembly during installation. If the curtain airbag assembly is twisted, it may not operate as designed.**

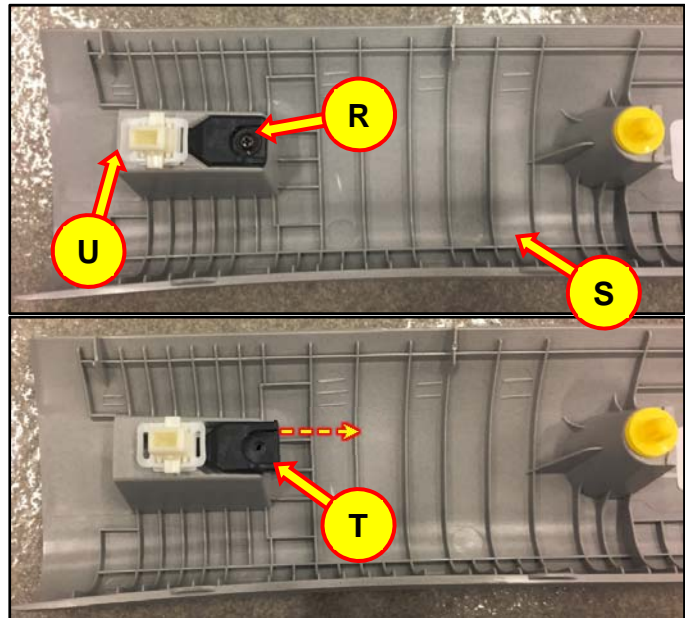
**NOTE: A-pillar tether clips MUST be replaced prior to reinstalling the A pillar trims.**
