HYUNDAI Technical Service Bulletin	GROUP RECALL	NUMBER 18-01-008
	DATE JANUARY, 2018	MODEL(S) SANTA FE SPORT (AN)
SUBJECT: 2018 SANTA FE SPORT (AN) CURTAIN AIRBAG REPLACEMENT (RECALL CAMPAIGN 171)

Description: Certain 2018MY Santa Fe Sport (AN) vehicles may contain curtain airbag modules with an inflator that could potentially not meet specification. If the curtain airbag inflator does not meet specification, the airbag may not inflate as designed in a collision. A failure of the curtain airbags to properly inflate could increase the risk of injury to the driver and the passengers in a side impact/rollover collision. This bulletin describes the procedure to replace the driver’s side and passenger’s side curtain airbags.

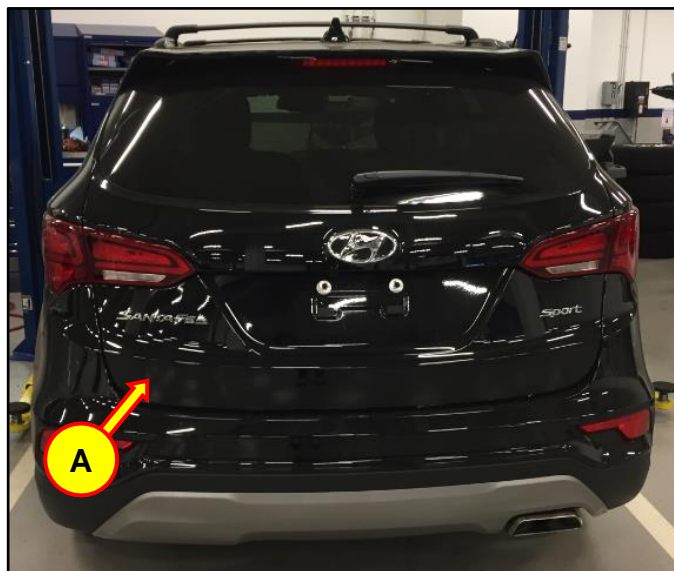
3. Remove the luggage covering mat (B), luggage floor front board (C), luggage tray board (D), jack tool set (E), luggage floor box (F) following procedures detailed in the 2013-2018 Santa Fe Sport Service Manual (Body (Interior and Exterior)) section.

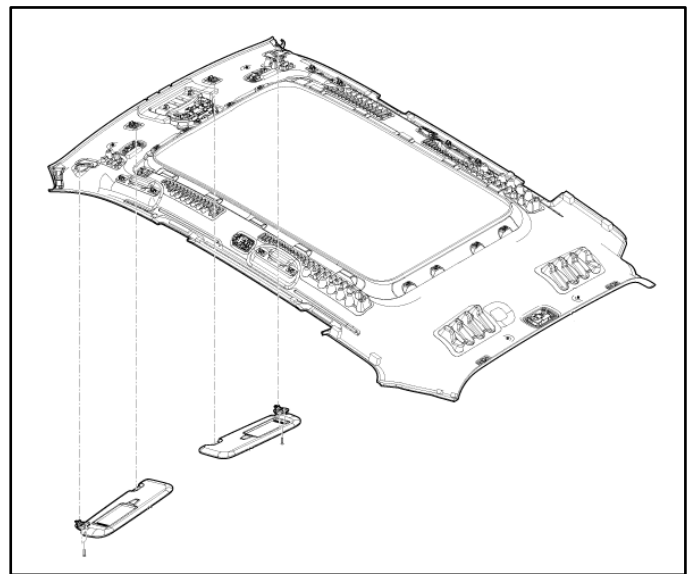
10. Place a protective cover over the dash to avoid permanent markings/scuffing on the dash panel from the corner of the headliner edges.
Lower the headliner (N).

Use caution not to lean or crease the headliner while replacing the curtain airbag modules.

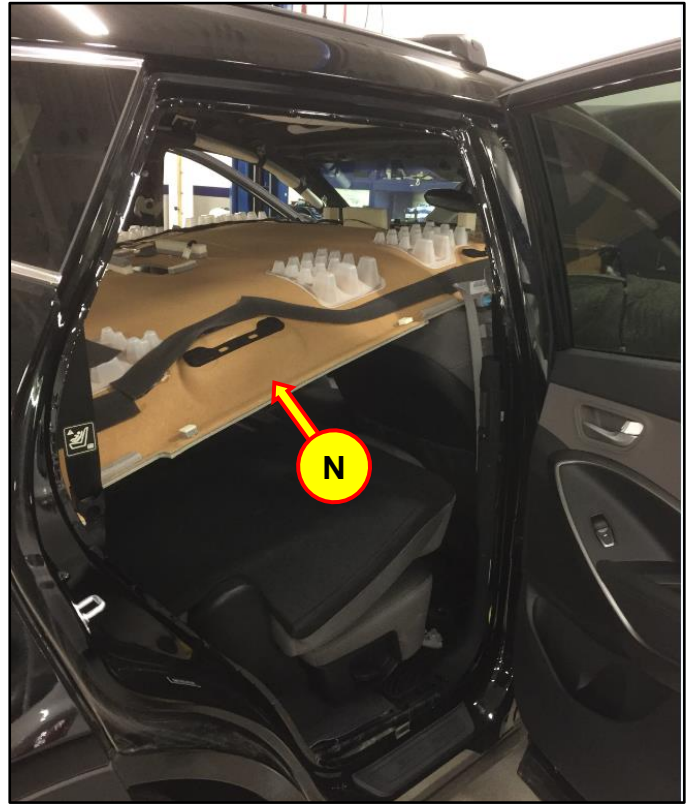
11. Carefully disconnect the driver curtain airbag harness connector by lifting up the locking tab (O) first, then separating the squib connector (P). Repeat for the passenger curtain airbag.

Be **EXTREMELY** careful when removing the locking tab. If the locking tab breaks, the entire airbag harness will need to be replaced.

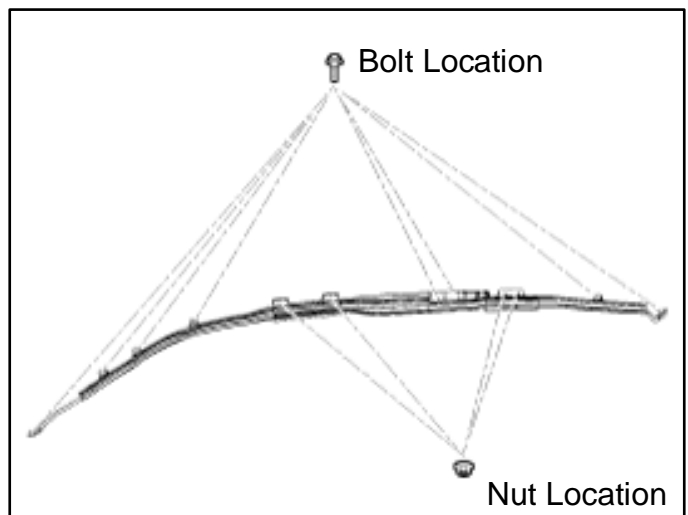
13. Install the new passenger and driver curtain airbag assemblies in the vehicle following the procedures detailed in the 2013-2018 Santa Fe Sport Service Manual (Restraint) section. Torque each nut and bolt to the spec shown below.

Bolt : 7.8 ~ 11.8 N.m (0.8 ~ 1.2 kgf.m, 5.8 ~ 8.7 lb-ft)

Nut : 3.9 ~ 5.9 N.m (0.4 ~ 0.6 kgf.m, 2.9 ~ 4.3 lb-ft)

Never twist the curtain airbag assembly during installation. If the curtain airbag assembly is twisted, it may not operate as designed.

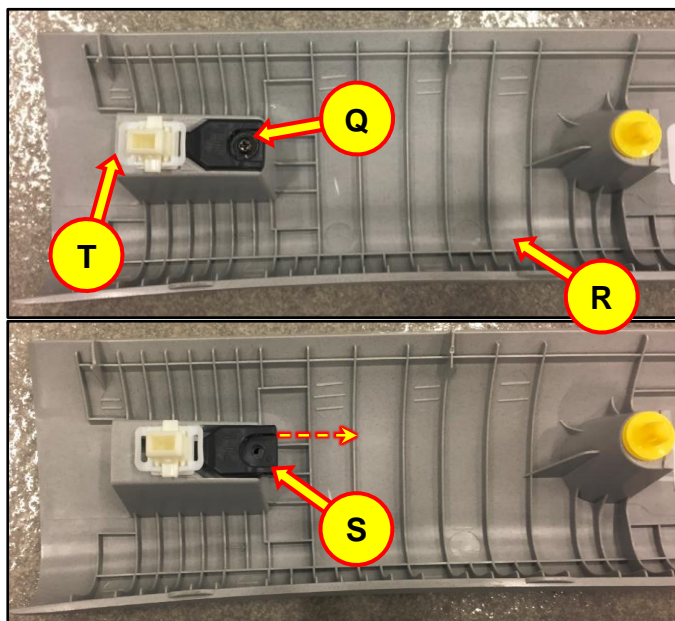
14. Remove the screw (Q) on the A-pillar trim (R) and slide the locking tab (S) out in order to replace the A pillar tether clip (T).

NOTE: A-pillar tether clips MUST be replaced prior to reinstalling the A pillar trims.
