2004-2006 B-SERIES - PASSENGER AIR BAG SAFETY RECALL 1817L

January 22, 2026.

### PASSENGER AIRBAG INFLATOR REPLACEMENT

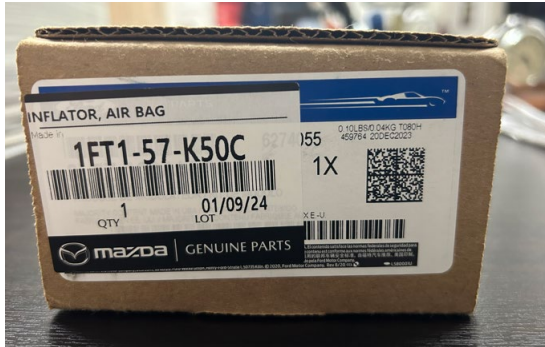
Inflator Part #1FT1-57-K50C

Inflator in box with warning label

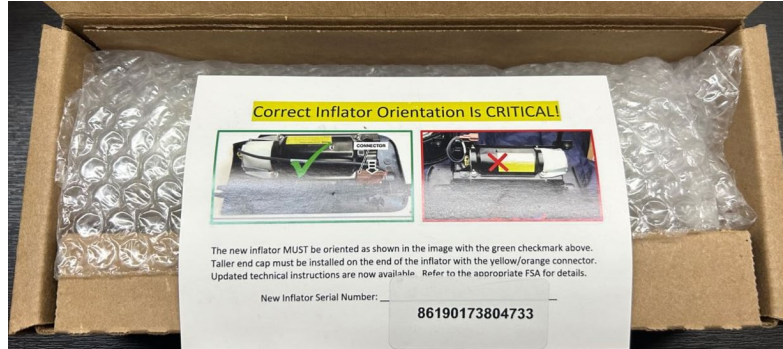
Inflator part box contents

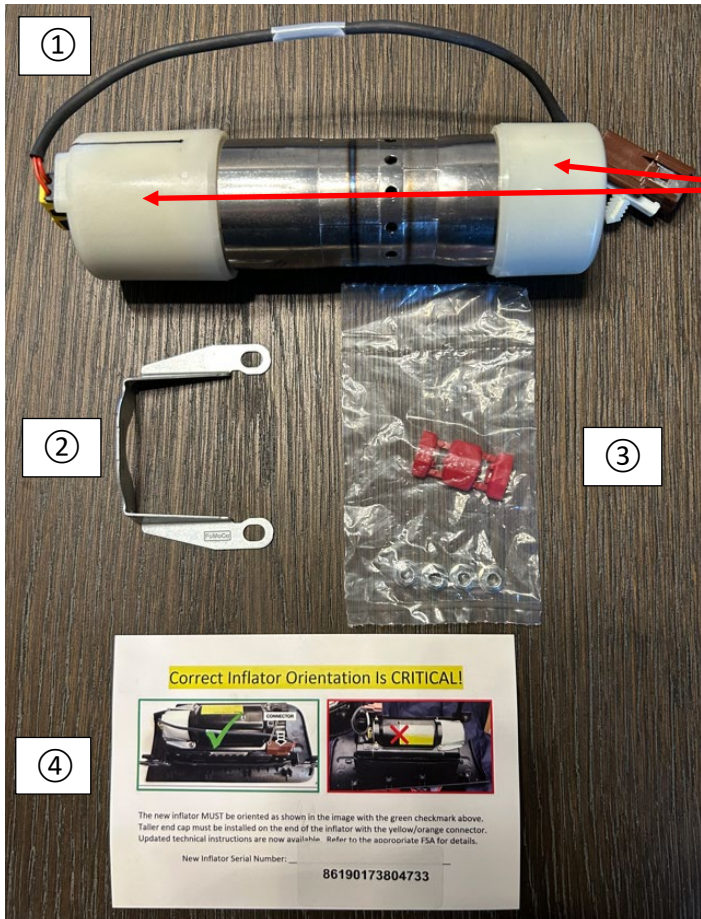
1. Inflator – **DO NOT REMOVE END CAPS AND INSTALL PREASSEMBLED, WITH THE SHORTER CAP FIRST (TAIL END CAP) INTO THE MODULE**
2. Bracket
3. Nuts (4) and clip (1)
4. PLEASE READ THIS WARNING LABEL

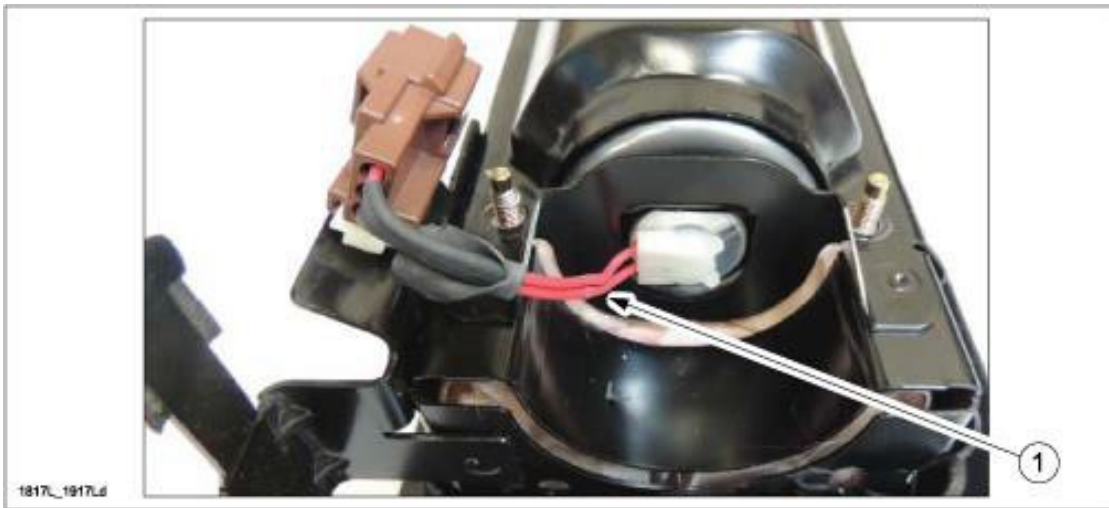
1. Cut and peel back the wiring sleeve to expose the inflator wiring (1).

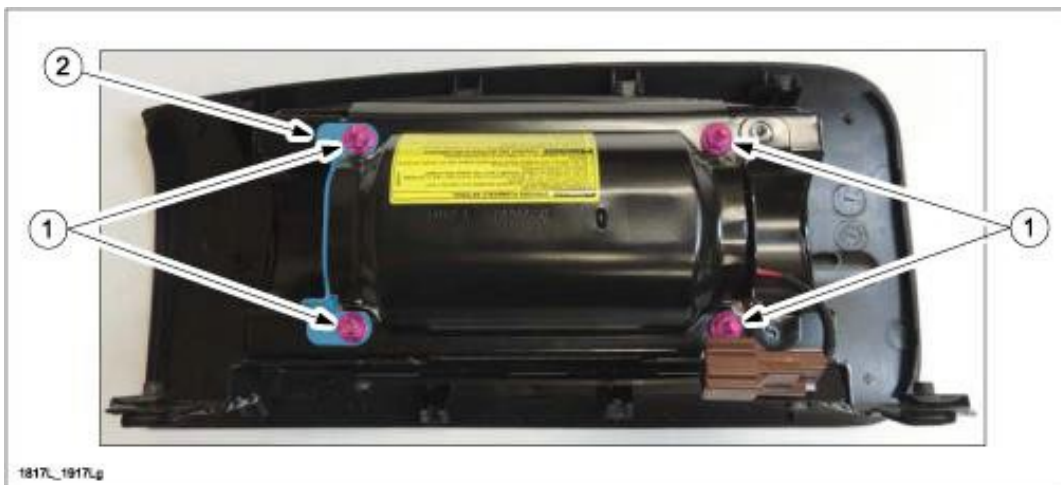
4. Remove and discard the four airbag inflator retaining nuts (1) and the bracket (2) using Hand tools.

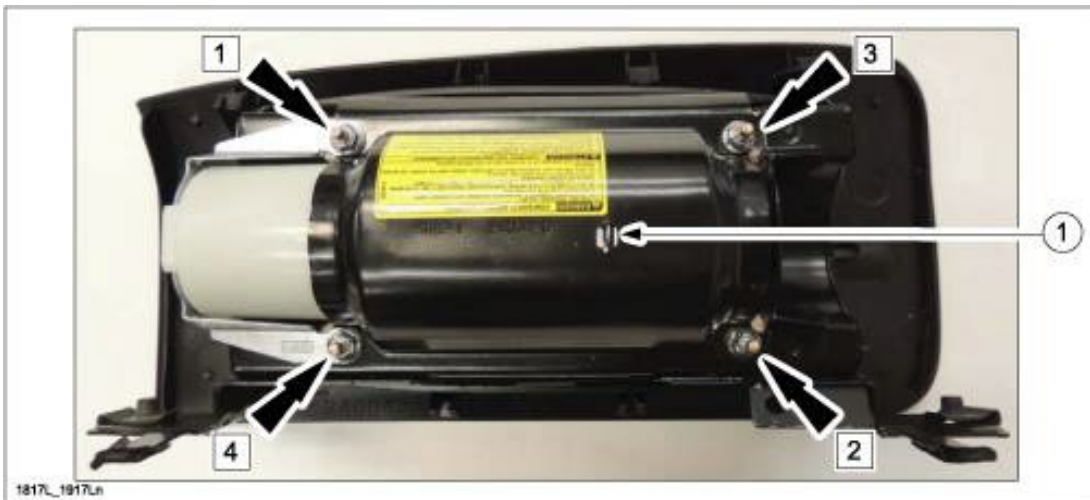
9. Install the new nuts, making sure the pop-up indicator (1) on the air bag assembly is present.

**Tightening torque: 3.9 Nm (35 lb-in) in the specified sequence [1] [2] [3] [4]**

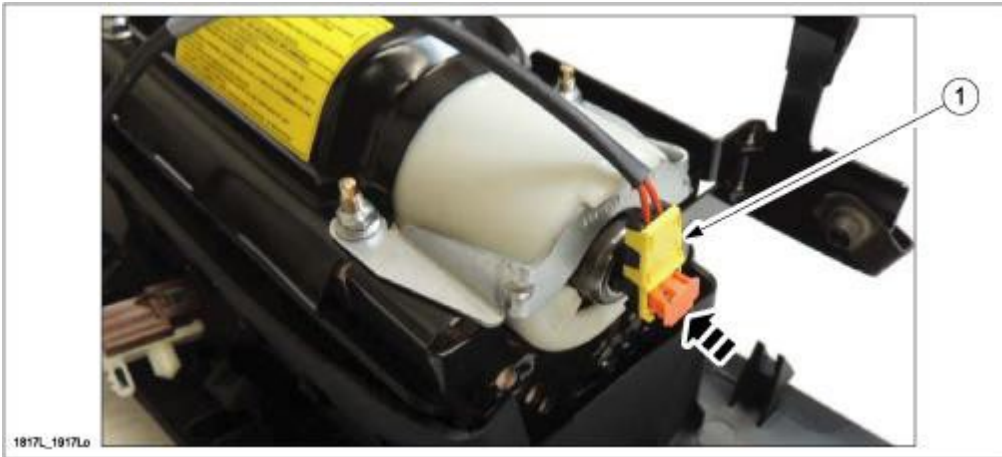
10. Align the T-shape index on both the wiring harness electrical connector and the airbag inflator, then connect the new airbag wiring harness to the inflator module and fully seat the orange tab.

11. Make sure the connection between the wiring harness electrical connector and the airbag inflator (1) is properly seated by gently pulling on the wiring harness.

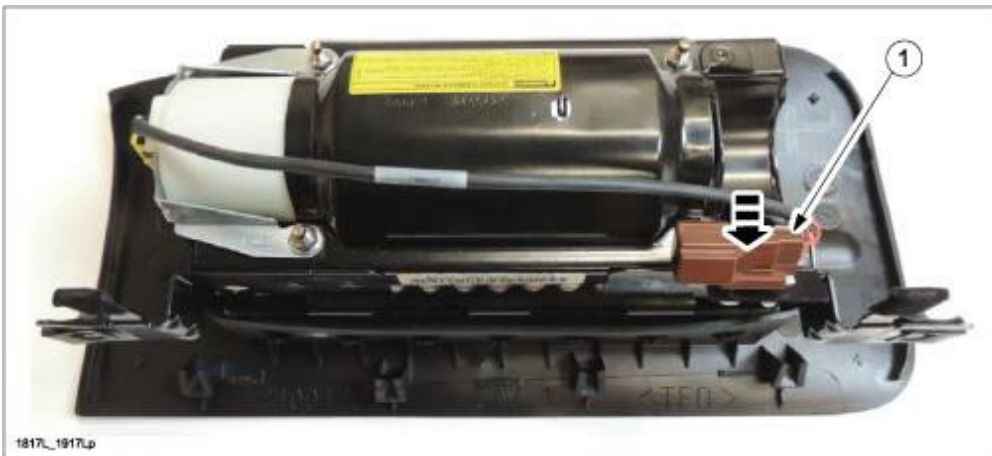
12. Install the inflator harness connector (1) to the air bag assembly bracket.

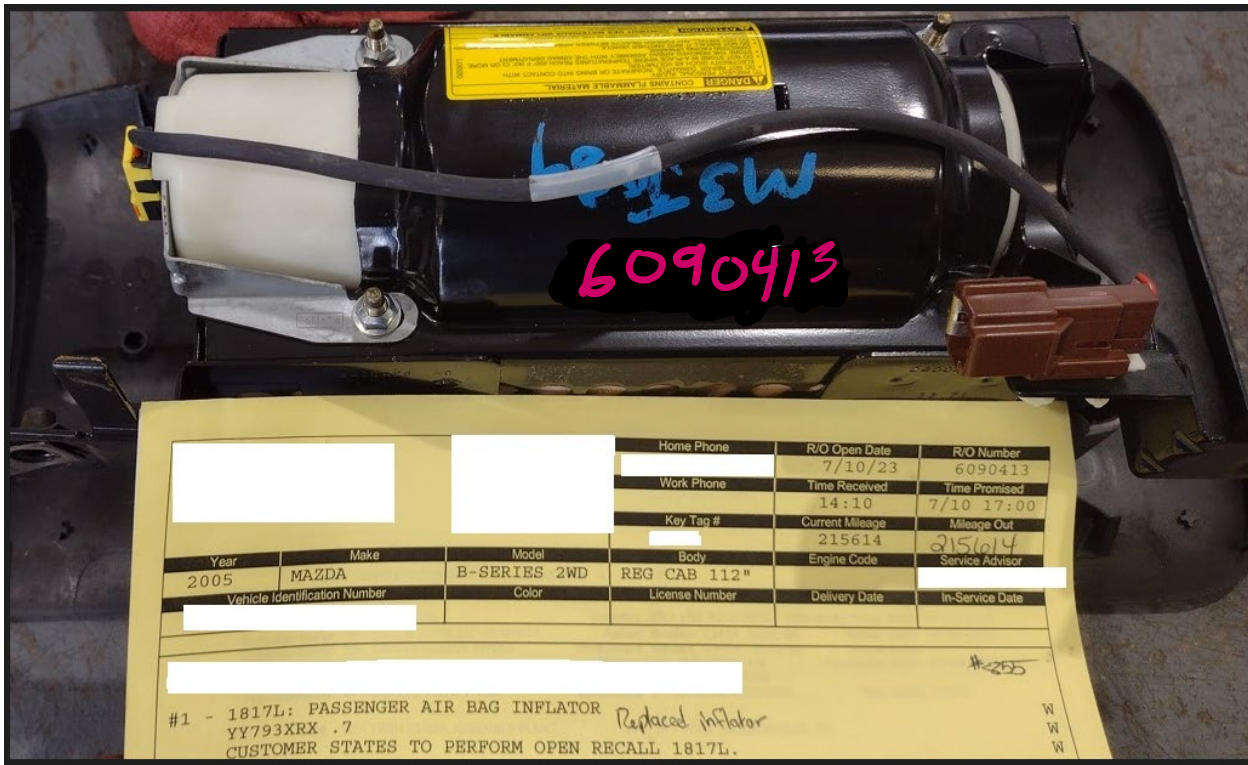
14. FINAL CHECK AND PHOTO REQUIREMENT: If any step is not correct **DO NOT PROCEED**. **Required Photo example showing correct wiring:** Write the RO# on the case of the inflator that you are repairing with a grease pencil. Alternatively you can use the RO as shown below in the photo.

- a. The large left cap has a notch in the up position ABOVE the bracket. You should NOT see the silver inflator on the left side.
- b. The wire is across the inflator, with the yellow connector on the left.
- c. Your dealer RO# is written on the inflator module housing
- d. The repair order is clearly visible in the photo. For dealers on Electronic Repair Order, the claim must have a clear pdf or jpg repair order attached as a D01 attachment ID matching the repair order on the inflator.
